Investigation of the August 1, 2002, Collapse of Roadside Billboard during Erection in Snellville, GA

U.S. Department of Labor
Occupational Safety and Health Administration
Directorate of Construction

December 2002

Report prepared by
Mohammad Ayub, PE
Dinesh Shah, PE

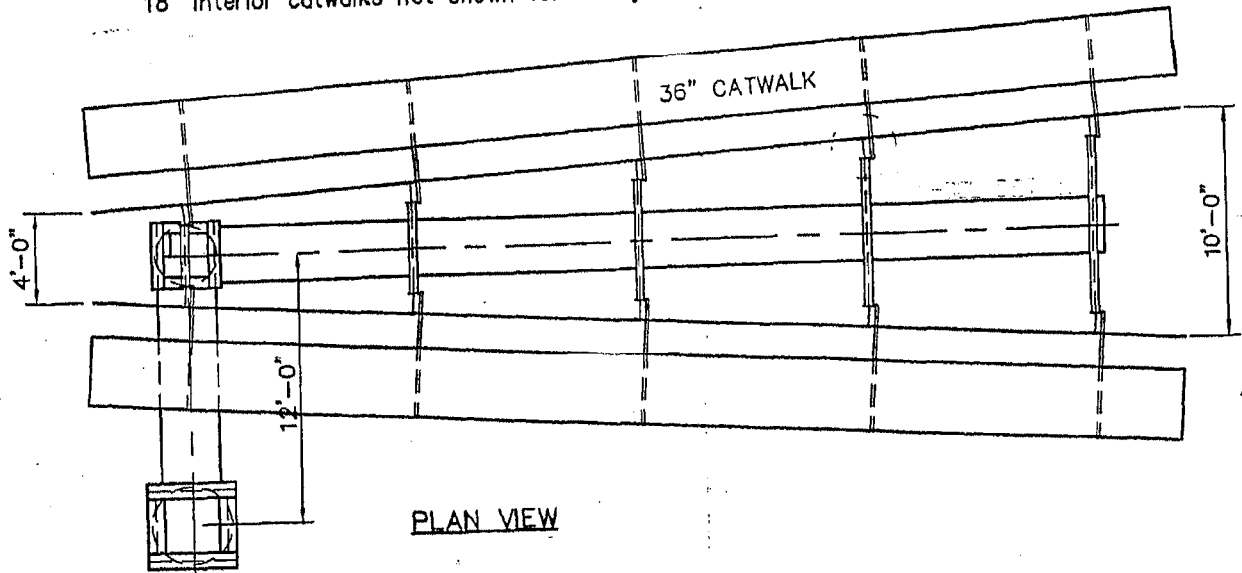
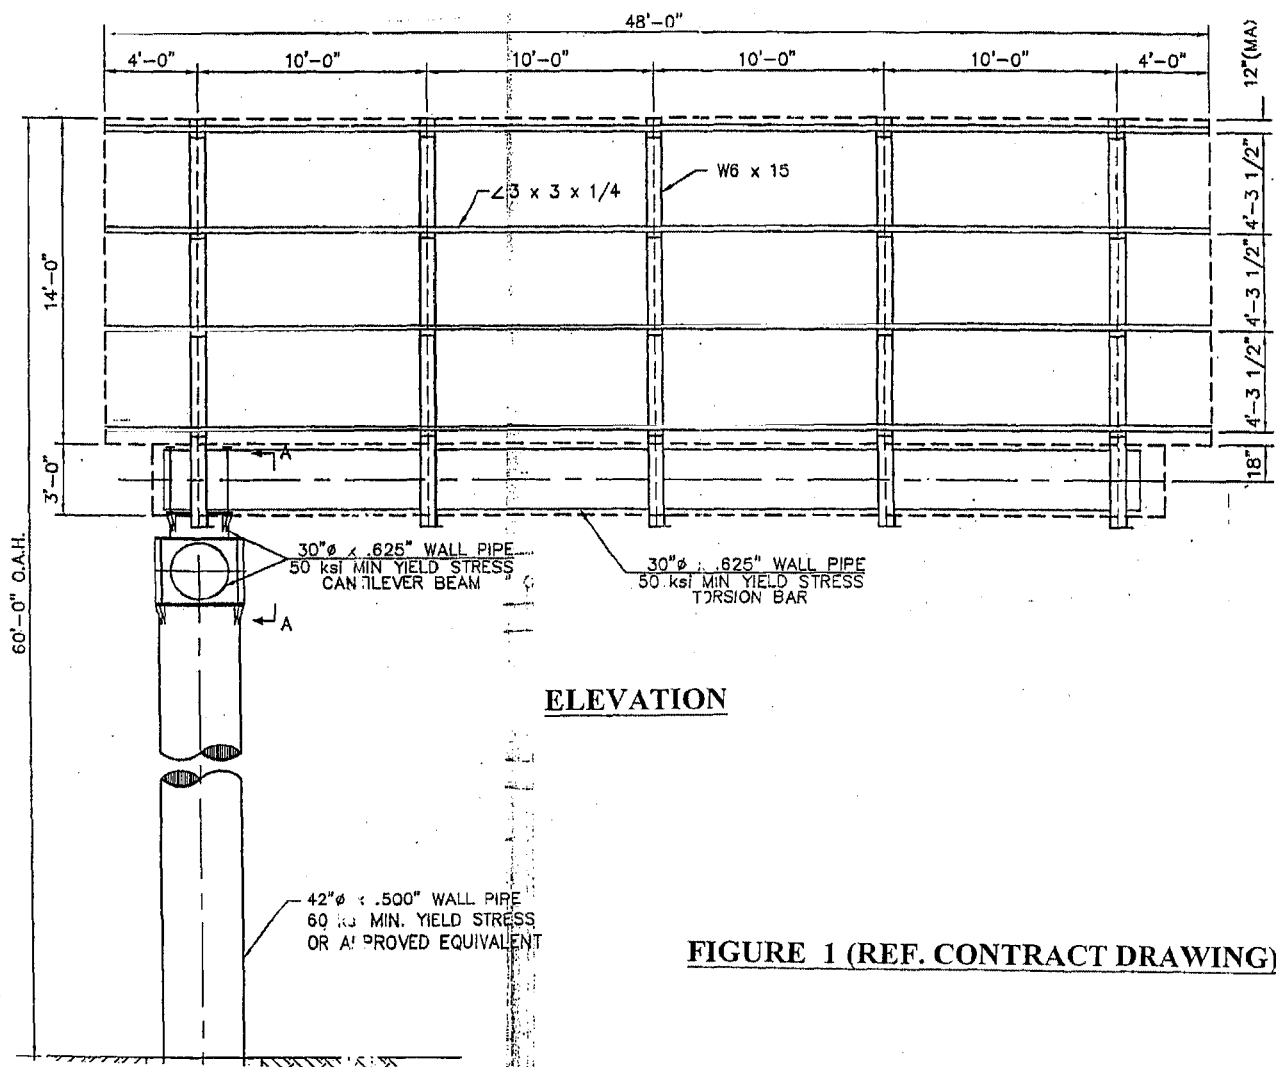
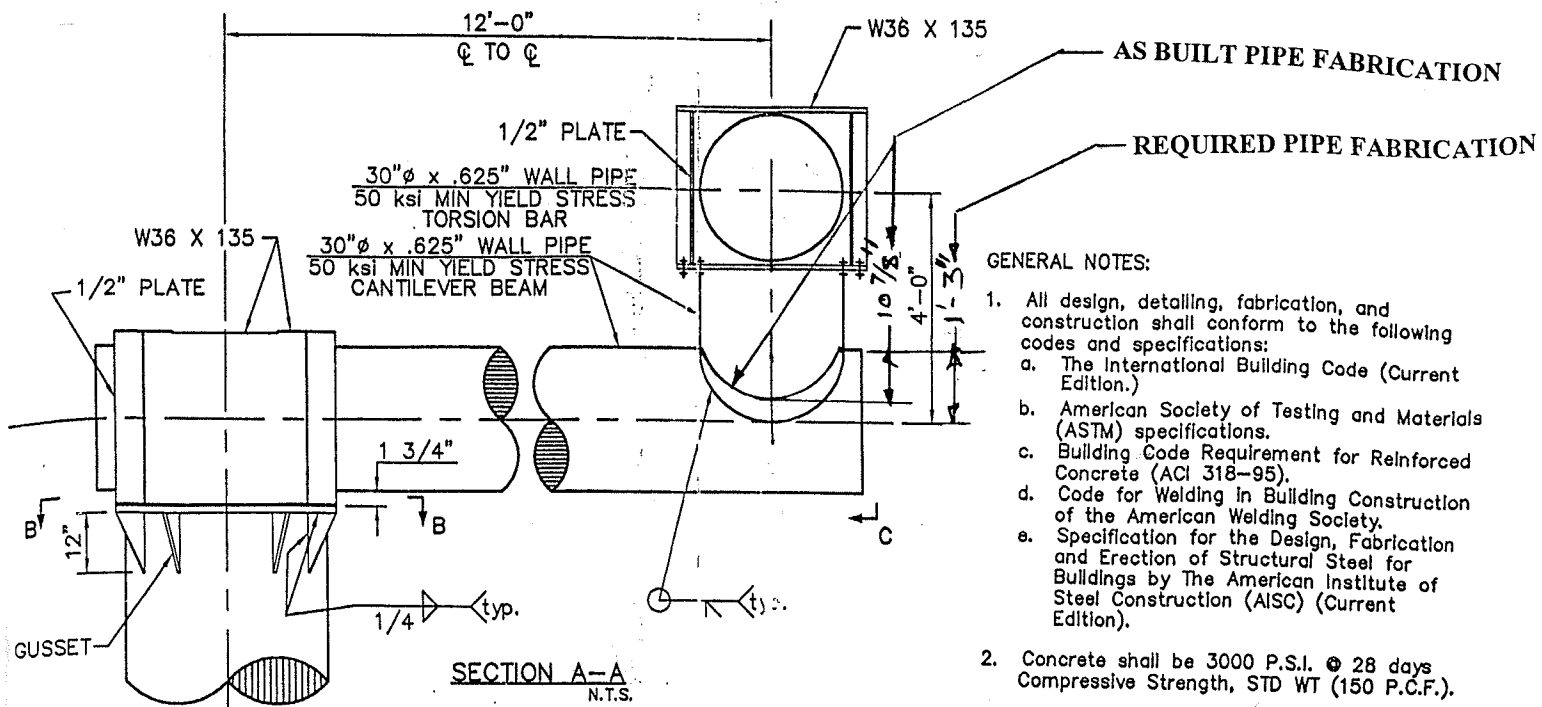
FIGURE 1 (REF. CONTRACT DRAWING)

The structural steel framing (Figures 1 & 2), including walkway and billboard, was completed one day prior to the incident. Since the steel erection was completed, steel erectors were not present on the day of the incident. On the morning of August 1, 2002, a three men work crew engaged in electrical and sign works was performing finishing work on the newly erected sign.

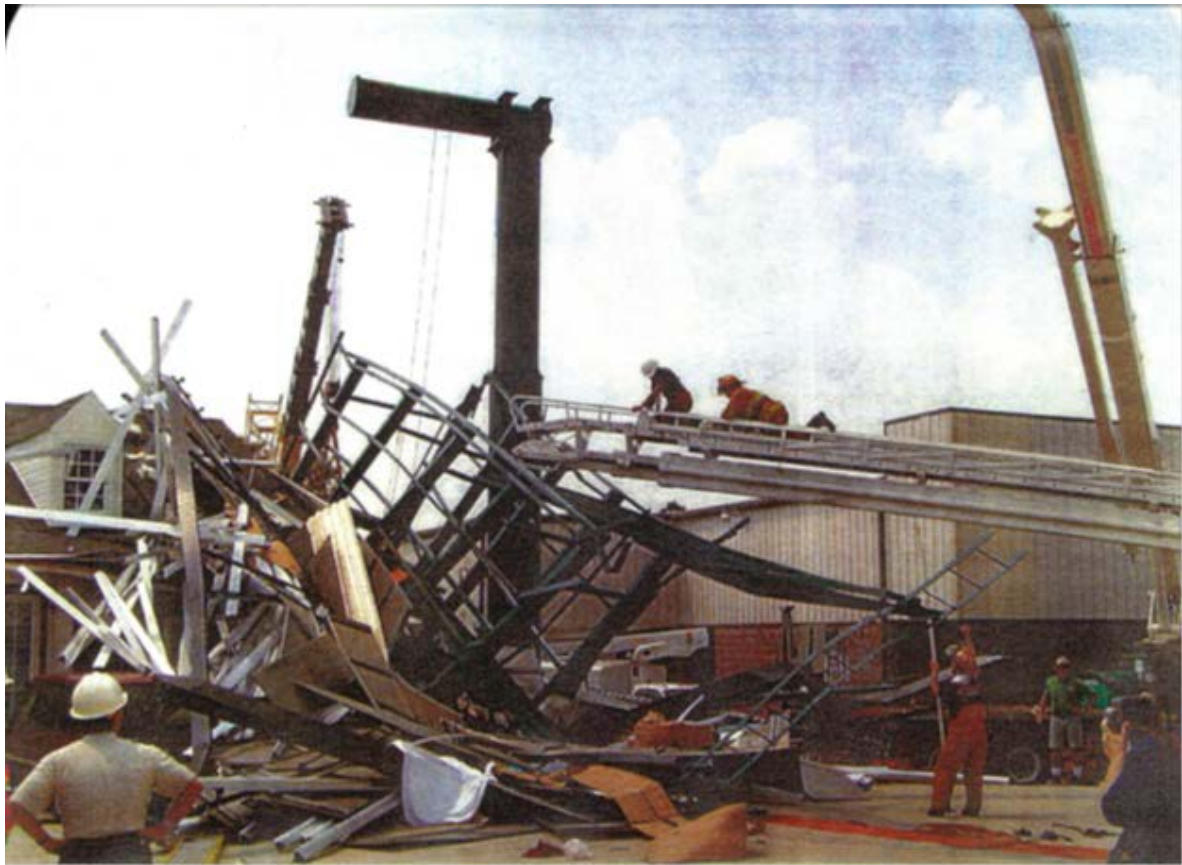
FIGURE 4

The billboard signs and a portion of the structural framing consisting of the torsion bar and the stub pipe suddenly collapsed (Figures 4 & 5) shortly before noon, killing all three workers and crushing the cars parked below (Figure 6). Fortunately there were no pedestrians present and the cars were unoccupied at the time of the collapse.

During the field visit on August 7, 2002, it was observed that the failure occurred at the welded joint between the stub pipe and the 12-foot long cantilever beam. The cantilever beam and the column remained in place during the collapse (Figure 4). The failed joint involved a complete separation of the stub pipe and the cantilever beam (Figures 7 & 8). In addition to the failure at the welded joint, there was a tearing of the tubular section of the cantilever beam near the junction of the stub pipe (Figures 9 & 10).
