INVESTIGATION OF THE OCTOBER 24, 2001 FATAL COLLAPSE OF TWO SCAFFOLD TOWERS AT 215 PARK AVENUE SOUTH IN NEW YORK, NY

U. S. Department of Labor
Occupational Safety and Health Administration

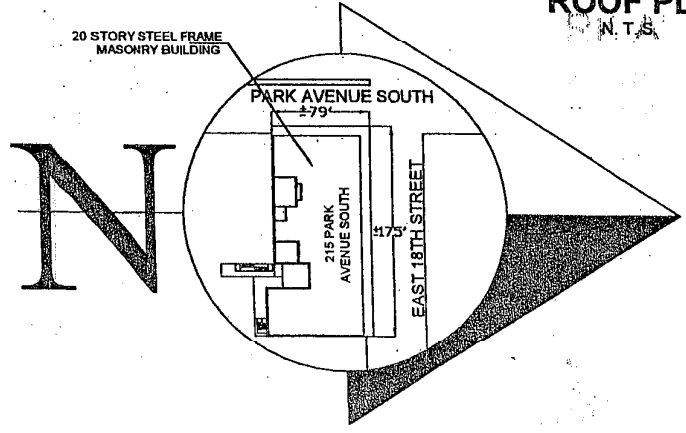
**PLOT PLAN
N.T.S.**

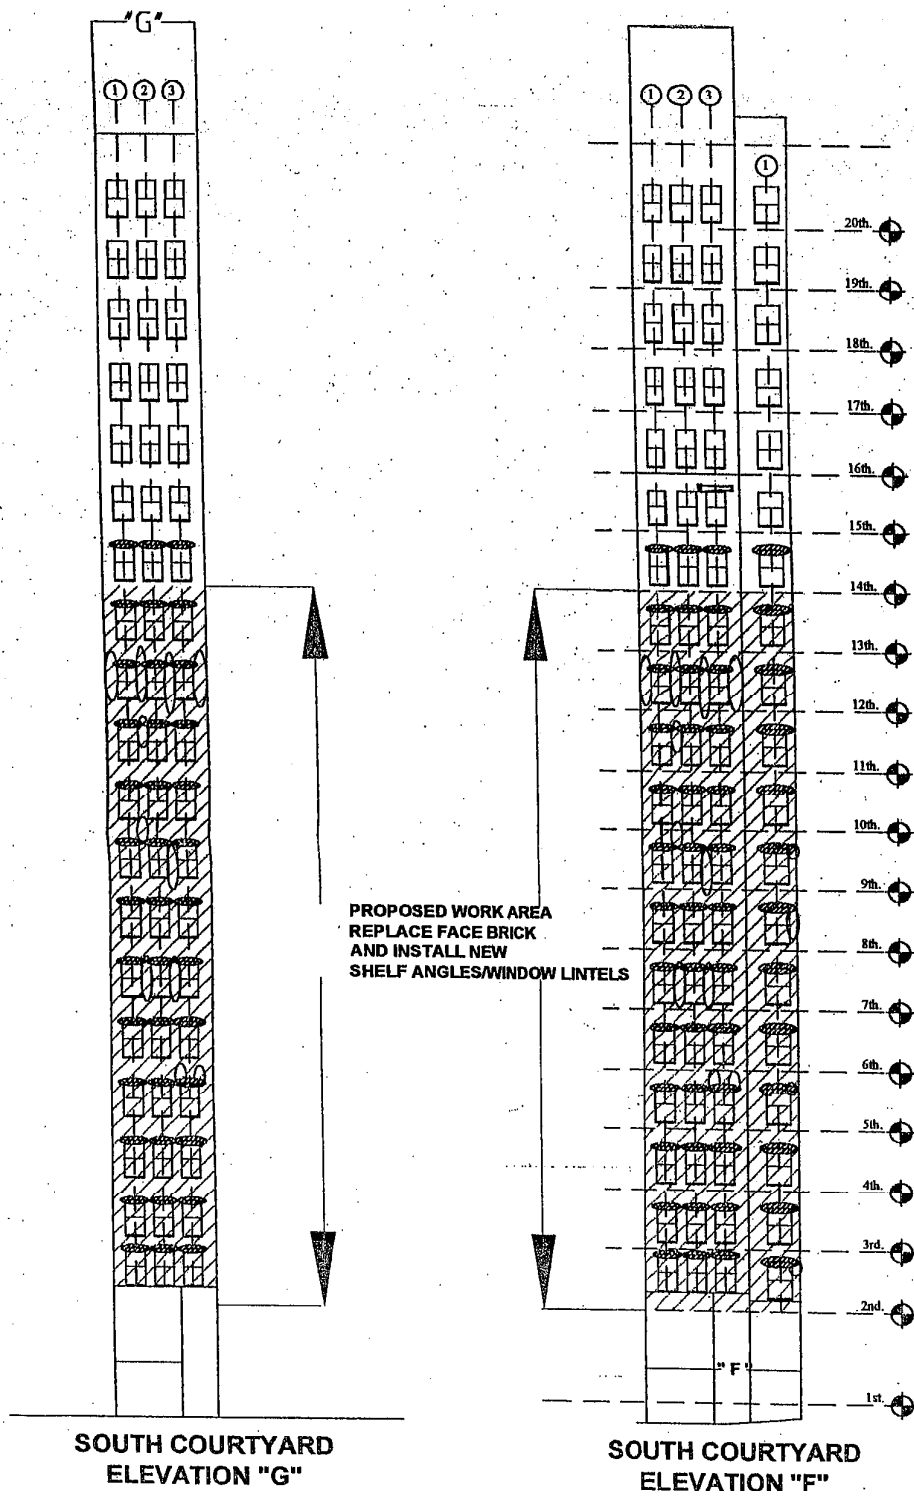
SOUTH COURTYARD ELEVATION "G"

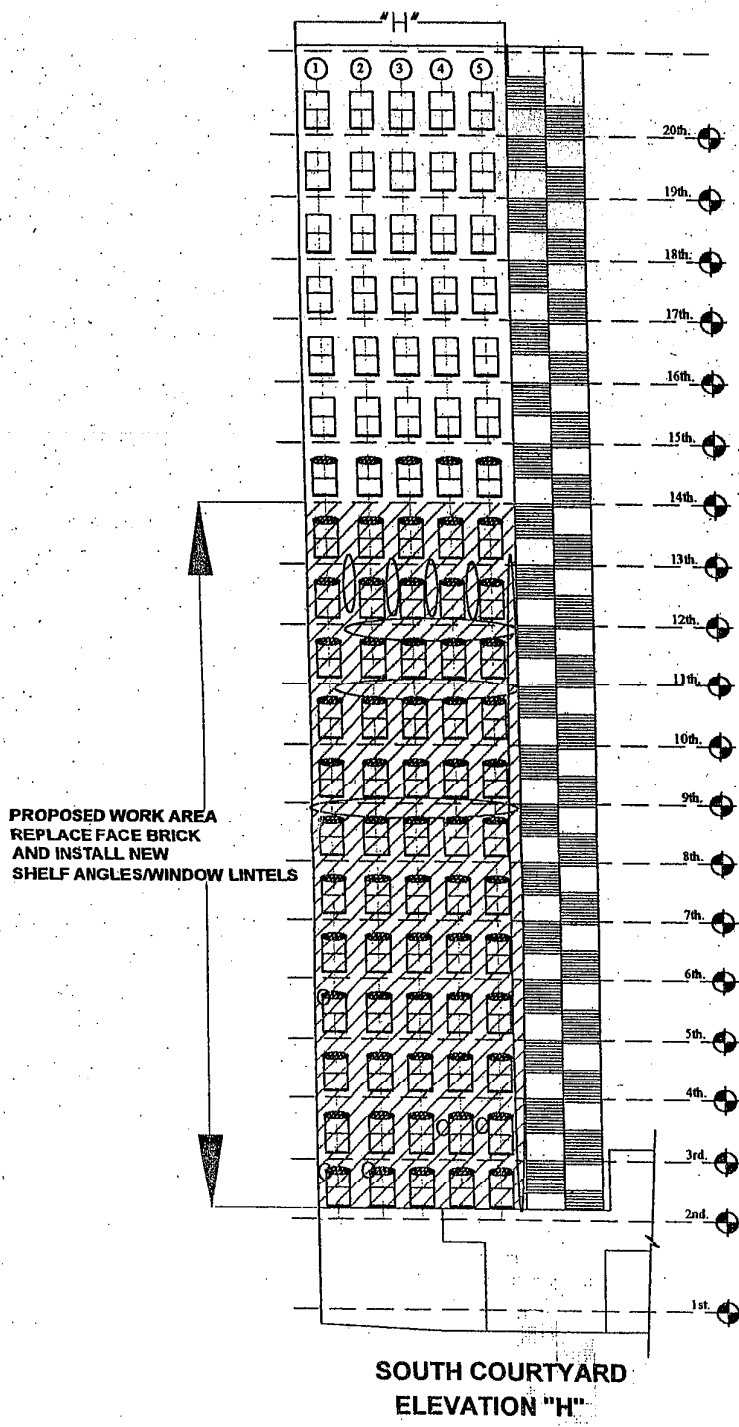
COURTYARD FACADE
N.T.S.

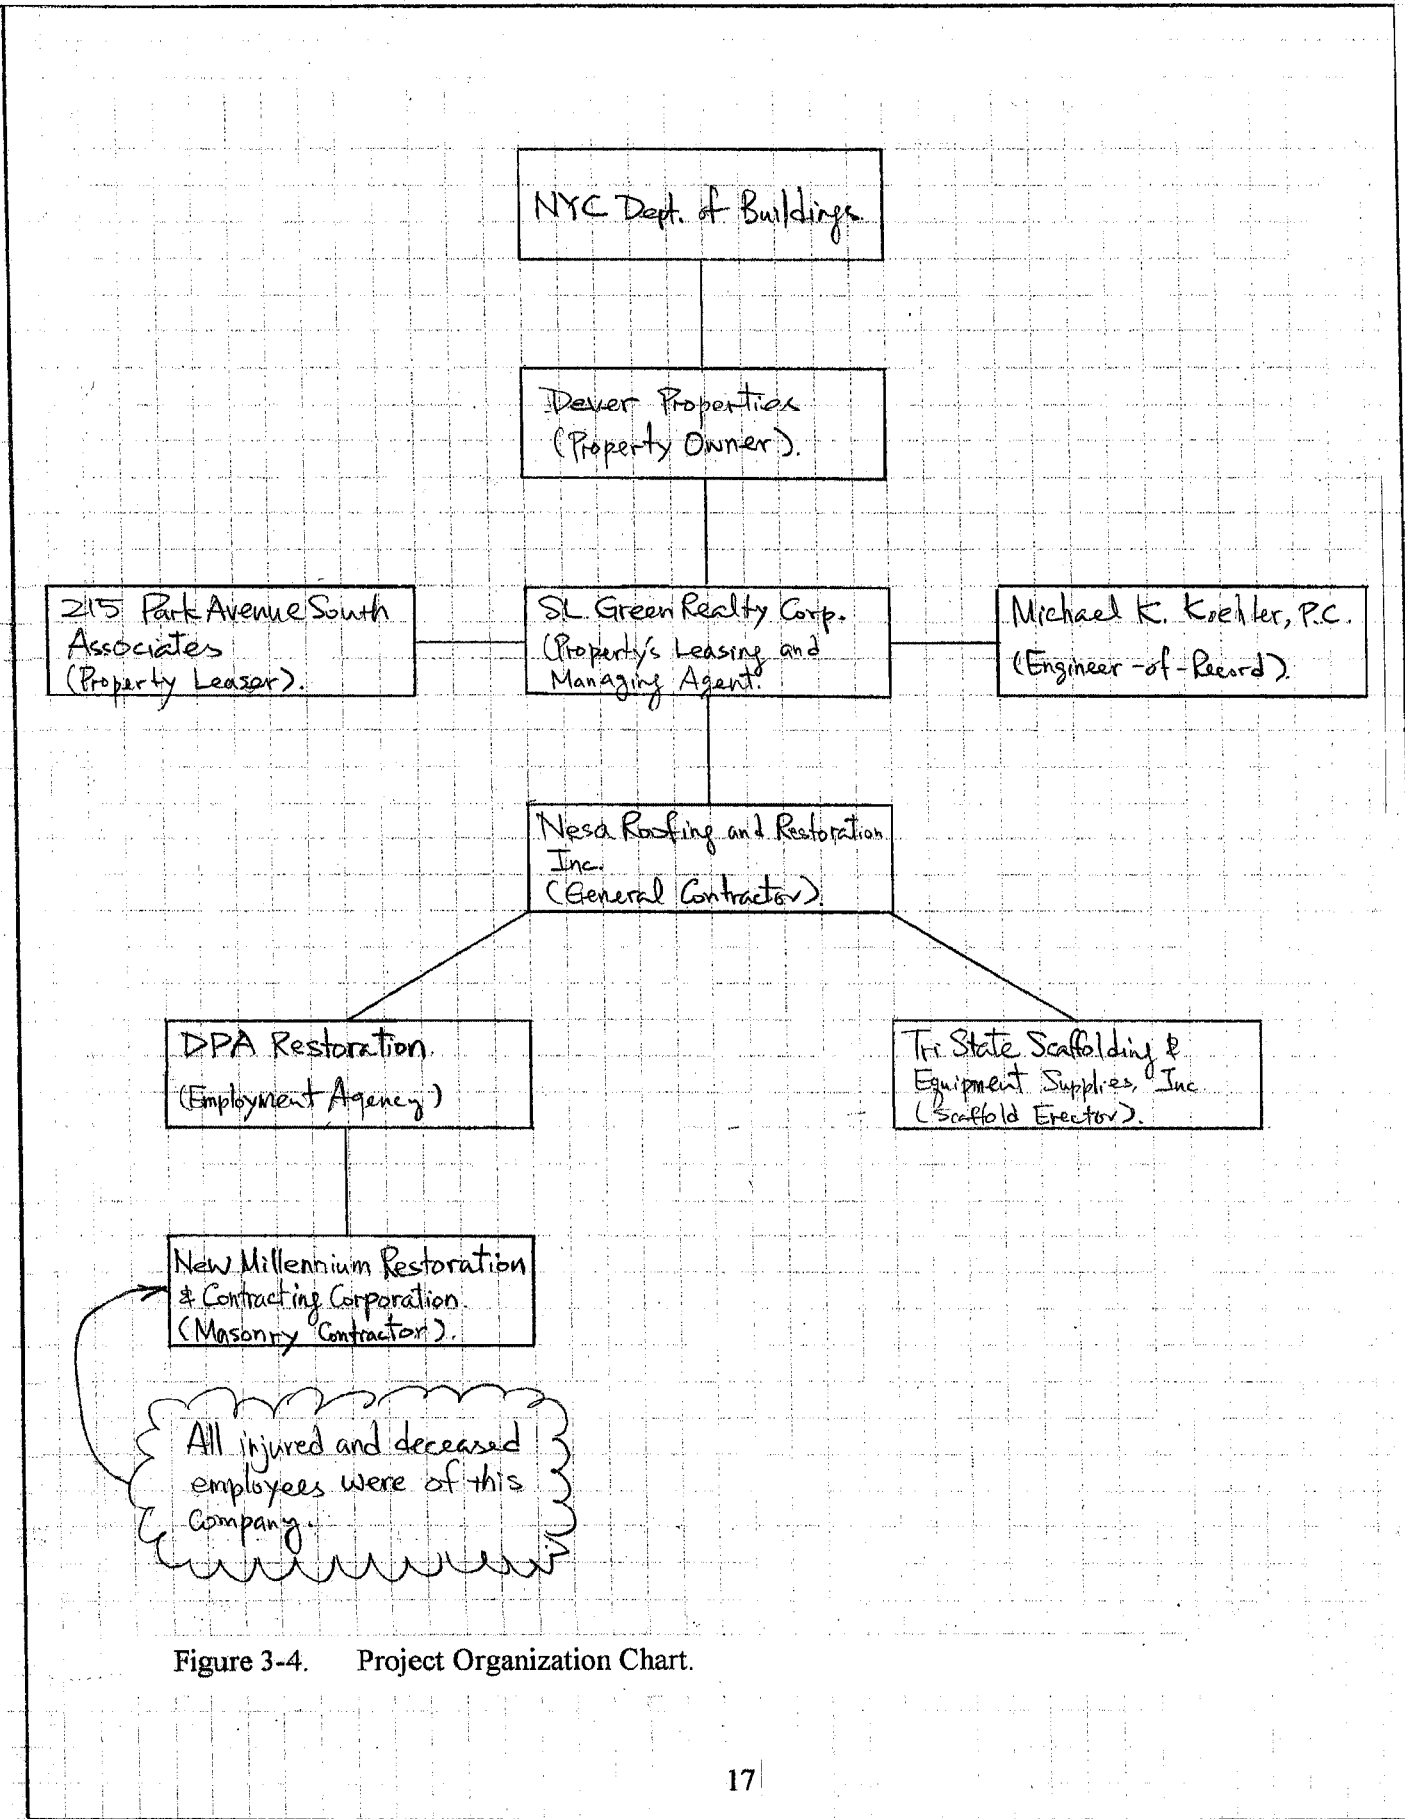
Figure 3-4. Project Organization Chart.

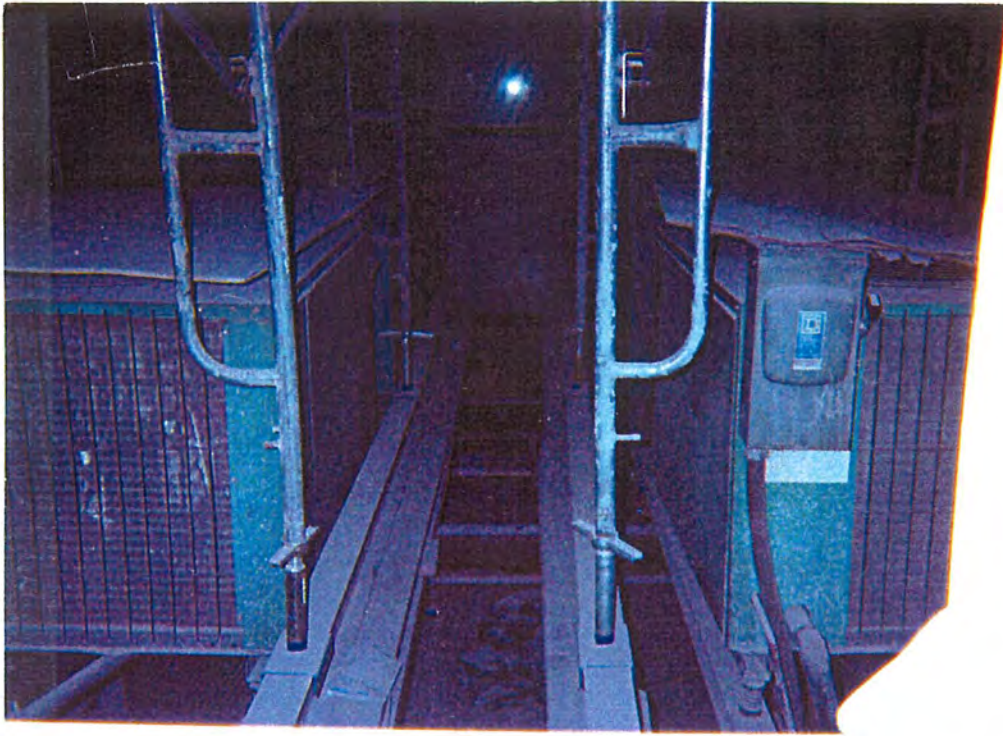
Figure 3-7. Support Conditions at the Base of the Northern Portion of the Scaffold Towers I (from Scaffold Erector, Looking Toward North).

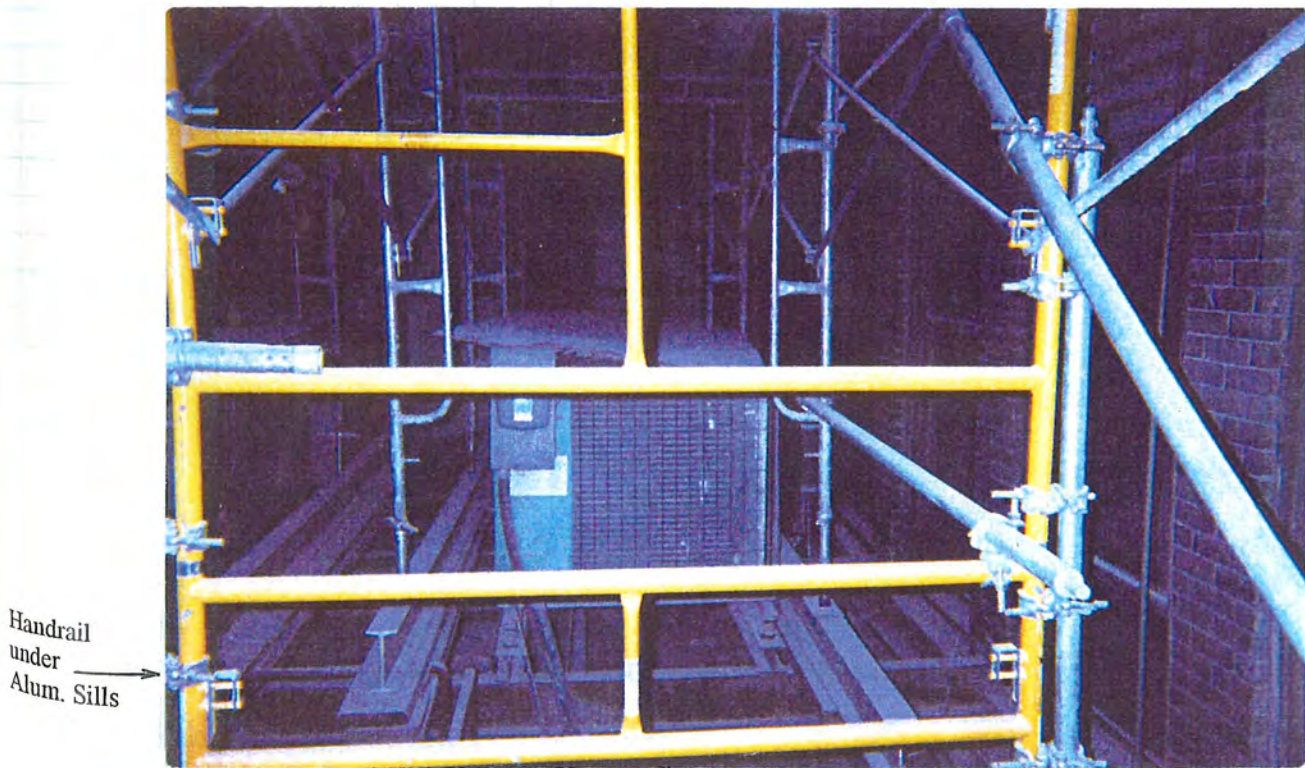
Figure 3-8. Support Conditions at the Base of the Northern Portion of the Scaffold Towers II (from Scaffold Erector, Looking Toward North).

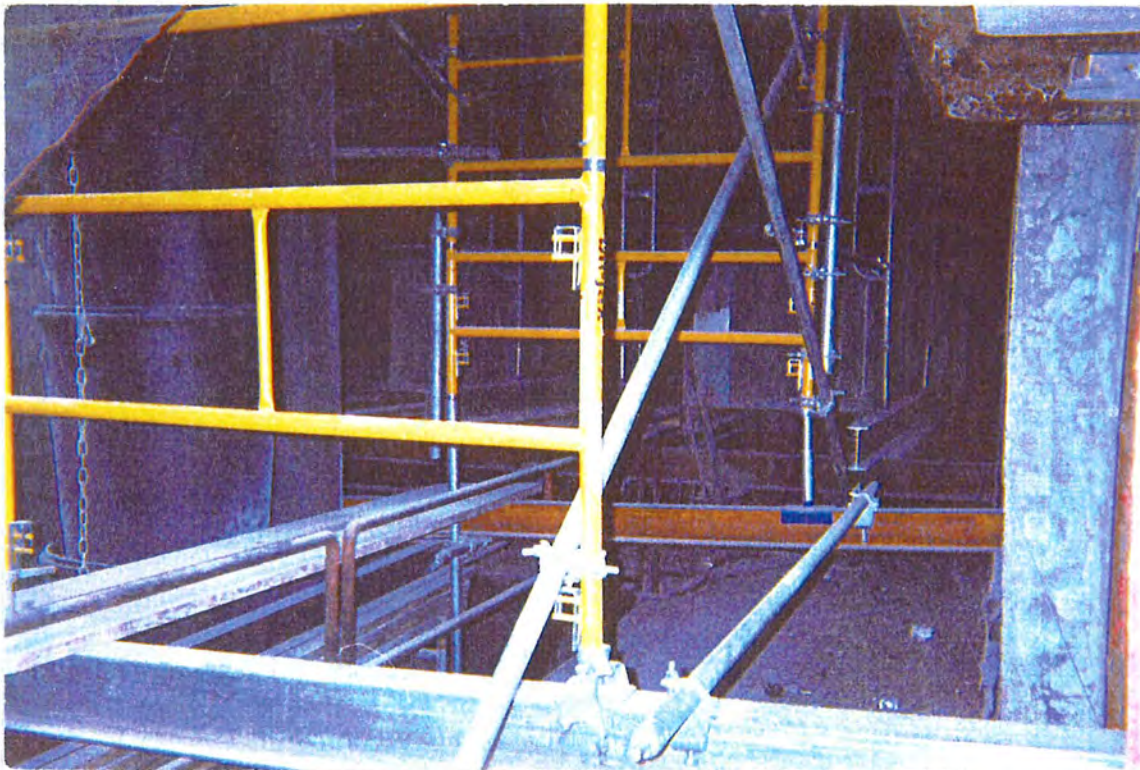
Figure 3-9. Support Conditions at the Base of the Southern Portion of the Scaffold Towers I (from Scaffold Erector, Looking Toward Northwest).

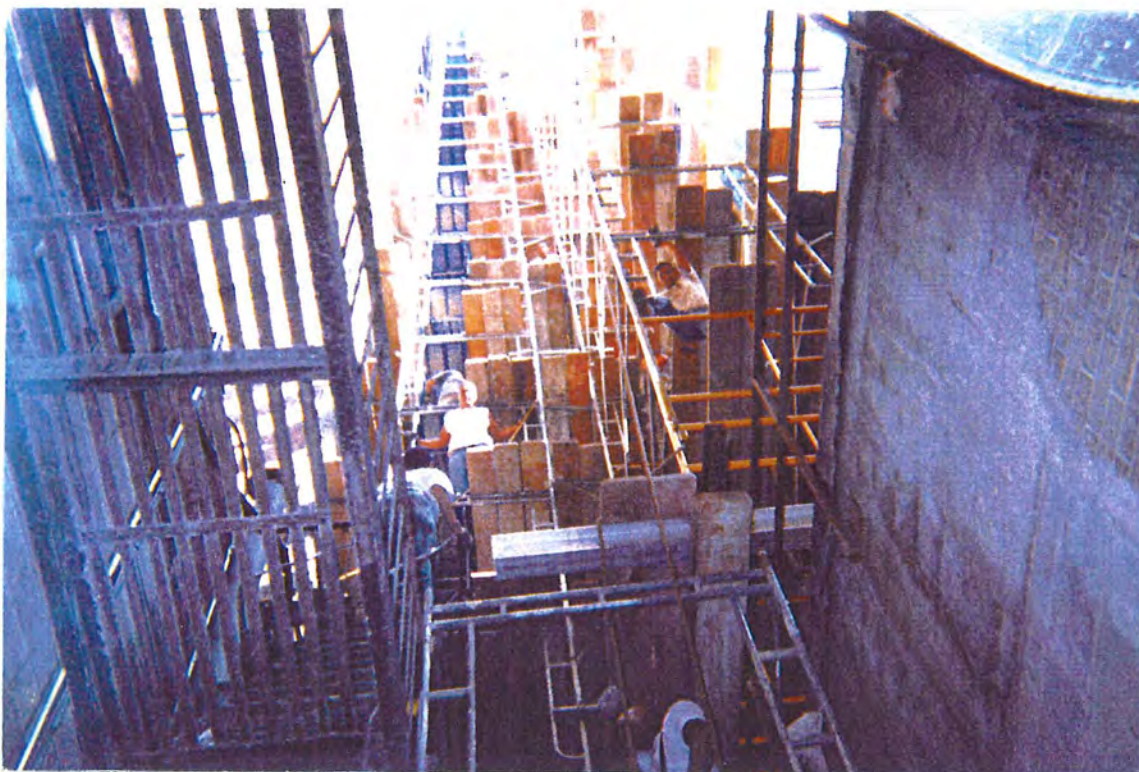
Figure 3-10. Support Conditions at the Base of the Southern Portion of the Scaffold Towers II (from Scaffold Erector, Looking Toward North and Upward).

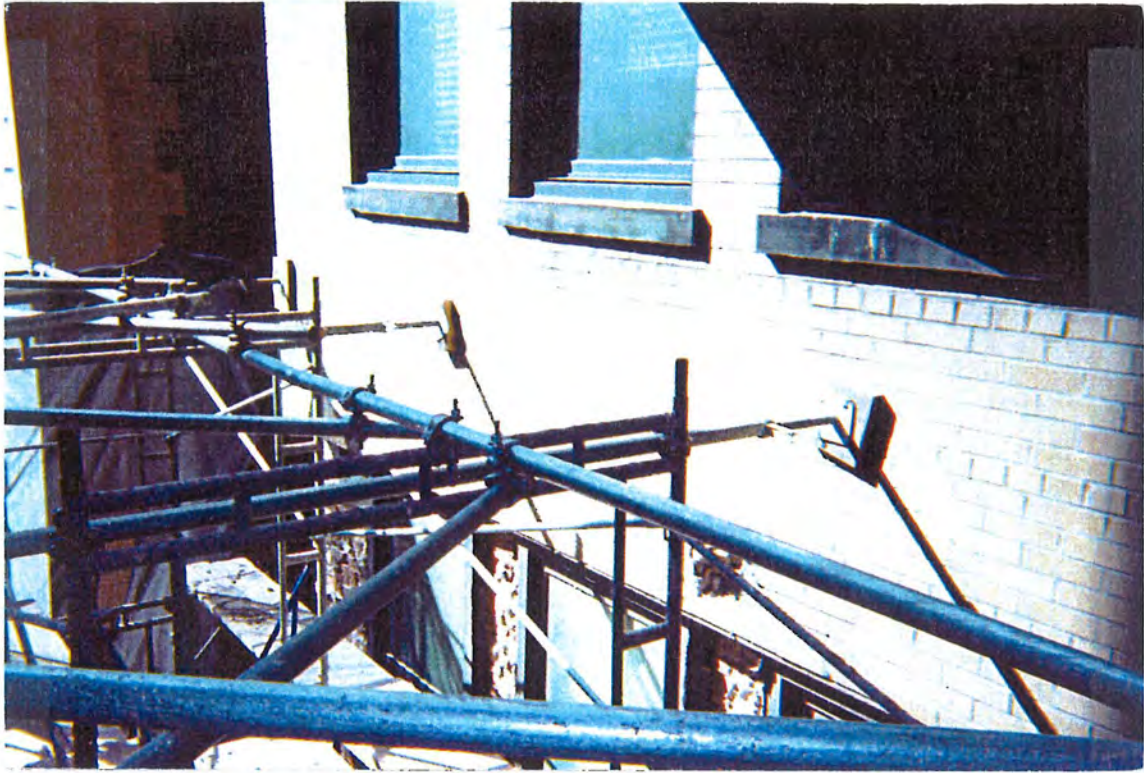
Figure 3-11. Lateral Bracing Conditions at the Top of the Scaffold Towers I (from Scaffold Erector, Looking Toward Southwest).

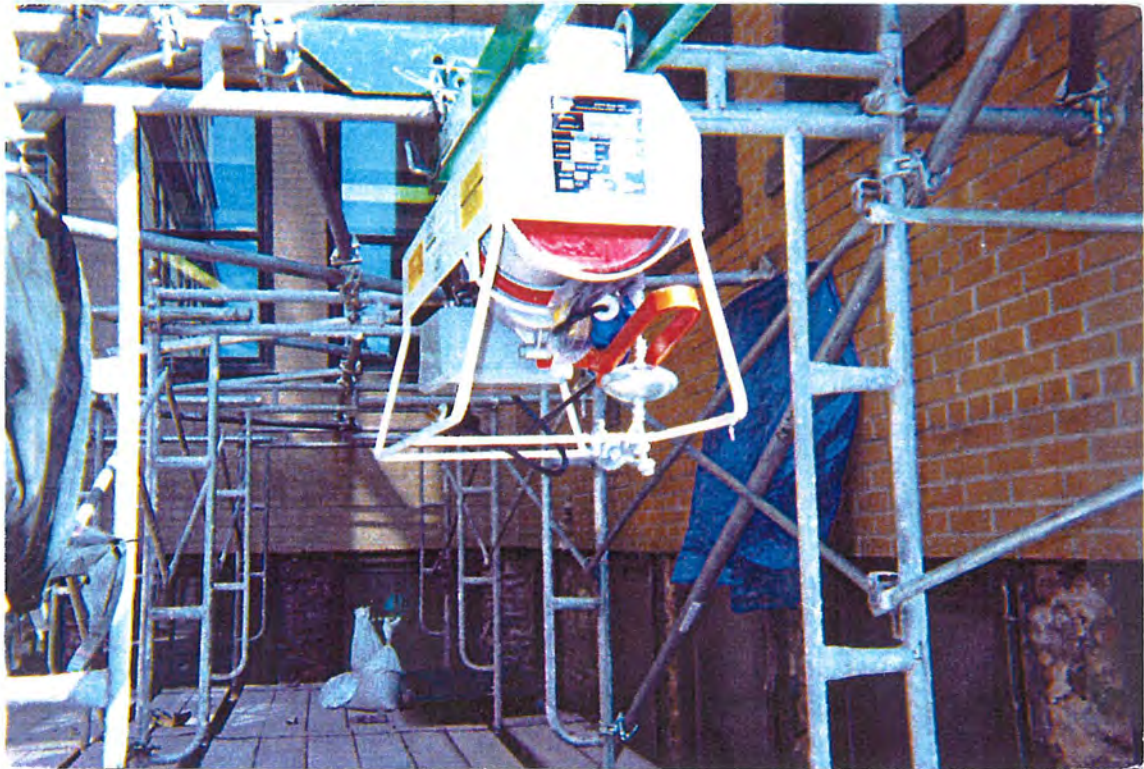
Figure 3-12. Lateral Bracing Conditions at the Top of the Scaffold Towers II (from Scaffold Erector, Looking Toward North). Note that the electrical hoist in the upper middle of this figure was mounted on top of the southmost bay of the east tower prior to the collapse.

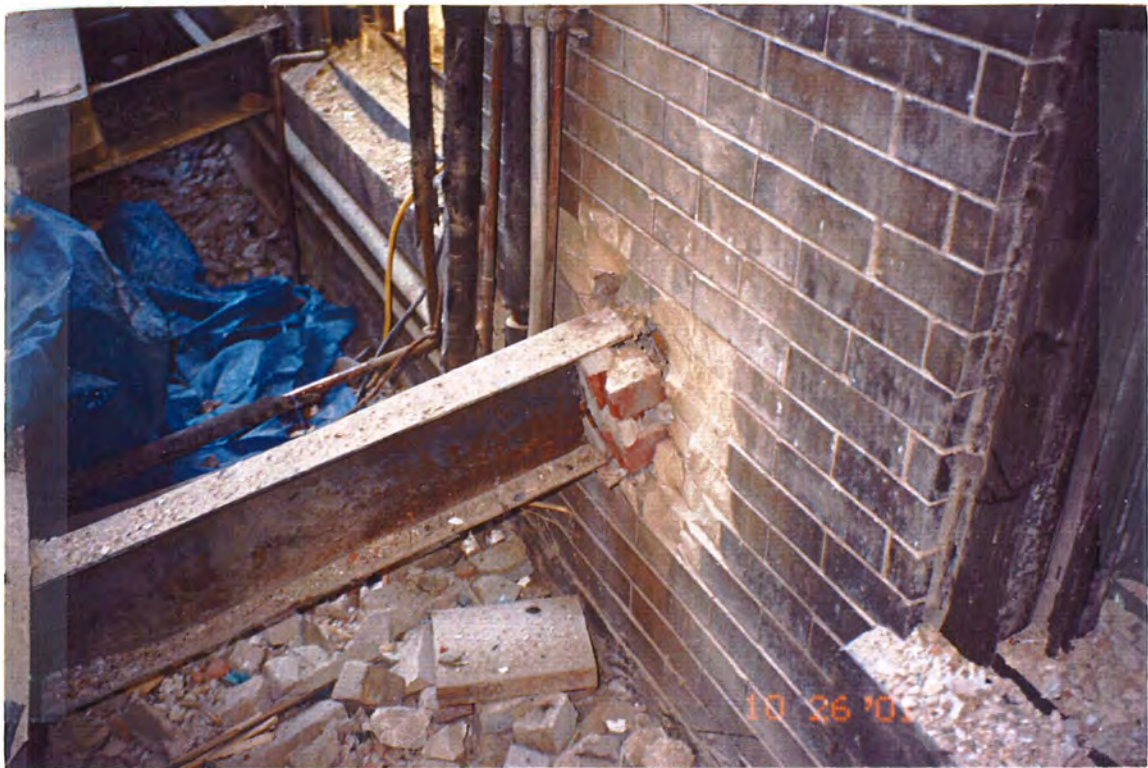
Figure 3-13. Collapsed Condition of Dunnage No. 1 at West End.

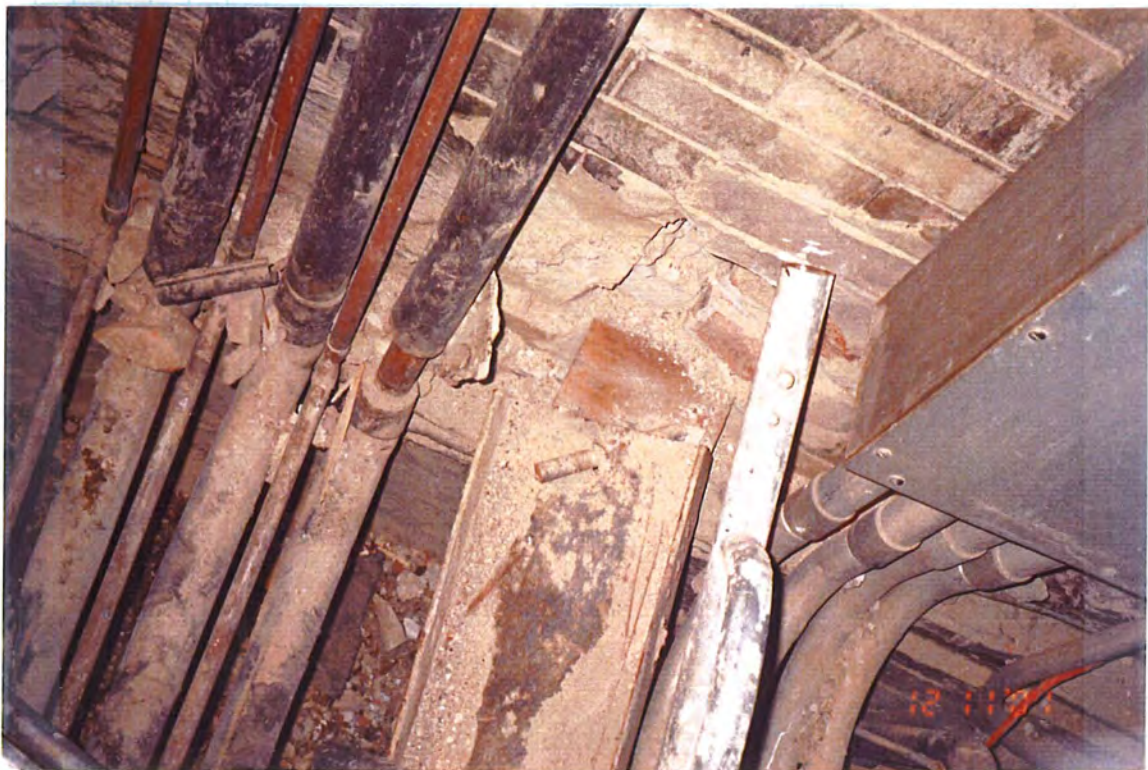
Figure 3-14. Collapsed Condition of Dunnage No. 1 at East End.

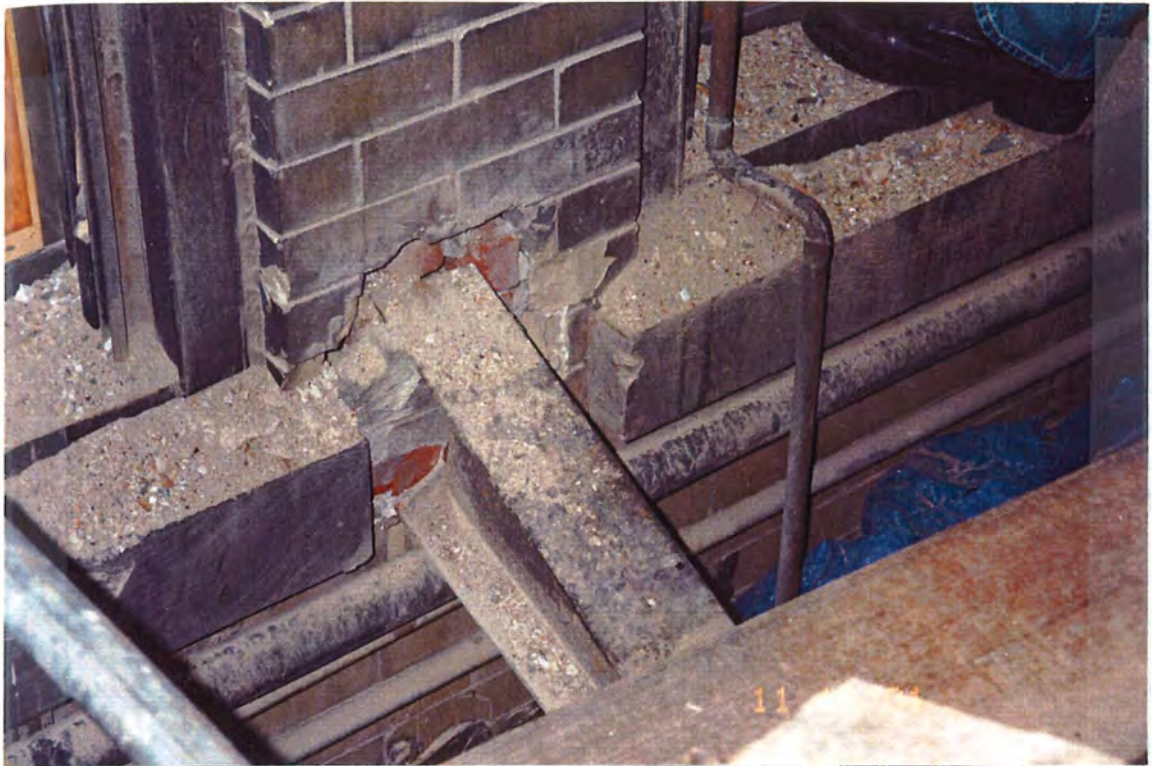
Figure 3-15. Collapsed Condition of Dunnage No. 2 at West End.

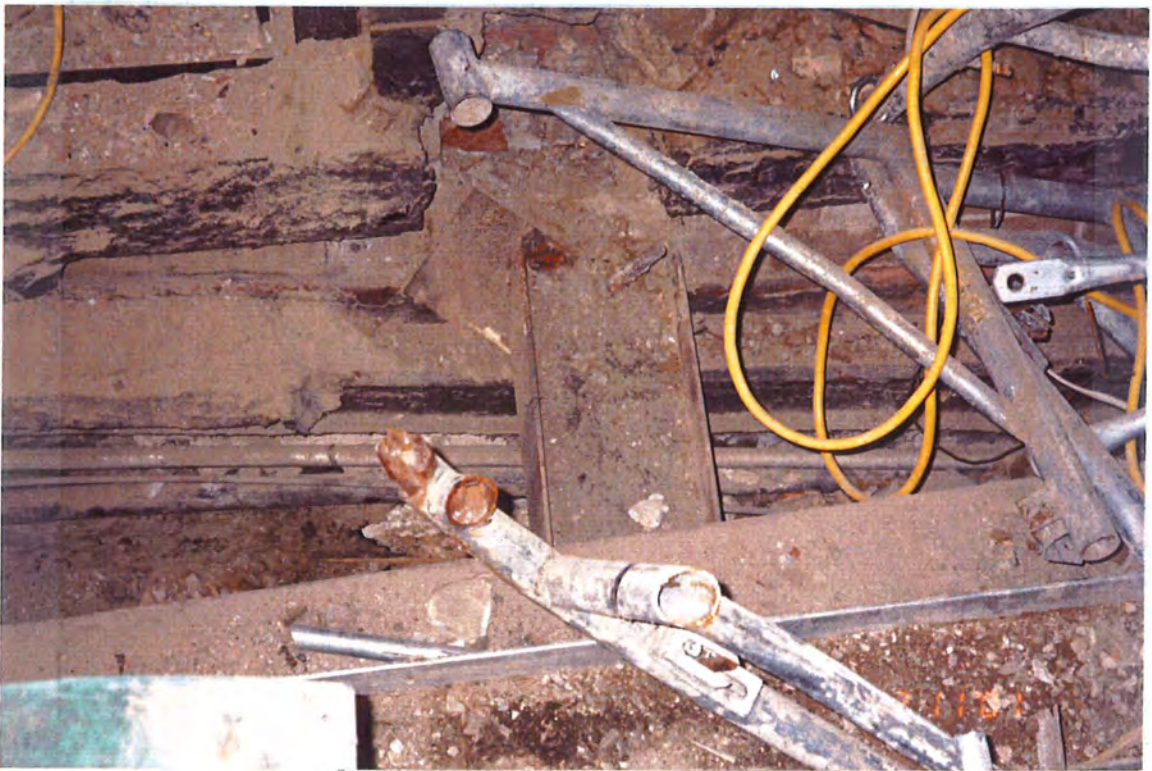
Figure 3-16. Collapsed Condition of Dunnage No. 2 at East End.

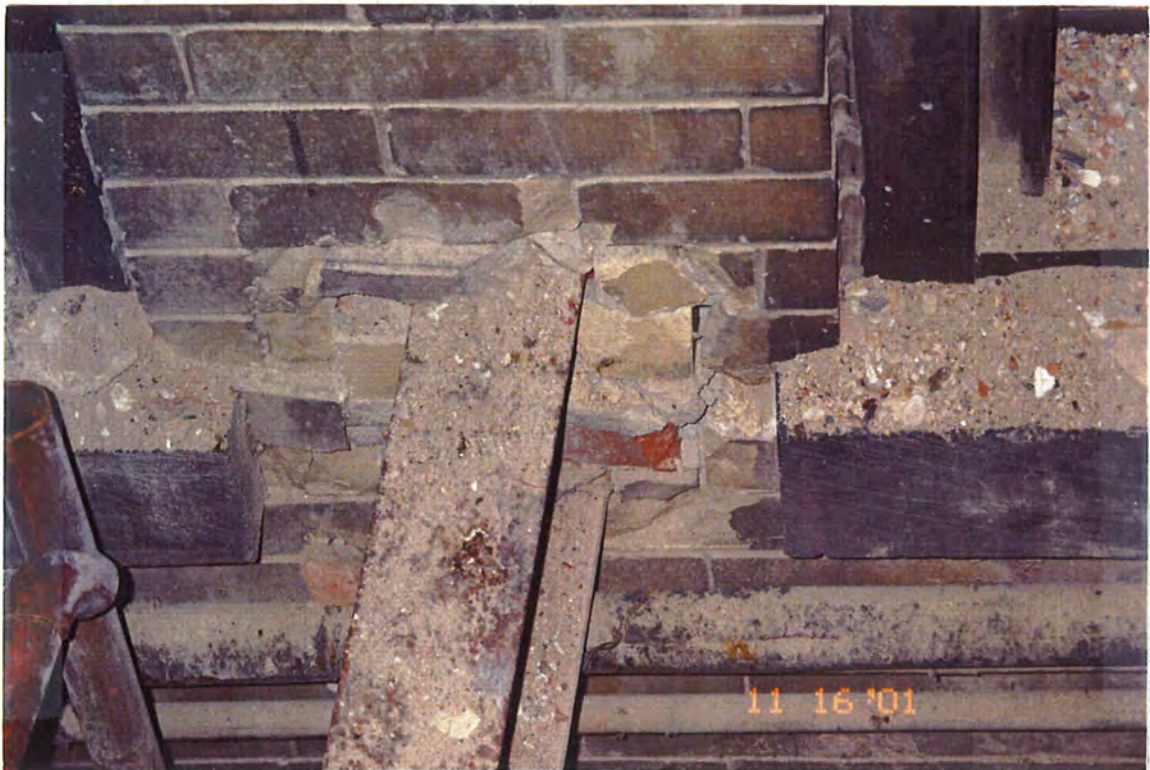
Figure 3-17. Collapsed Condition of Dunnage No. 3 at West End.

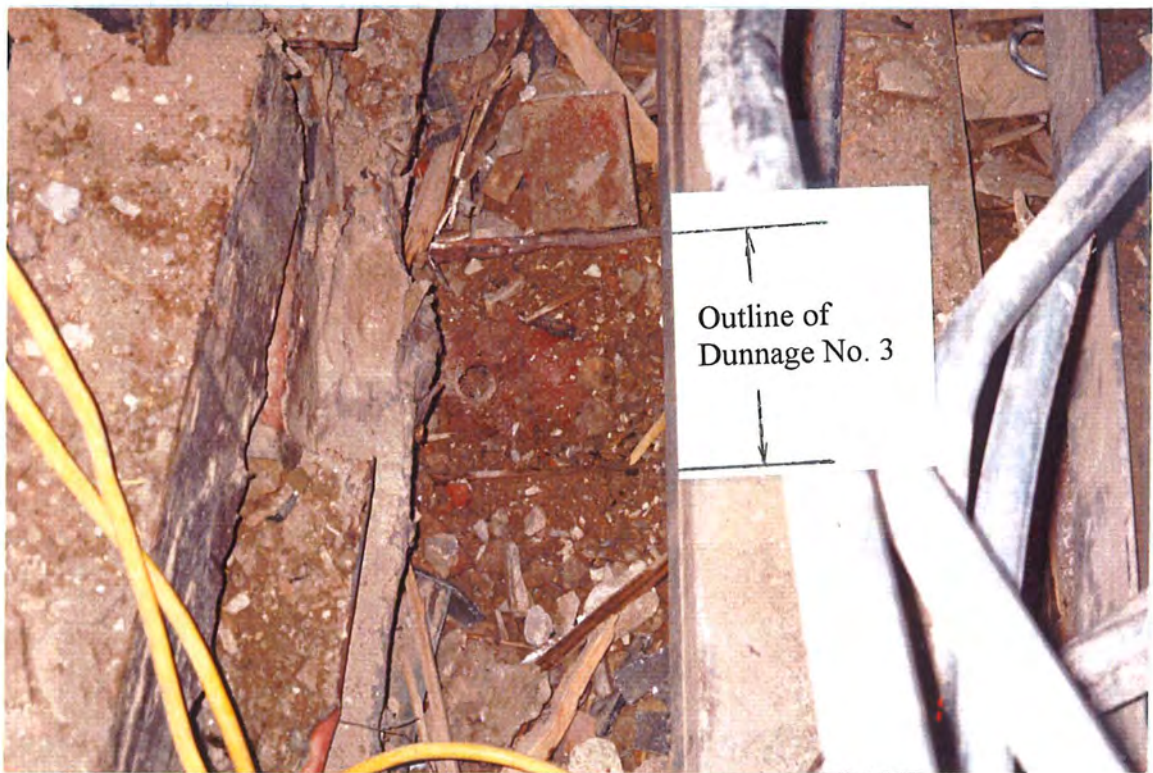
Figure 3-18. Collapsed Condition of Dunnage No. 3 at West End.

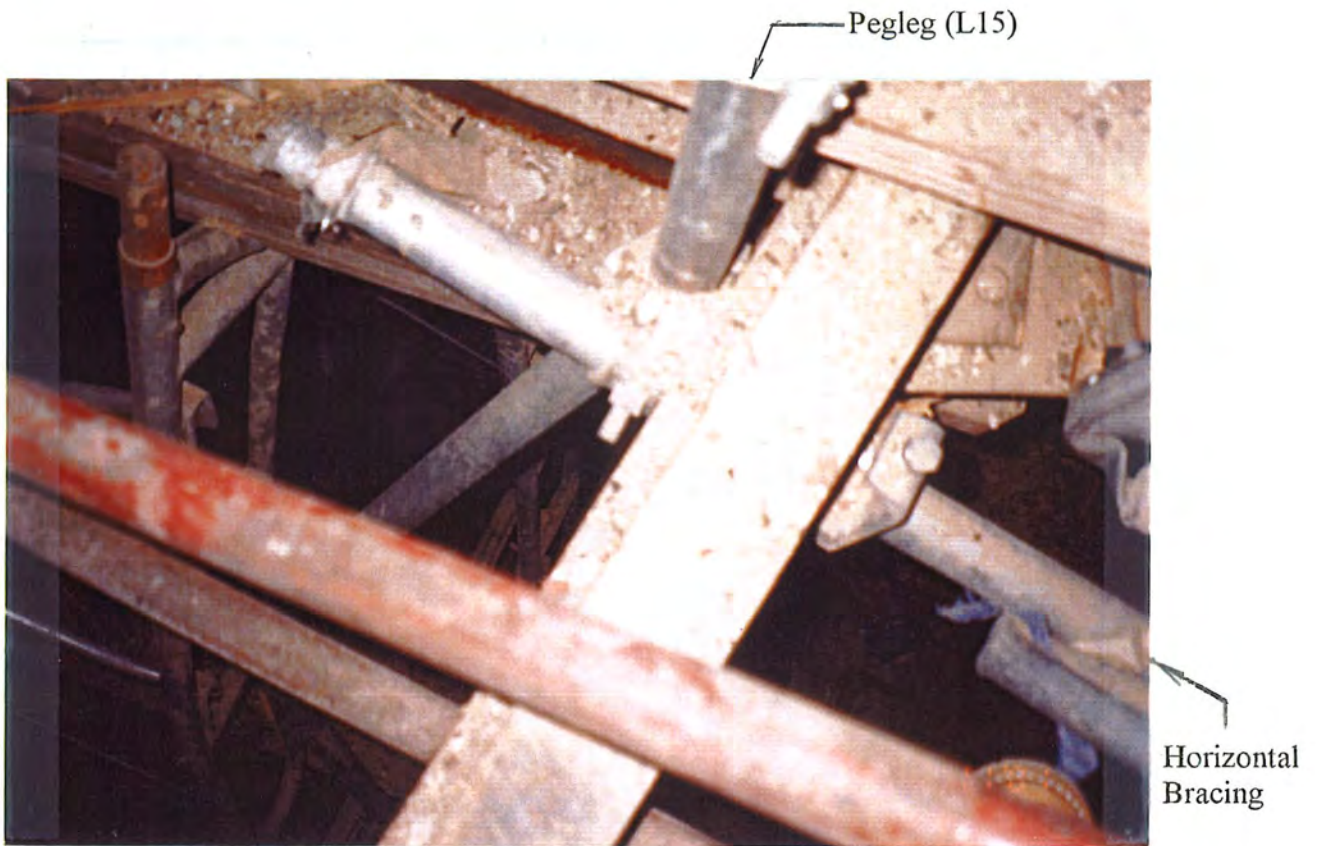
Figure 3-19. Failed Condition of the Pegleg with a Clear Bent at the Upper Bracing Connection (Looking Downward from Top).

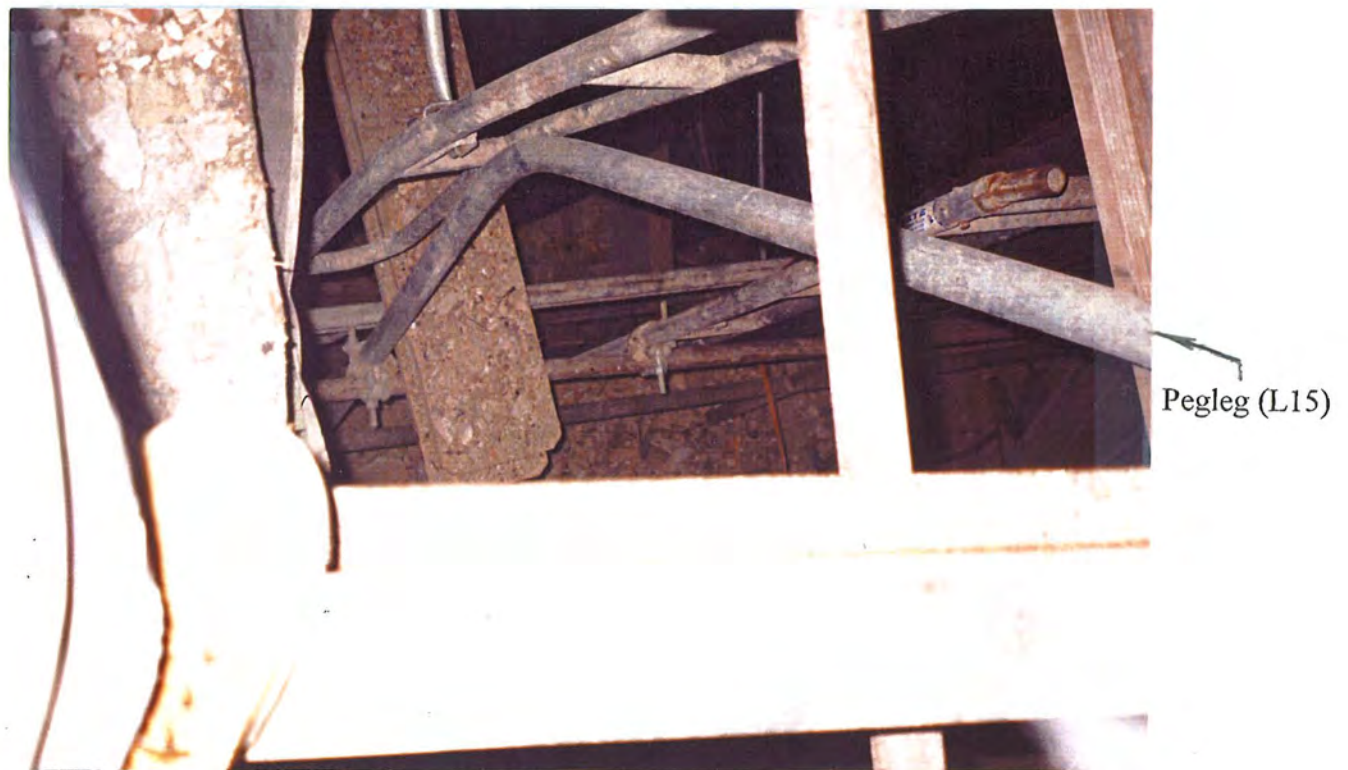
Figure 3-20. Failed Condition of the Pegleg with no Bent at the Lower Connection to the Handrail (Looking Downward from Top).

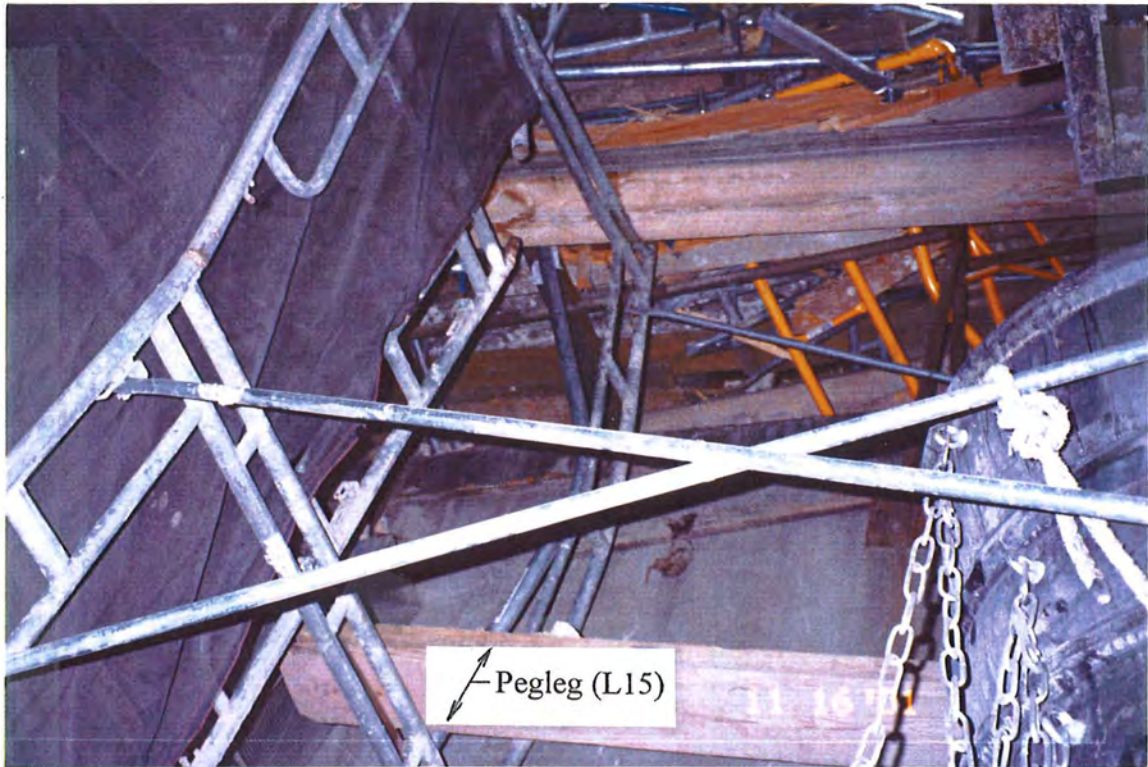
Figure 3-21. Failed Condition of the Pegleg (Looking Toward Northeast and Upward).

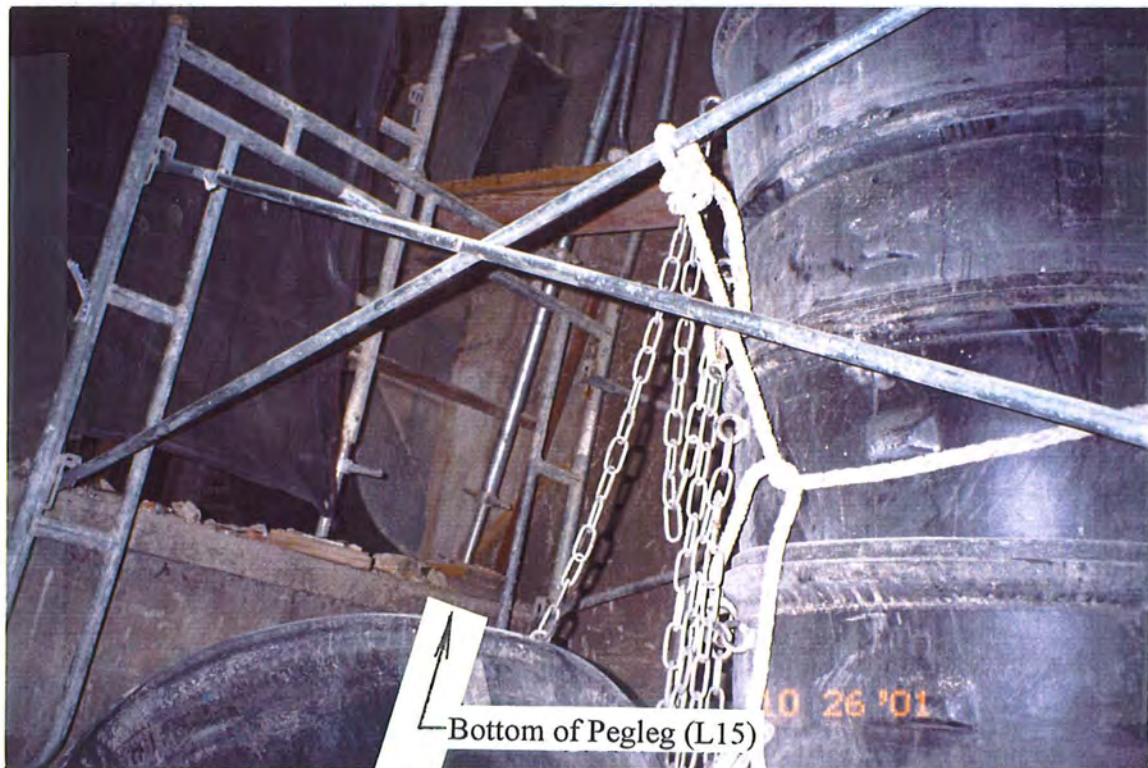
Figure 3-22. Failed Condition of the Pegleg with no Bent at the Lower Connection to the Handrail (Looking Toward Northeast and Upward).

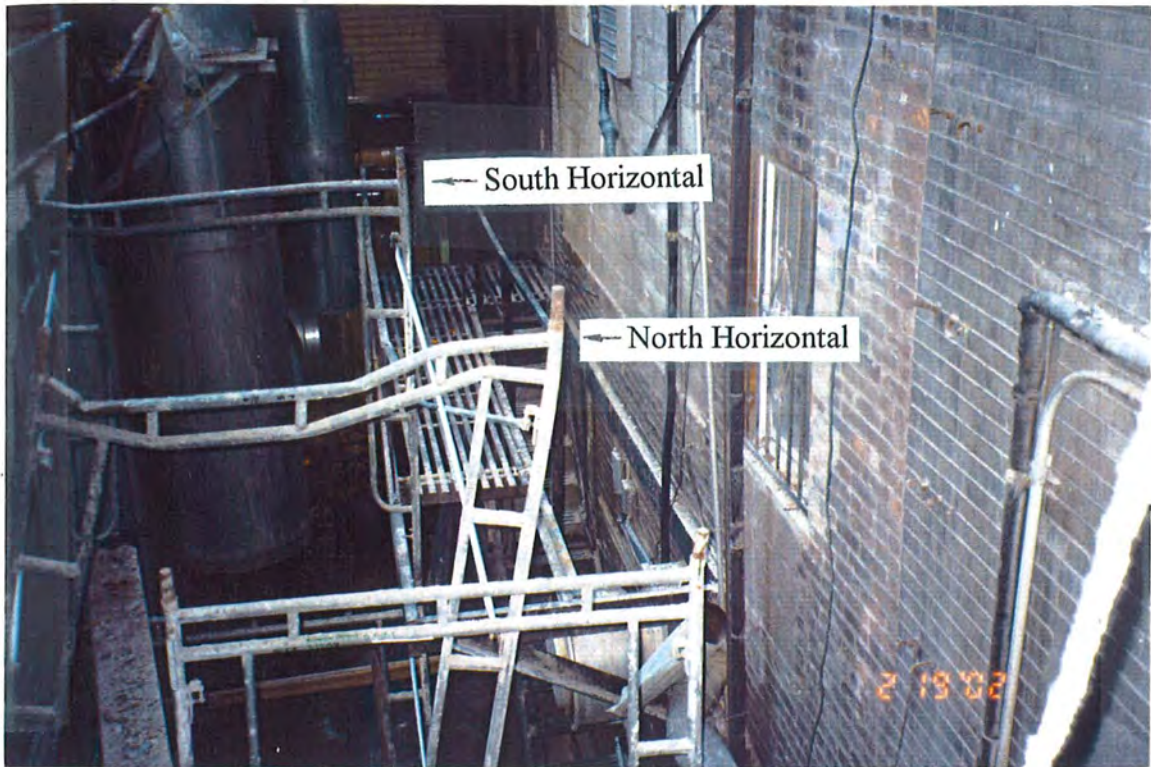
Figure 3-23. The Deflected Conditions of the Top Horizontal Members at the upper Frames of the Offset Scaffold from the First Floor Level (Looking Toward South).

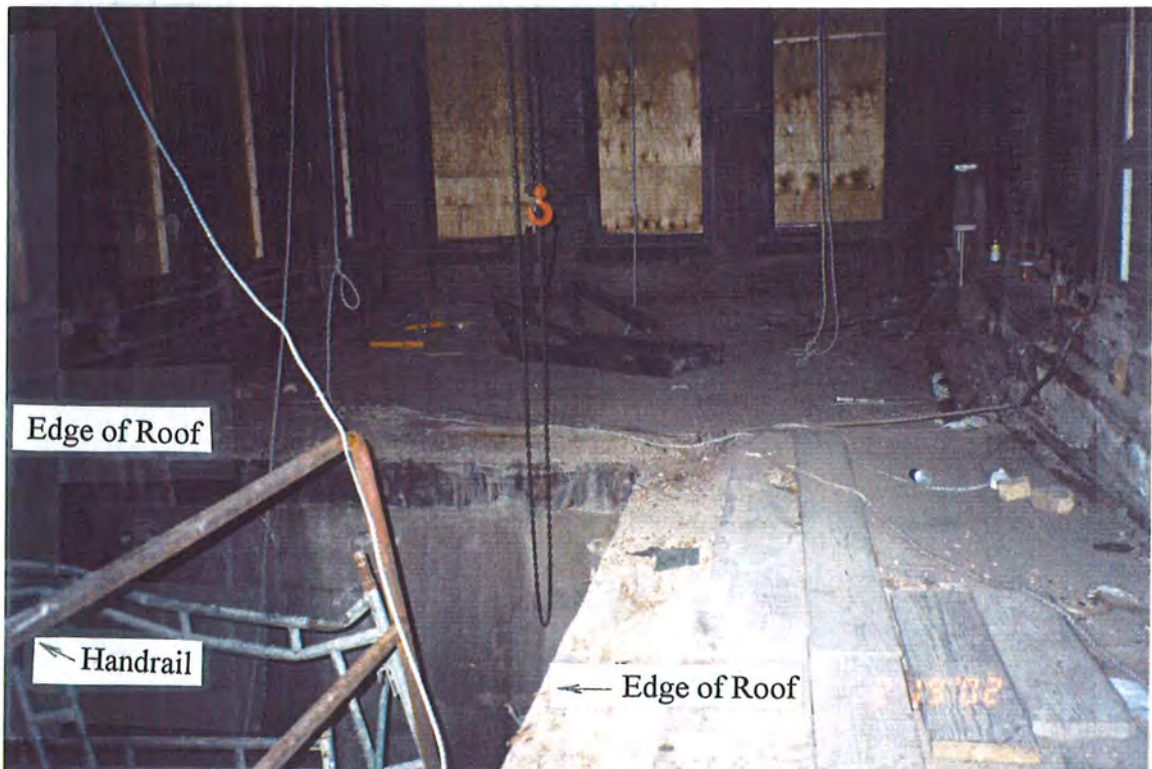
Figure 3-24. The Conditions of the Handrails along the Edges of the Roof Deck at the Second Floor Level after the Collapse (Looking Toward Northwest). Note that prior to the collapse the handrails were all around the edge of the roof and the pegleg was located near the intersection of two edges from the lower mezzanine level.

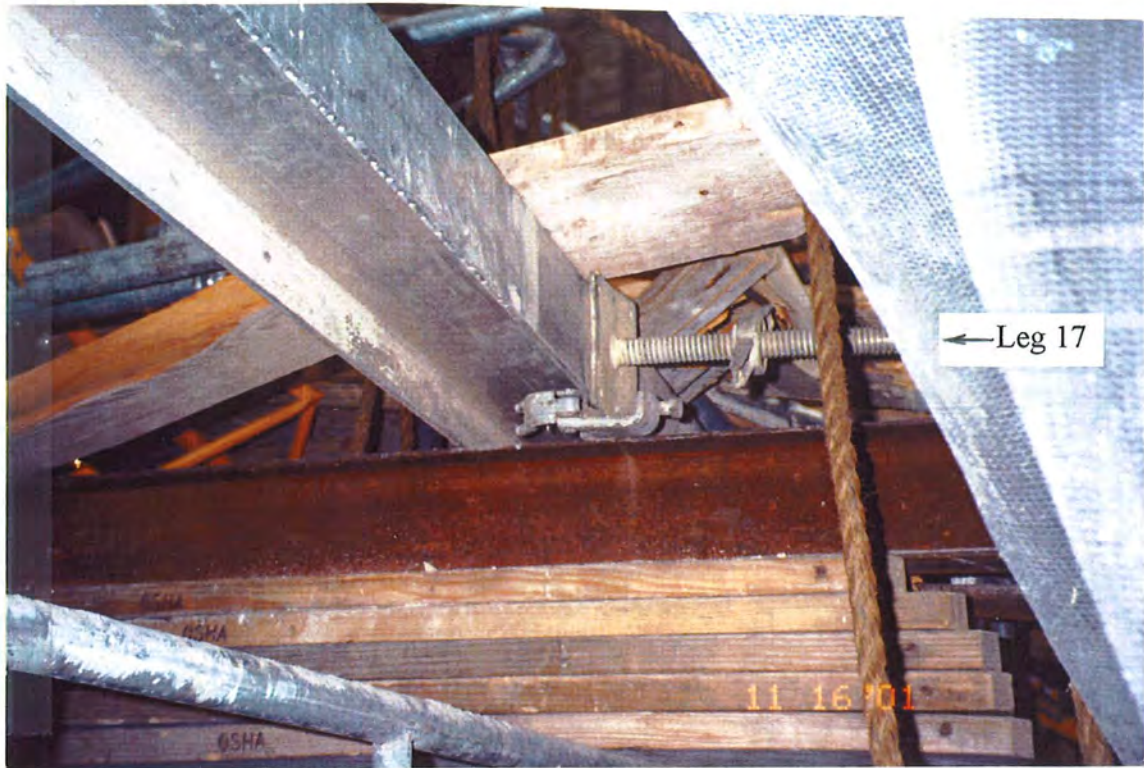
Figure 3-25. The Rotational Failure of Leg 17 above the South Top Horizontal Member of the Offset Scaffold (Looking Toward East).
