INVESTIGATION OF THE OCTOBER 24, 2001 FATAL COLLAPSE OF TWO SCAFFOLD TOWERS AT 215 PARK AVENUE SOUTH IN NEW YORK, NY

U. S. Department of Labor
Occupational Safety and Health Administration

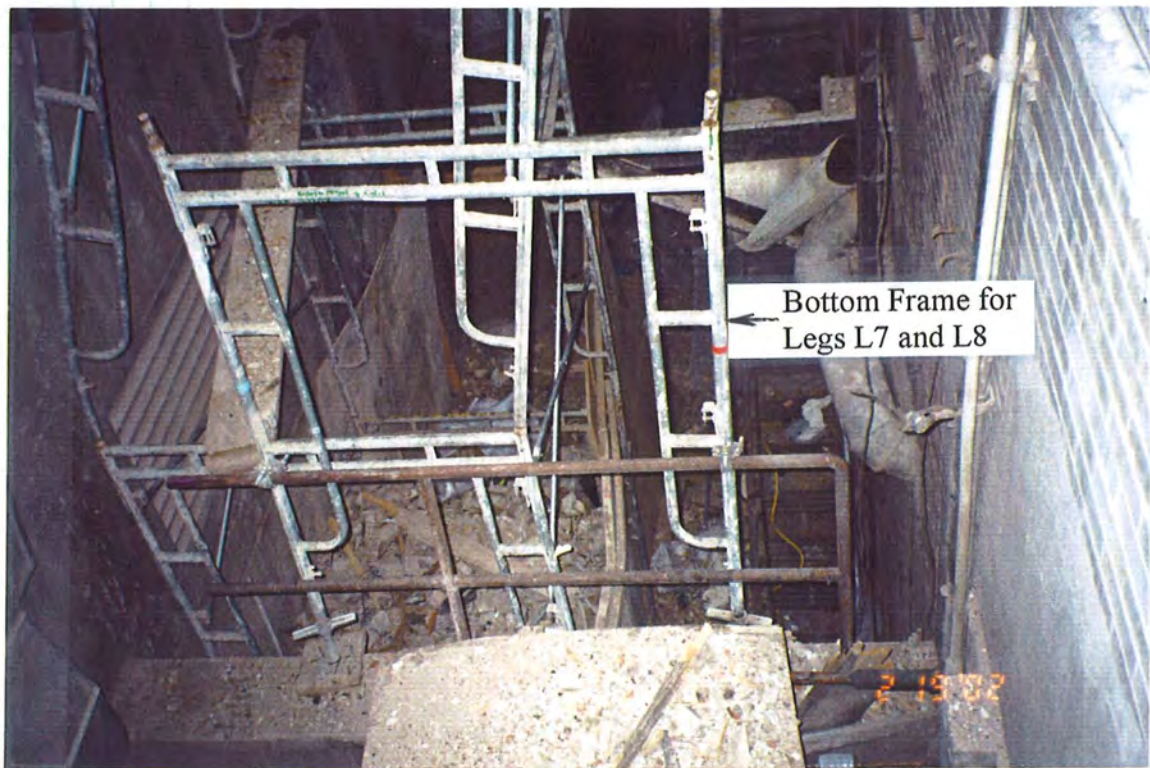
Figure 3-26. The improper Bracing Condition of the Bottom Frame from the Parapet Wall at the Mezzanine Level (Looking Toward South and Downward).

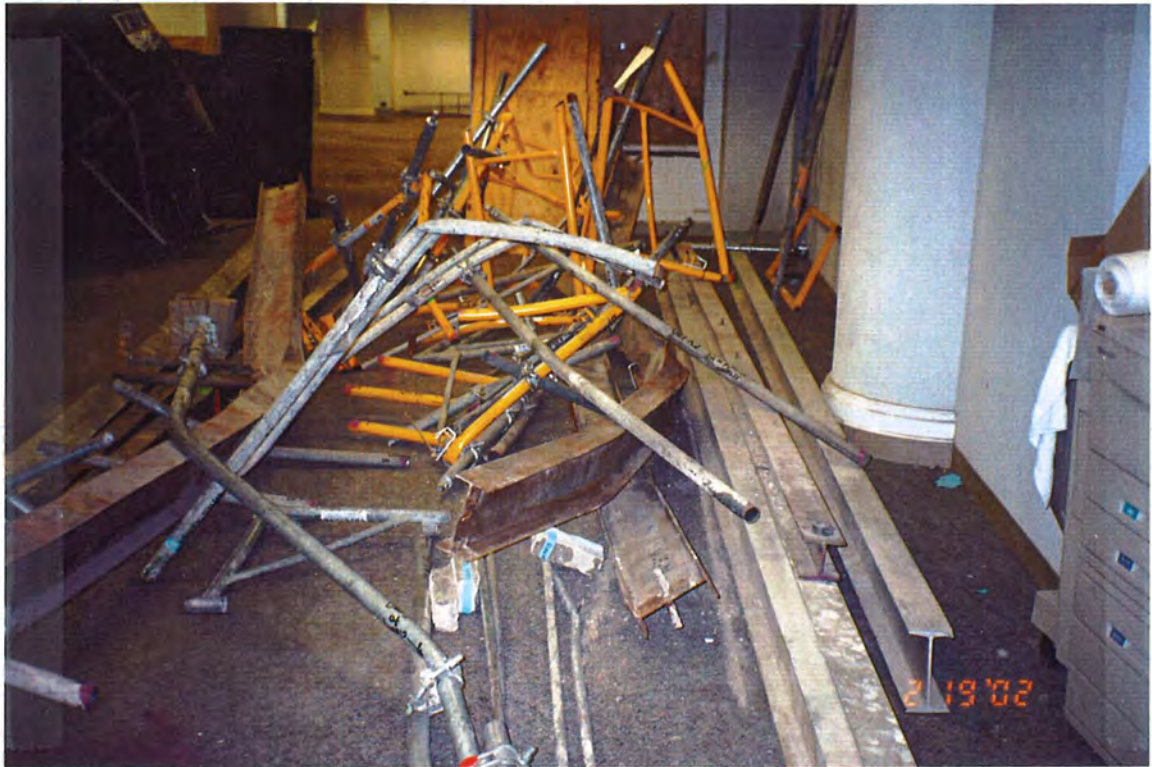
Figure 3-27. Condition of the Recovered Scaffold Frames, Lateral Bracings, and Bottom Support Members I.

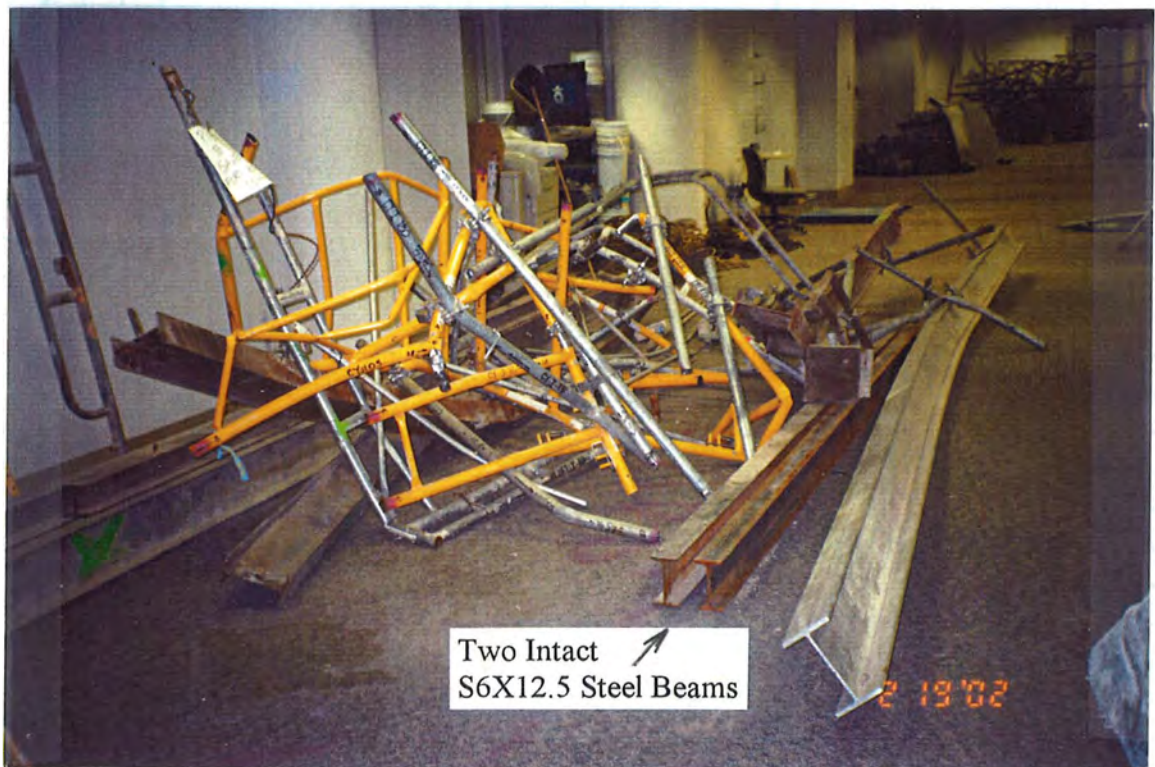
Figure 3-28. Condition of the Recovered Scaffold Frames, Lateral Bracings, and Bottom Support Members II.

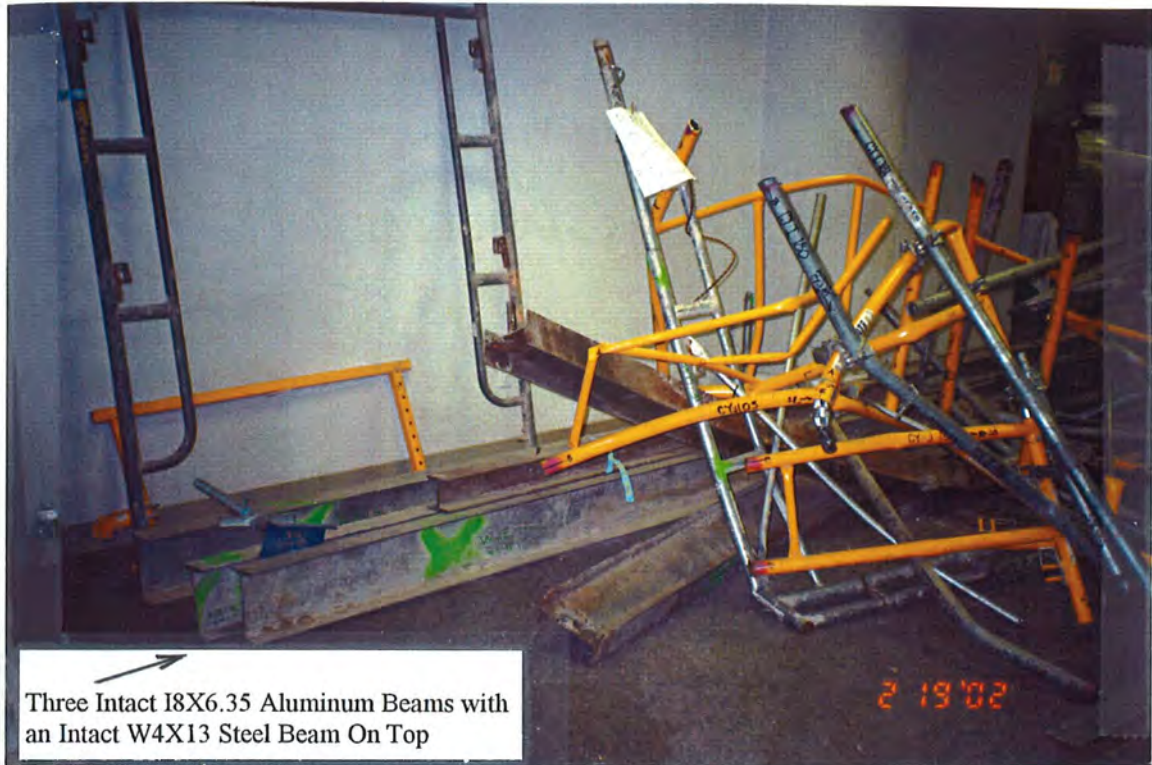
Figure 3-29. Condition of the Recovered Scaffold Frames, Lateral Bracings, and Bottom Support Members III.

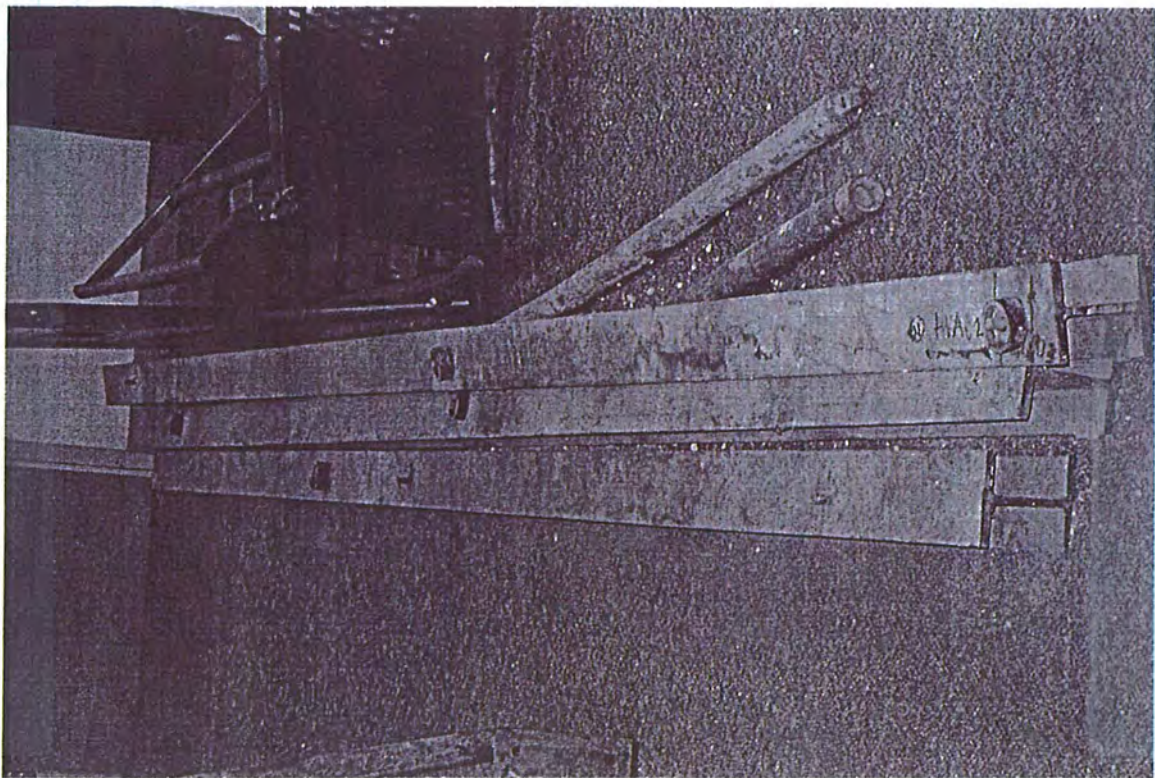
Figure 3-30. Intact Condition of the Other Three W4X13 Steel Beams.
