Investigation of the July 22, 2004, Collapse of a Building, “Tranquility at Hobe Sound”, Hobe Sound, FL

U.S. Department of Labor
Occupational Safety and Health Administration

December 2004

Report Prepared by
Mohammad Ayub, PE

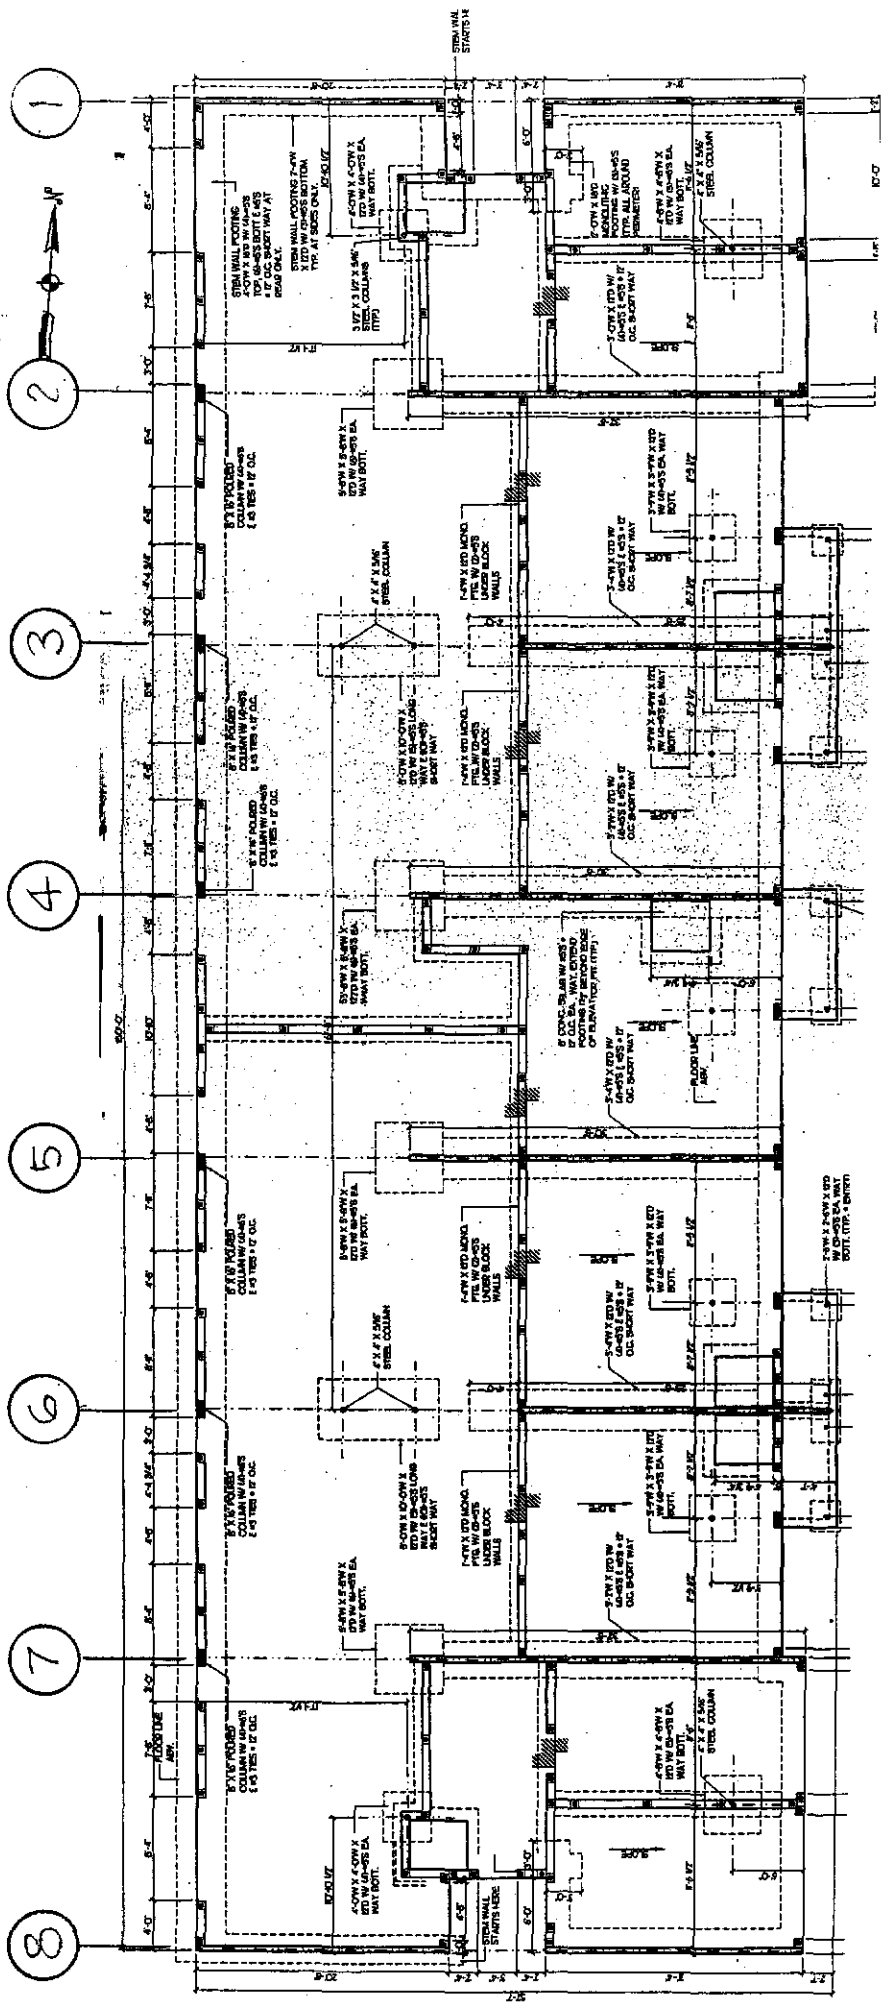
FIGURE 1

FOUNDATION PLAN (FIRST FLOOR PLAN)

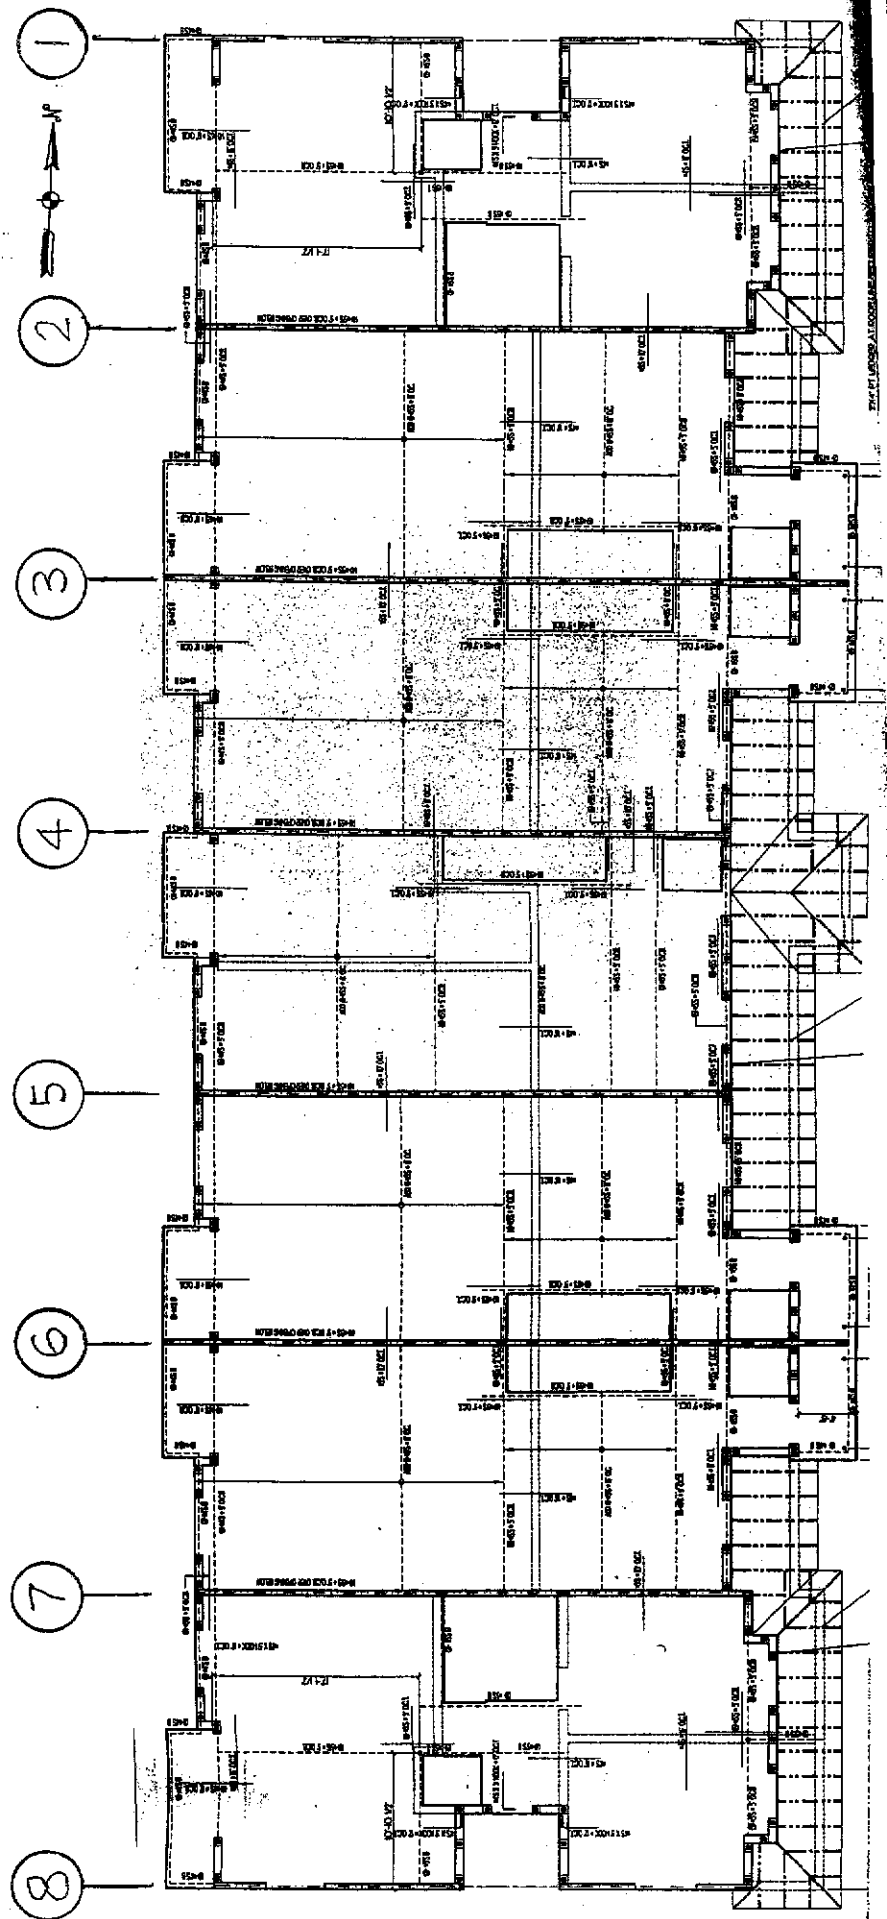
FIGURE 2

SECOND FLOOR PLAN

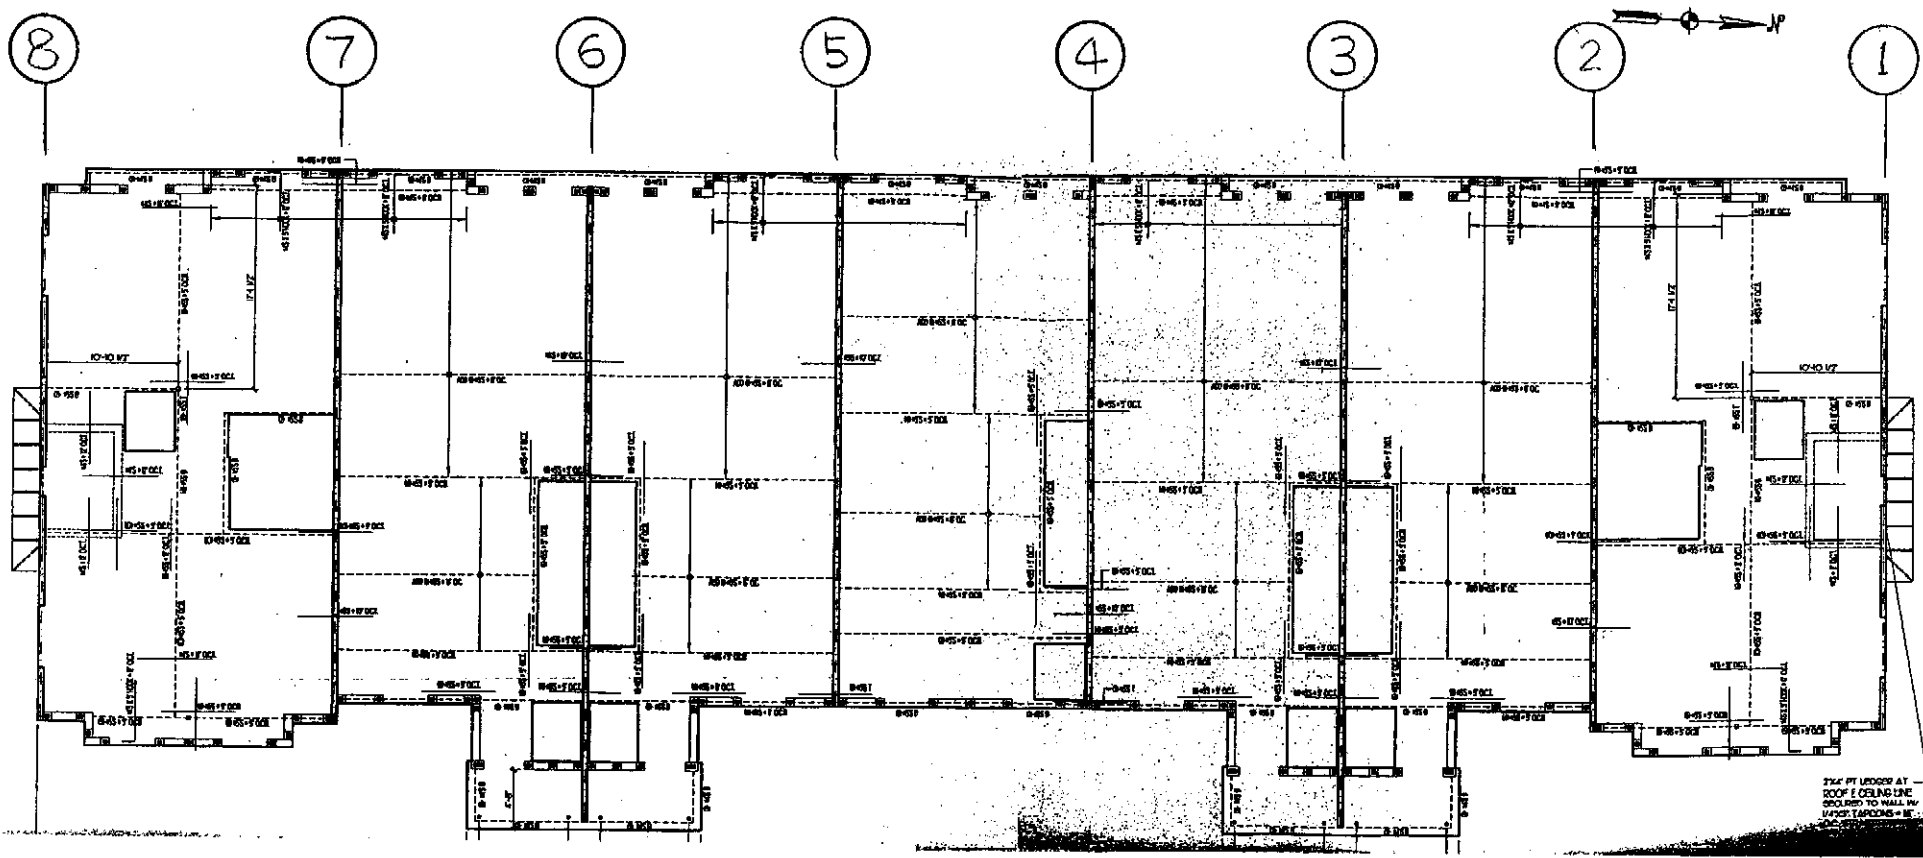
FIGURE 3

THIRD FLOOR PLAN

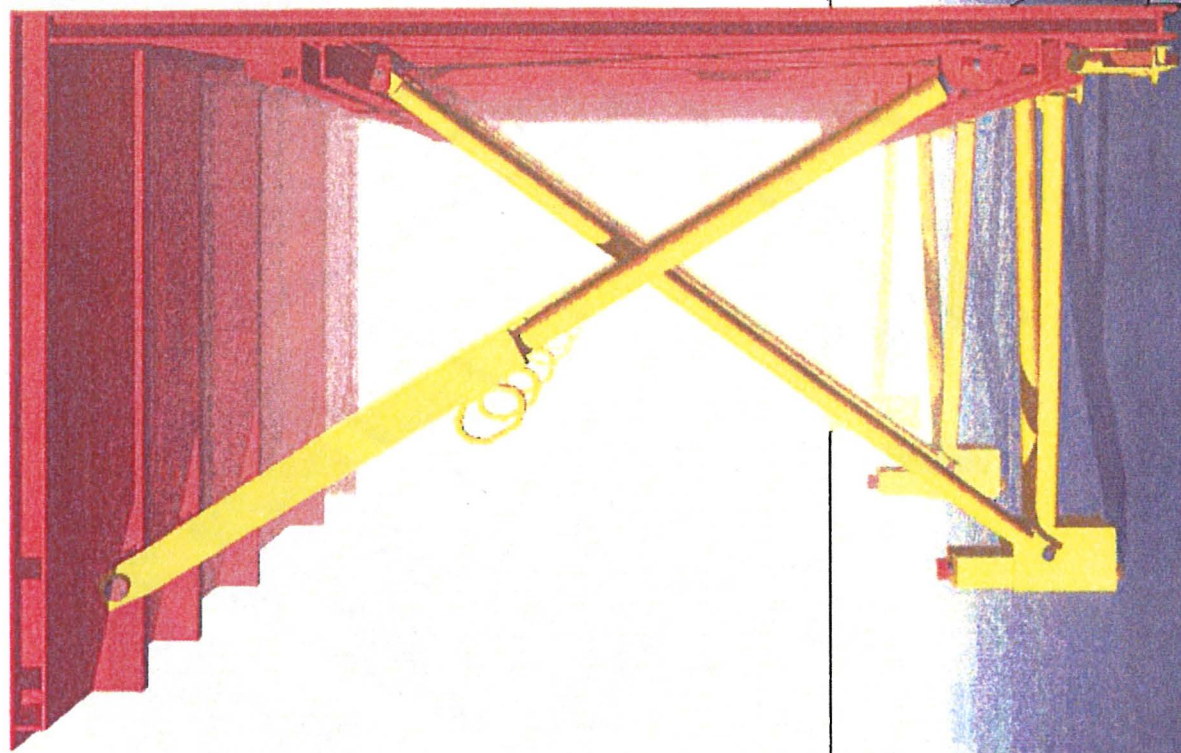
FIGURE 4

TMPH half tunnel

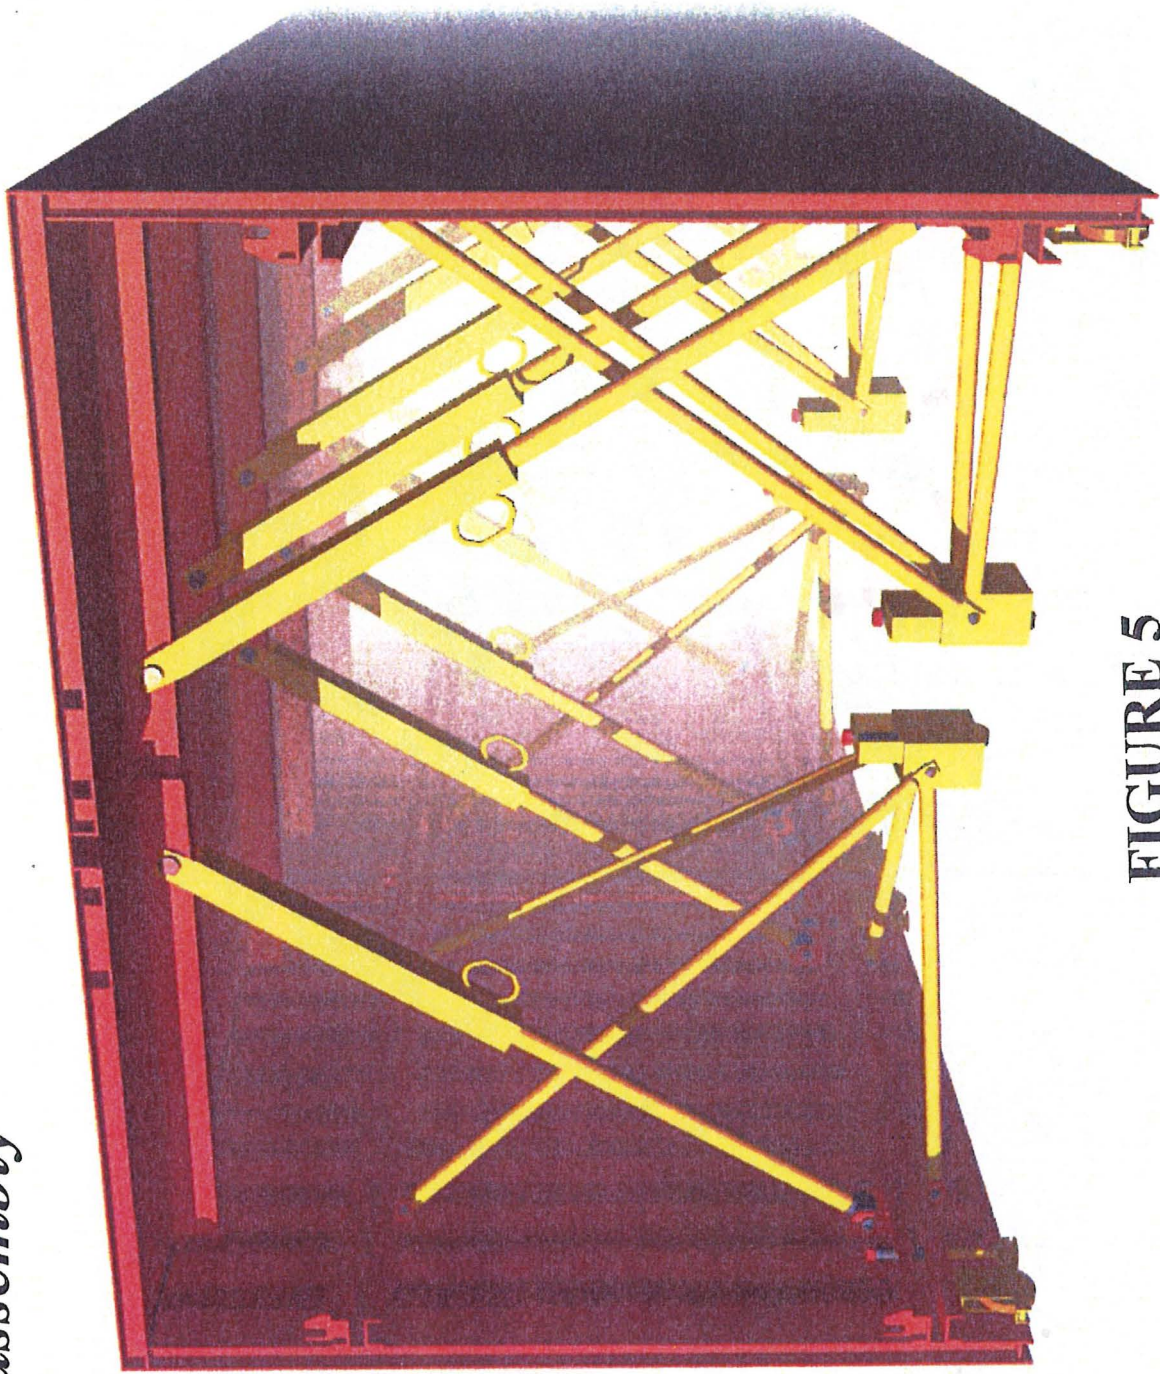
FIGURE 5

TMPH tunnel assembly

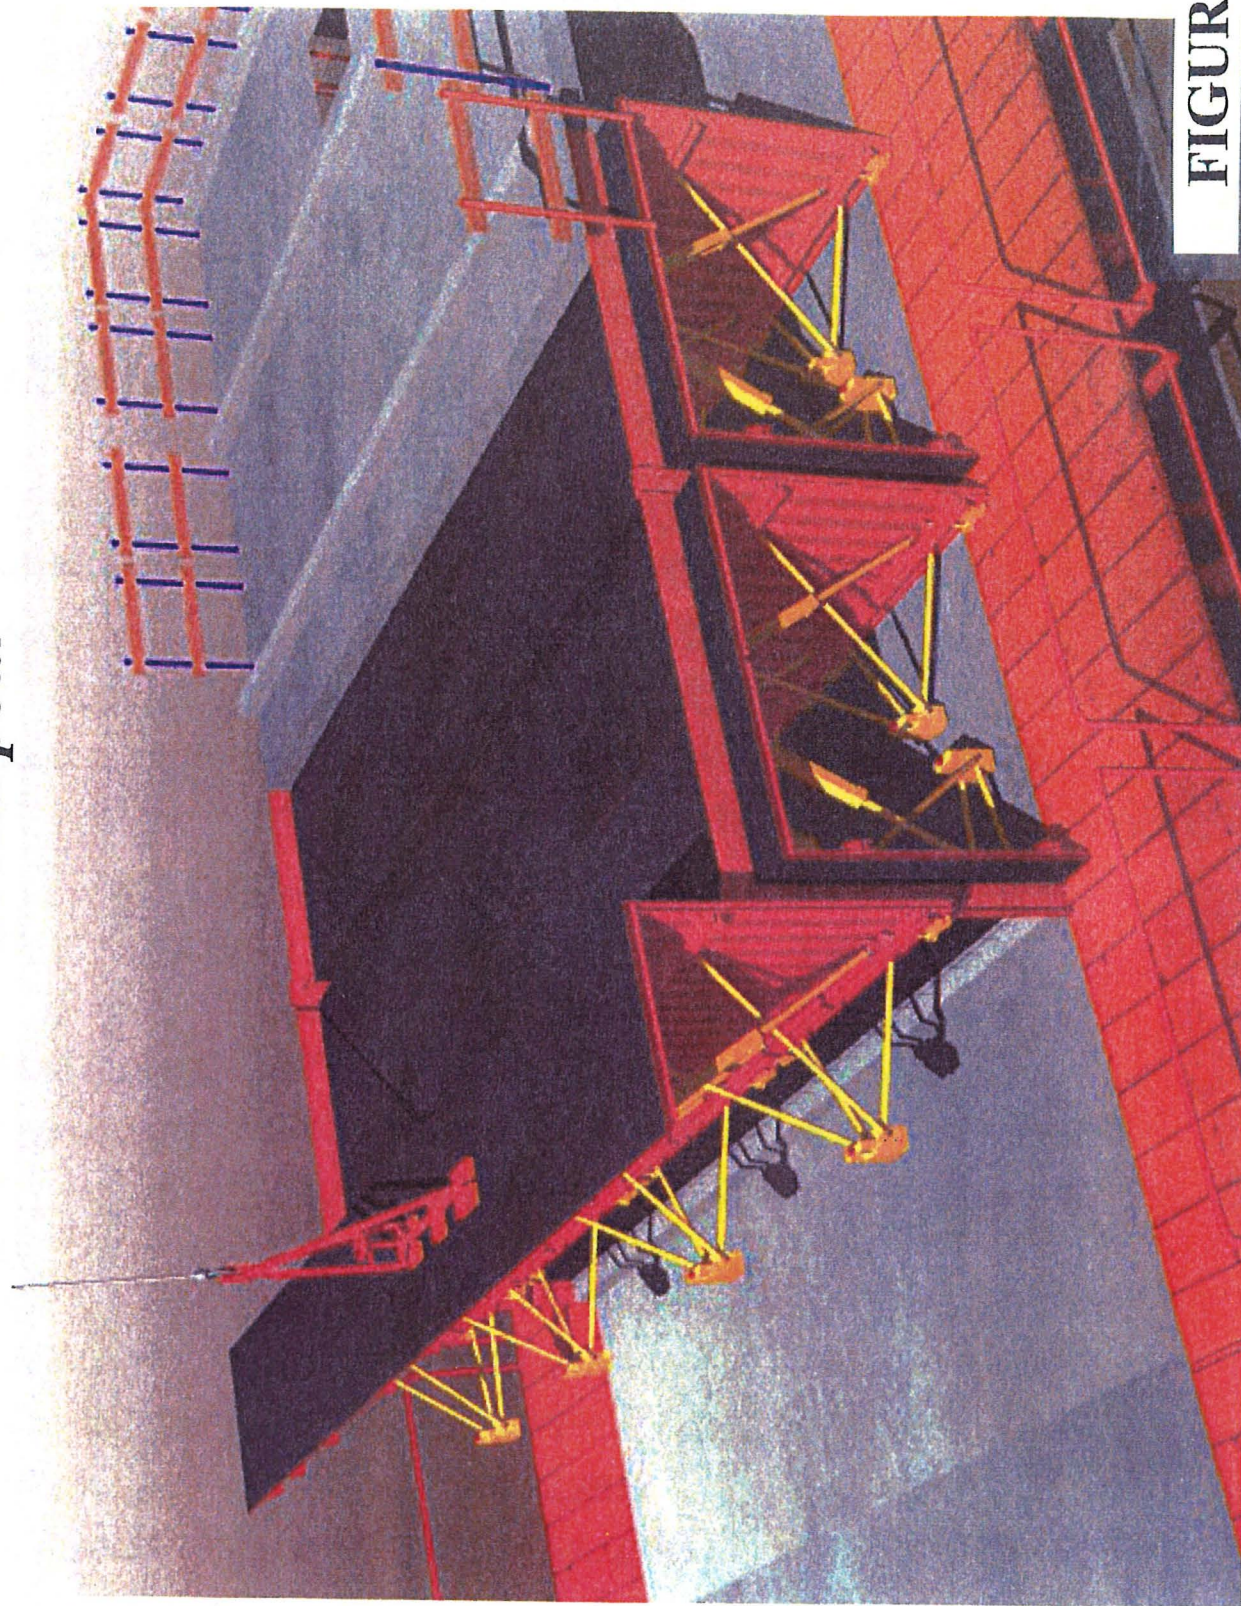
FIGURE 6

Second pour
