# Investigation of the June 3, 2006, Collapse of Grandview Triangle Bridge in Kansas City, MO

U.S. Department of Labor  
Occupational Safety and Health Administration

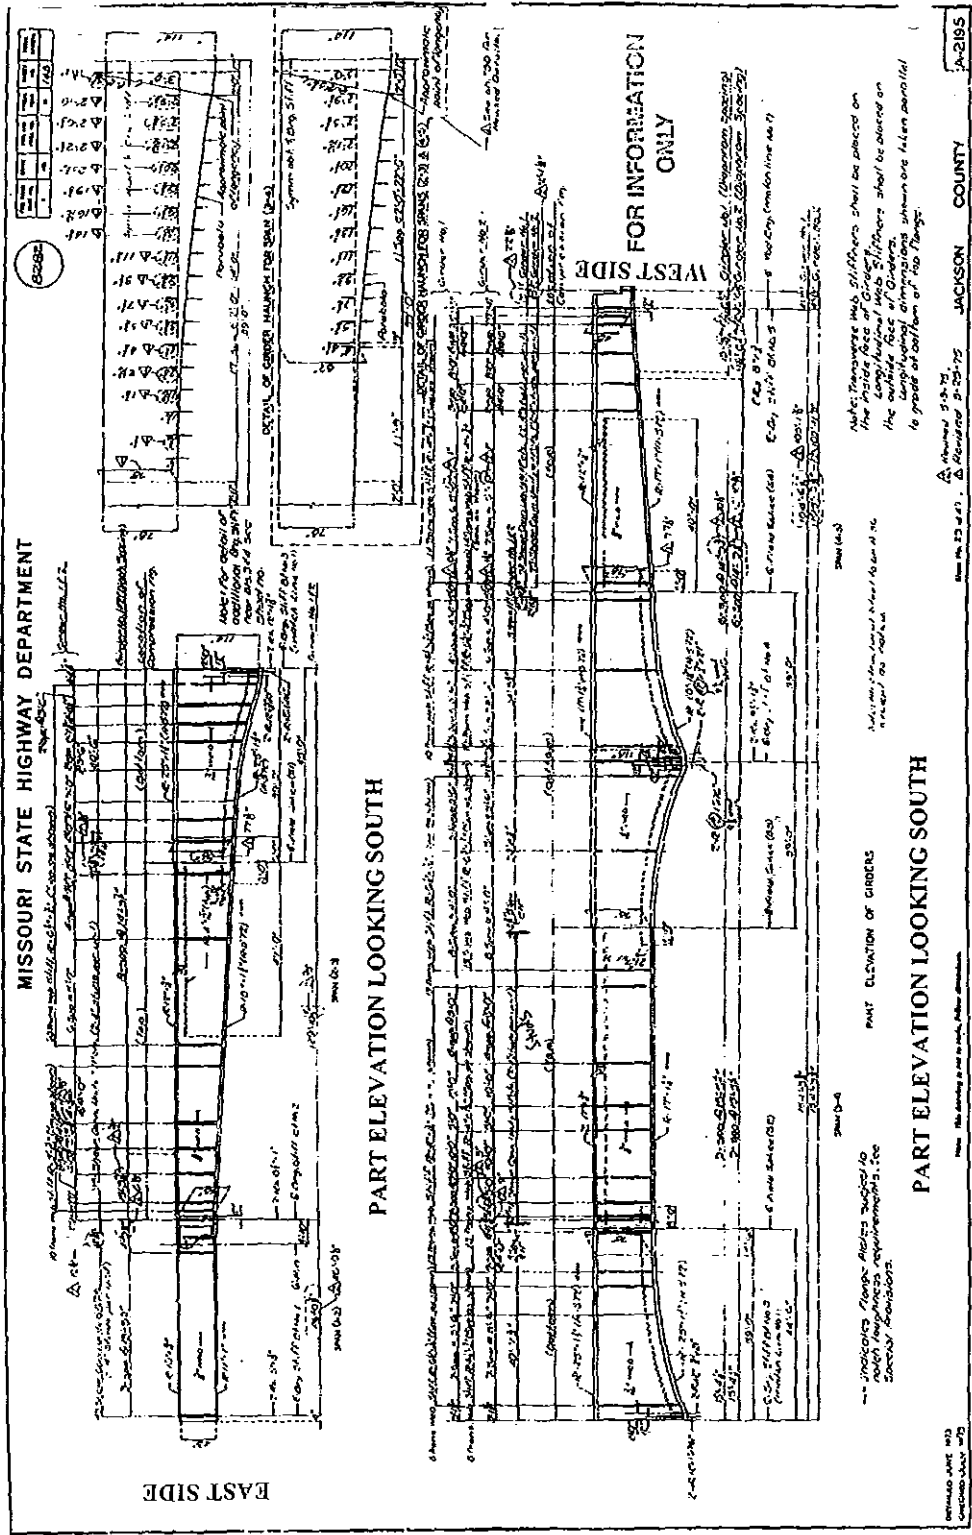
PARTIAL LONGITUDINAL ELEVATION OF BRIDGE GIRDER

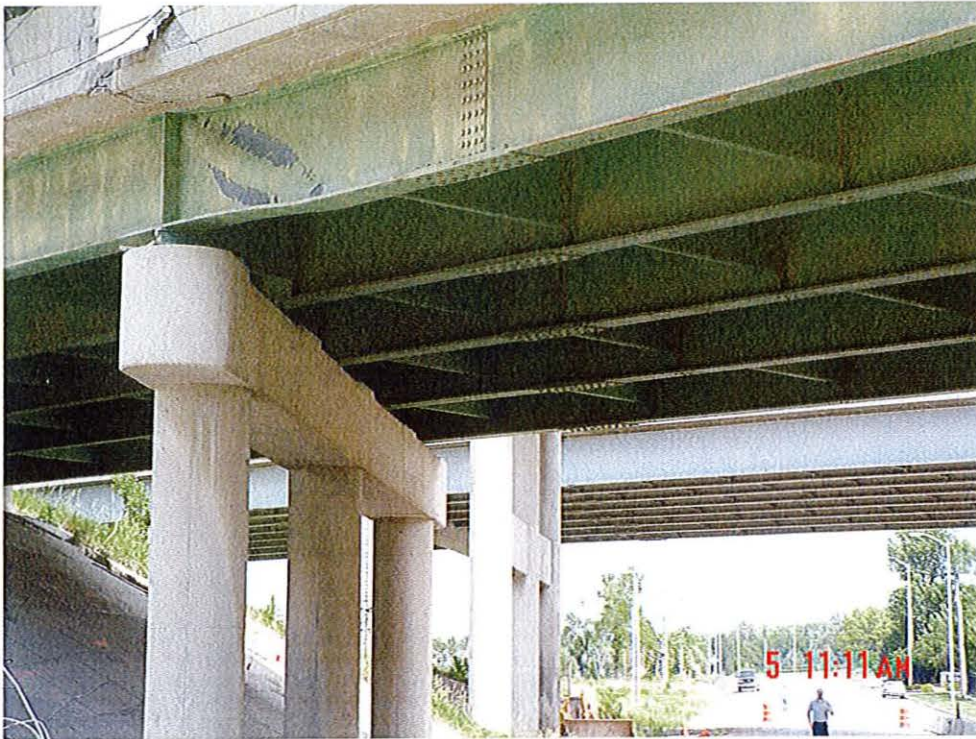
**FIGURE 19**  
(damage to lower bridge girder framing due to upper bridge collapse)

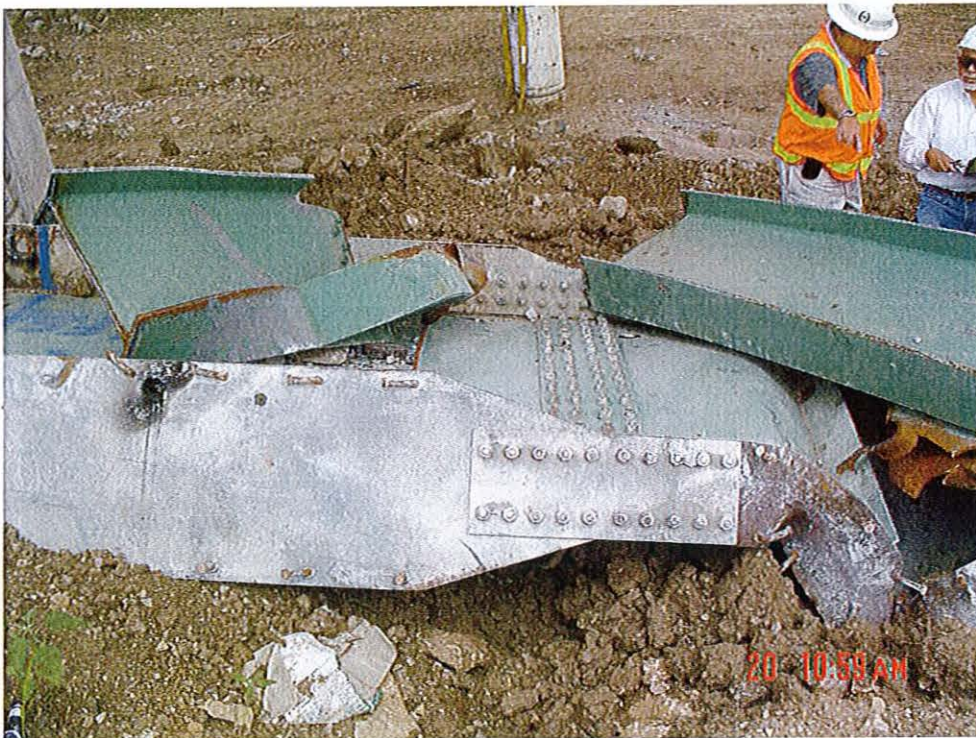
**FIGURE 20**  
(Damaged top flange of the bridge girder)

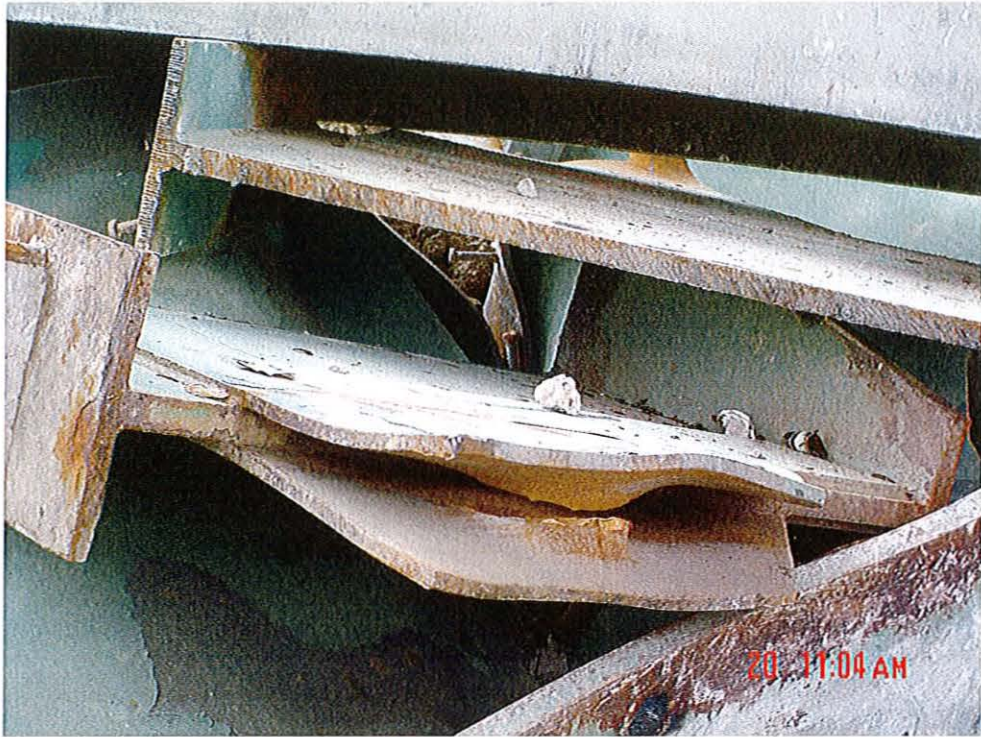
**FIGURE 21**  
(Damaged top flange of the bridge girder)

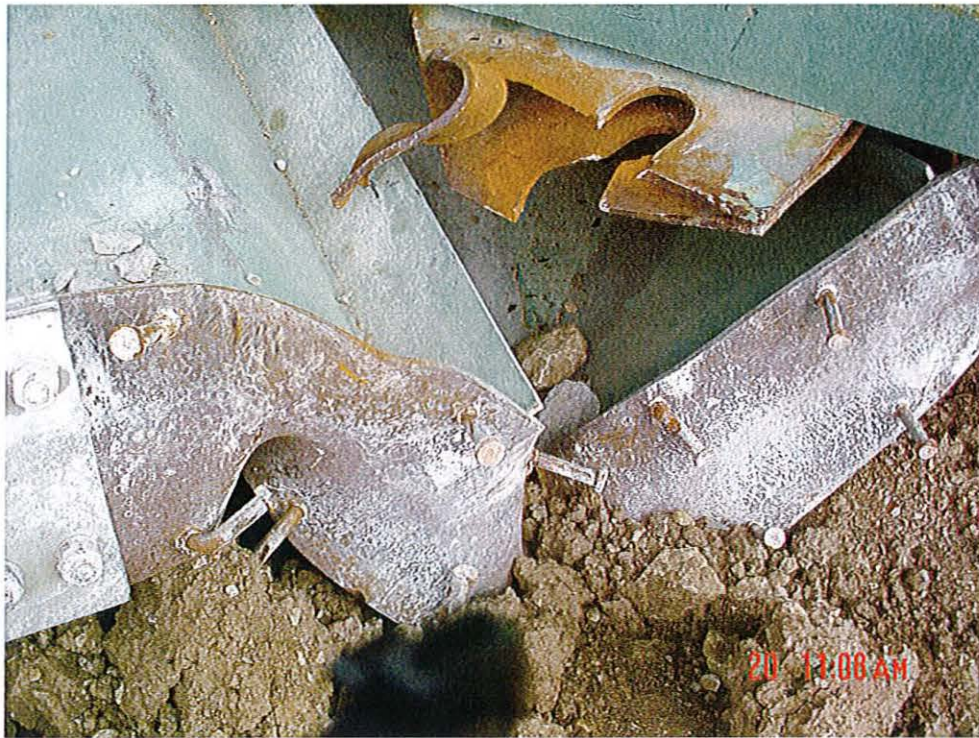
**FIGURE 22**  
(Damaged top flange of the bridge girder)

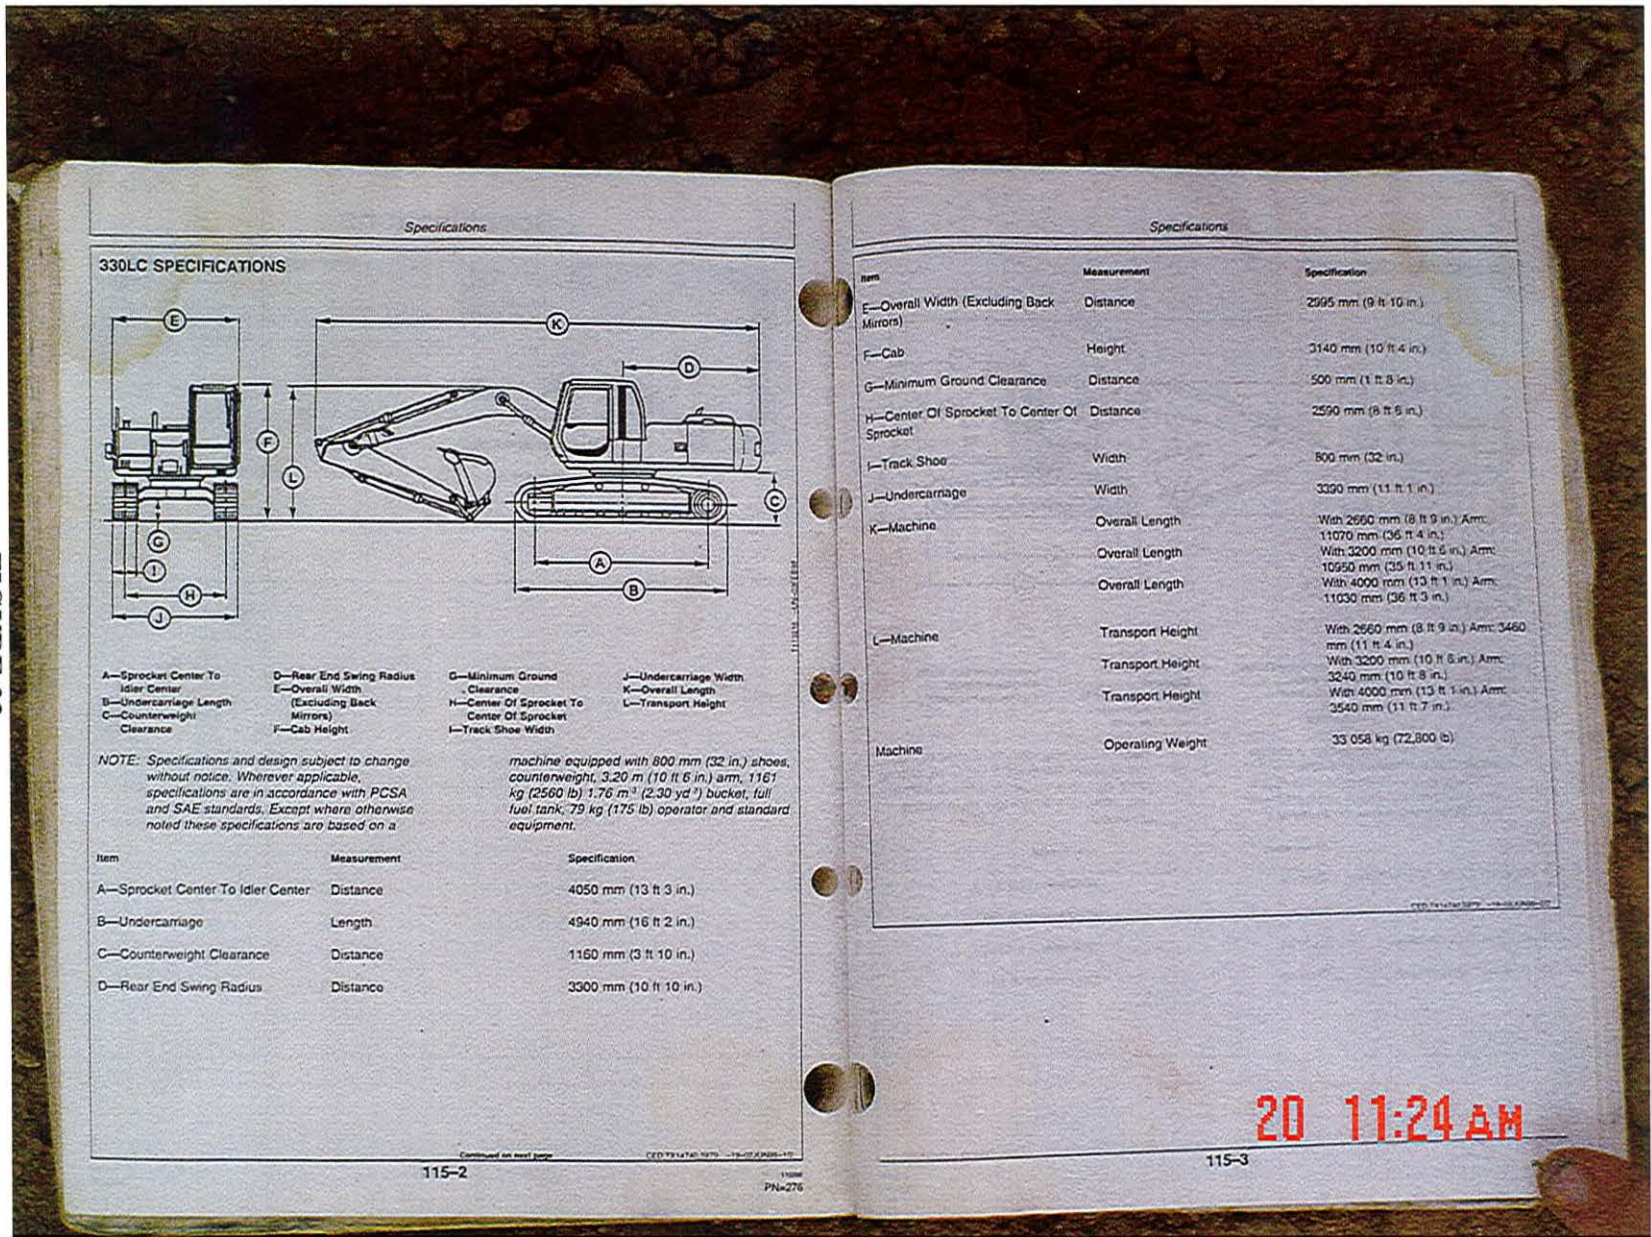
- A—Sprocket Center To Idler Center
- B—Undercarriage Length
- C—Counterweight Clearance
- D—Rear End Swing Radius
- E—Overall Width (Excluding Back Mirrors)
- F—Cab Height
- G—Minimum Ground Clearance
- H—Center Of Sprocket To Center Of Sprocket
- I—Track Shoe Width
- J—Undercarriage Width
- K—Overall Length
- L—Transport Height
