# Investigation of the June 10, 2009 Mast Climbing Platform Collapse in Austin, Texas

U.S. Department of Labor  
Occupational Safety and Health Administration  
Directorate of Construction

December 2009

Report Prepared by  
Mohammad Ayub, P.E., S.E.

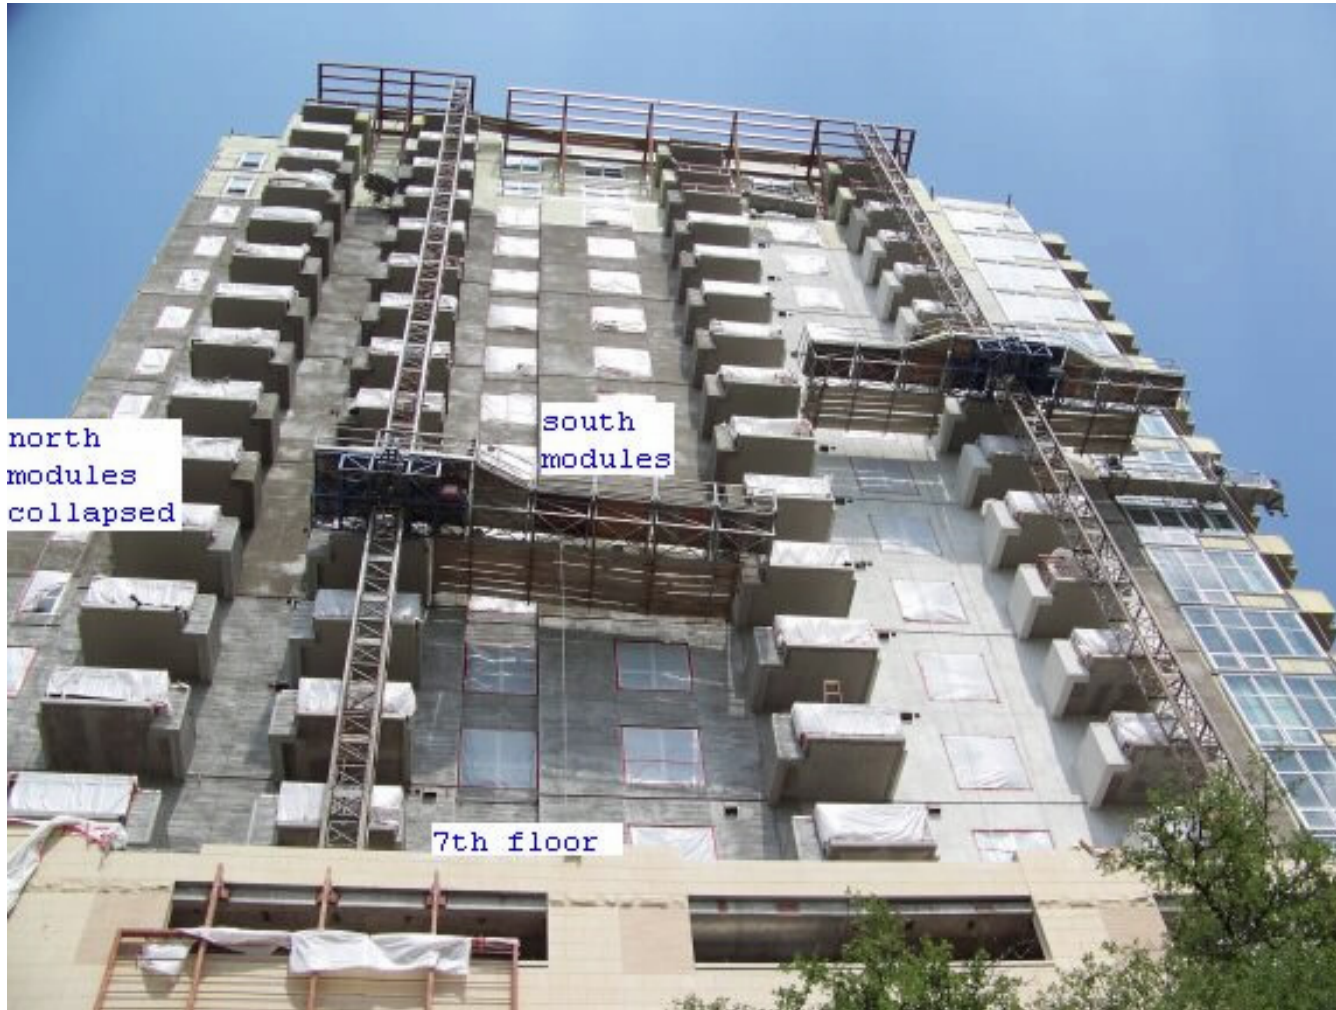
On June 10, 2009, at about 2:20 p.m., three construction employees of Capoera Construction, LLC of Margate, FL were killed when a mast climbing platform north of the mast collapsed at a condominium project under construction in Austin, Texas. The platform south of the mast and the mast itself remained intact and did not collapse. The site where the accident occurred was located at 2101 Rio Grande, Austin, Texas. At the time of the collapse, about eight employees including the operator were located on both sides of the platform. Immediately before the incident, the platform descended from the 13<sup>th</sup> floor and was stopped at the eleventh floor when the north platform suddenly separated from the main frame (motorized unit) and the mast, and fell to the seventh floor. As a result of the failure, three employees fell with the platform. Two of them fell 11 stories to the ground and the third fell to the seventh floor. The other two employees on the north side were able to hold onto the balcony and were saved.

**Figure 1 - Failed scaffold with north side modules separated.**

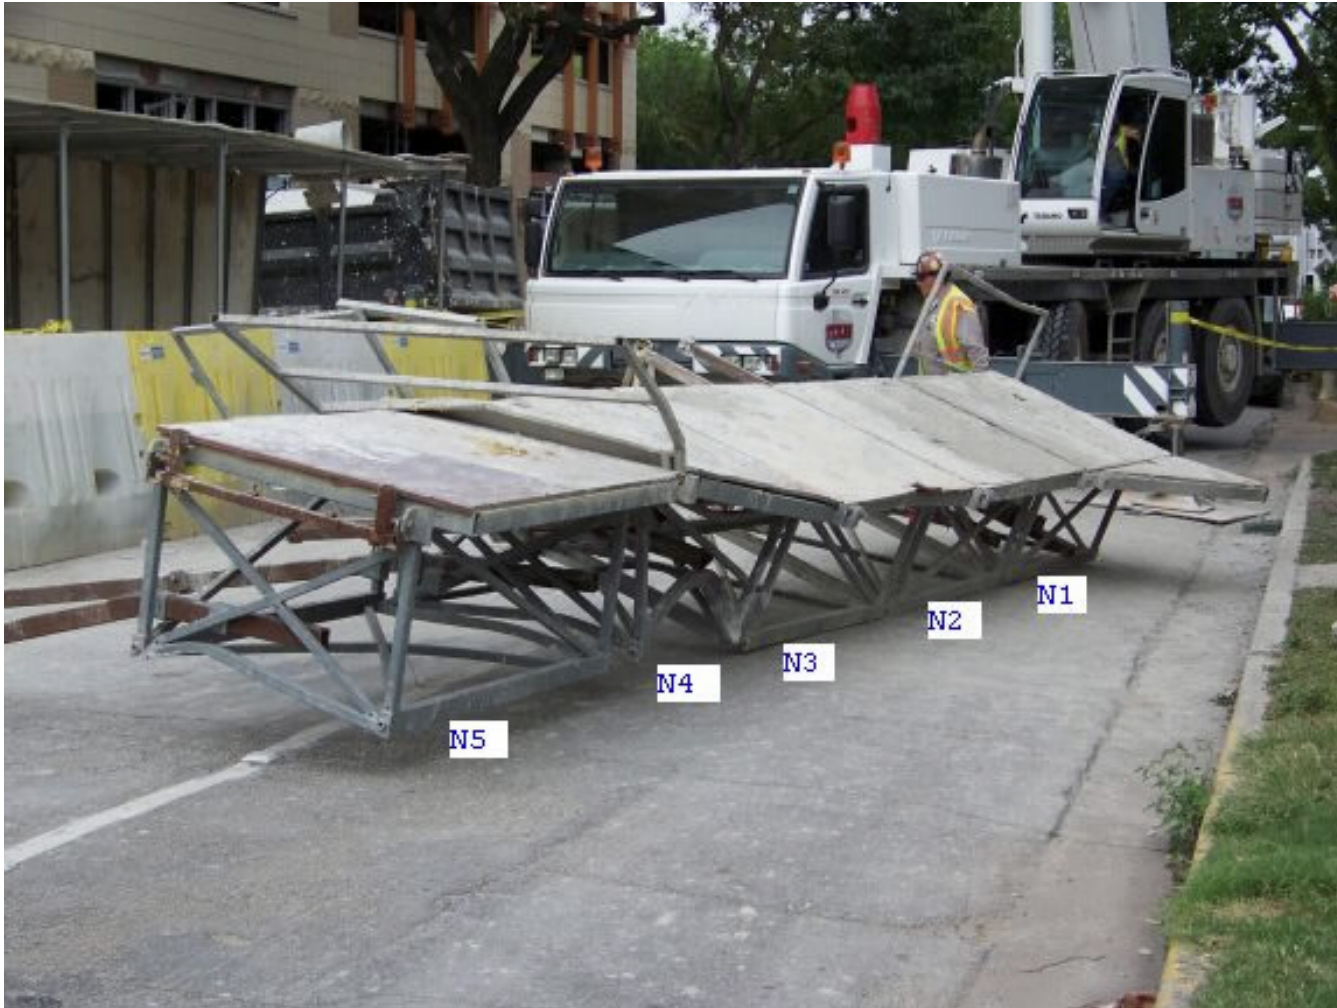
Figure 2 is a photograph of the failed platform on the ground. Five modules are identified as N1 thru N5, N1 being closest to the mast. Loads on the platform were resisted by tensile and frictional forces at the top connection between the modules and the compressive forces by the bottom leveling bolts. The top connection was comprised of high strength bolts in single or double shear. The bottom connection was simply comprised of leveling bolts butting against the

Among the failed deck modules, most damage to the steel members was to module #N4. The bottom HSS steel tubes on the side and the bottom diagonal members were bent upwards. This damage to the deck module #N4 is believed to have happened during the fall when it hit the wall on the 7<sup>th</sup> floor. The outriggers attached to the modules #N4 and #N5 on the failed platform were bent downward. This is also believed to have happened from the module hitting the wall during the fall.

**Figure 2 - Failed Deck Modules (North side)**

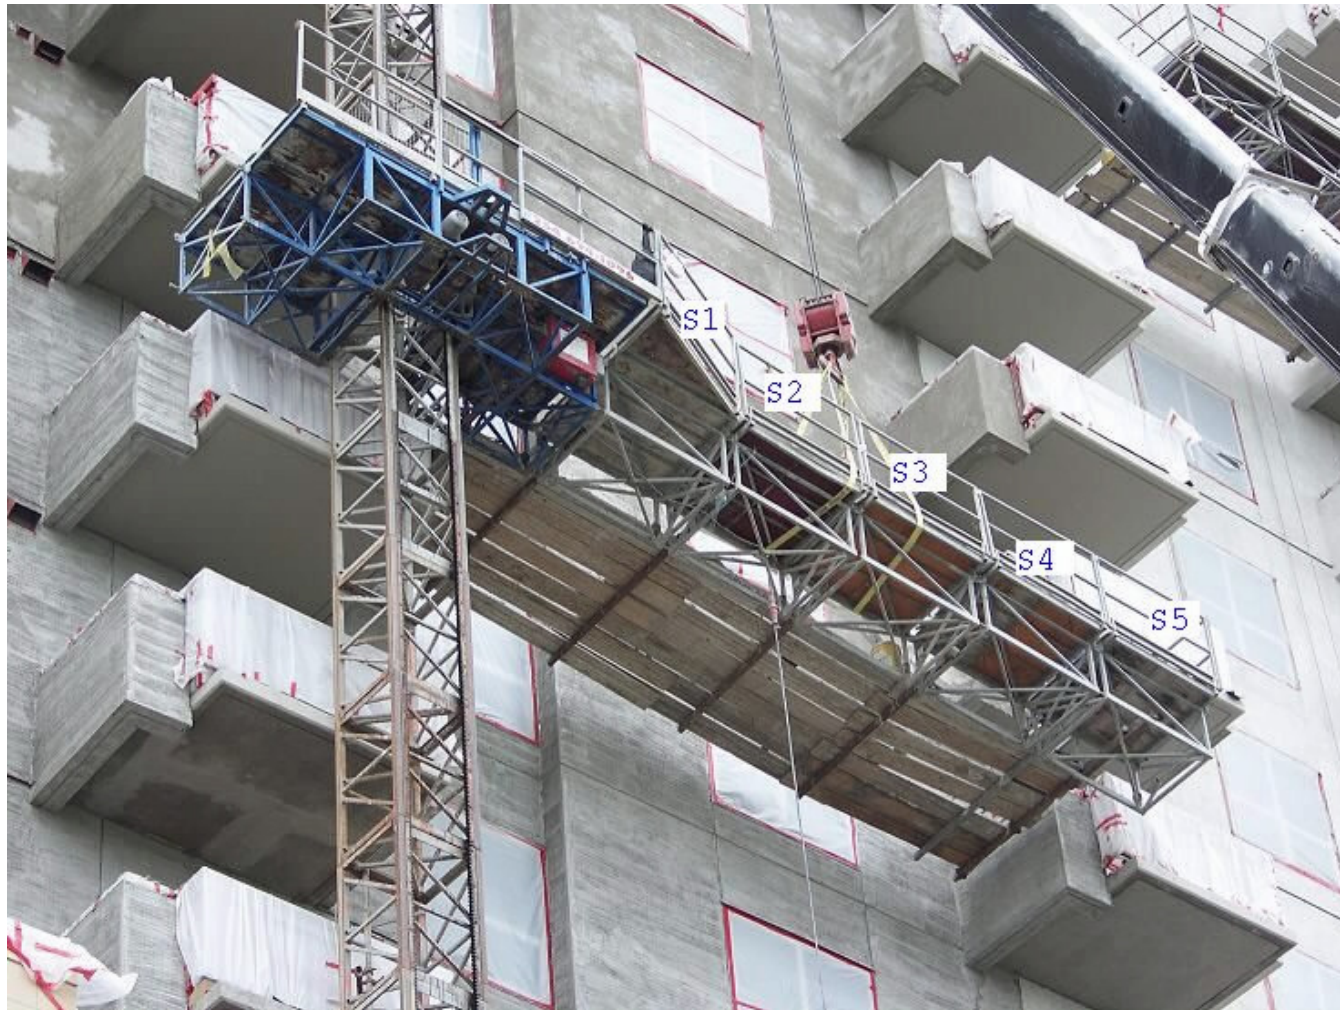
Figure 3 is a photograph of the tower mast, motorized unit and south modules after the incident. Although the mast was standing intact, it was observed that main tubular members on which the motorized unit was moving up and down were not aligned properly. Also, many of the tower mast members had corrosive damage. Some of the sections were crooked and were non-uniform.

The south modules S1 thru S5 can be seen in figure 3. Some of these modules had double ears for the top connection, thereby enabling a three plate double shear bolt connection as shown in the operations manual, see figure 13. The outriggers measured 66” to 69” and there were as many as 7 planks used to create the walk board on this side, see figure 3.

The outriggers were observed to be 69” long. Seven (7) planks were placed to form the walkway platform and five employees were believed to be standing on the collapsed section of the platform. AMC reportedly advised GMI not to use more than 6 planks on the outriggers but seven planks were used nevertheless. Although AMC advised GMI to use six planks, there is no evidence that AMC conducted any analysis to study the impact of six planks on the structural integrity of the platform.

**Figure 3 - Outriggers with seven walk board (south side deck modules shown)**

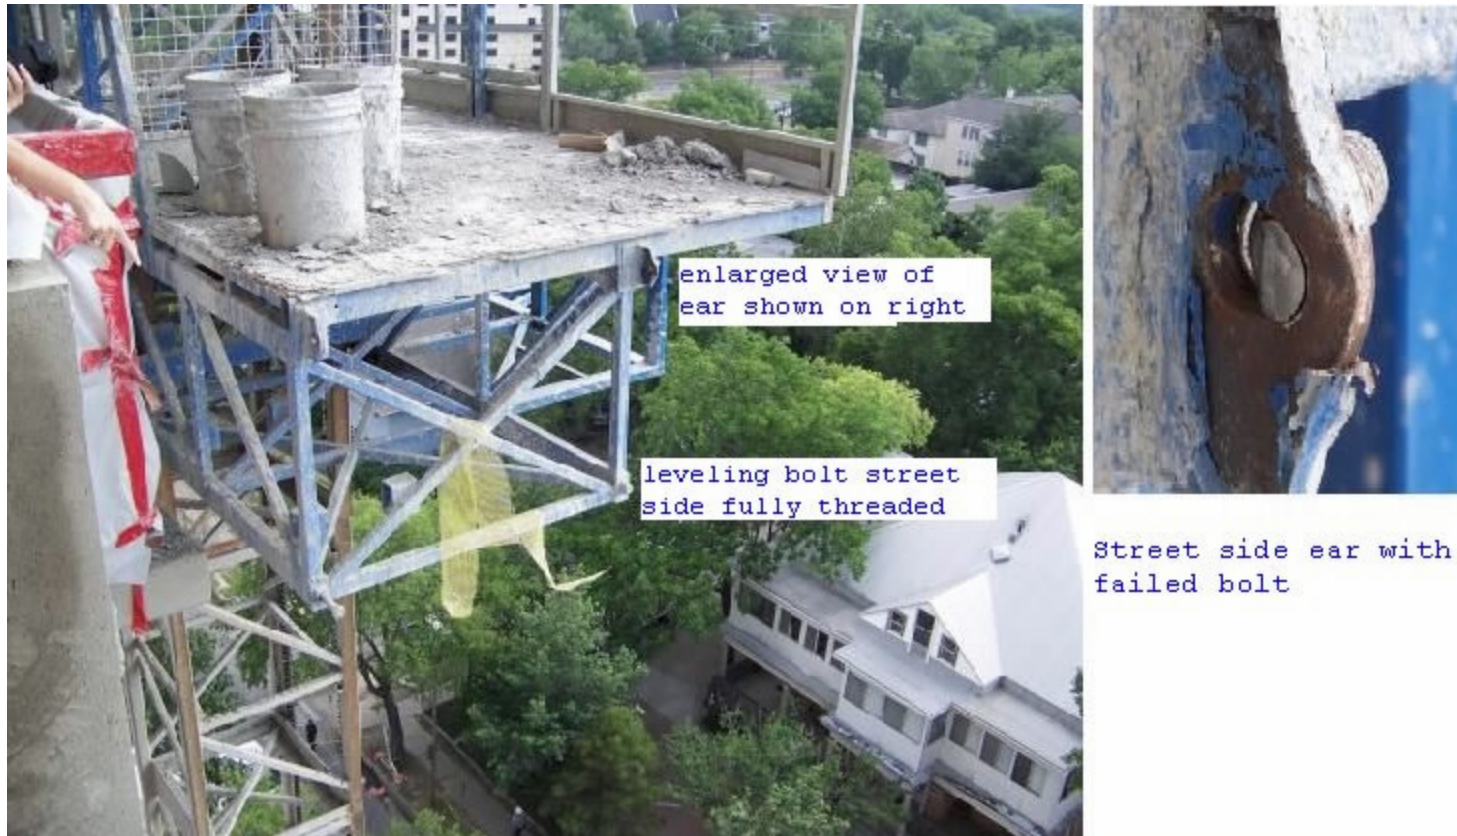
adjoining module. There was no positive connection at the bottom. The modules N1 thru N5 each had a single ear at the top and the bolts were in single shear. Figure 4 shows the single ear used for the top connection between the motorized unit and module #N1. It was observed that the bottom leveling bolt on the street side between the first section N1 and the motorized unit was rendered ineffective as it was completely threaded into the motorized unit, see figure 4. The photo in figure 4 also shows the deformed ear on the street side with a piece of failed bolt trapped. It was also observed that one of the leveling bolts on the street side between deck modules #N4 and #N5 was missing in the failed platform. The outriggers on the north side measured 66” to 69” and there were as many as 7 planks used to create the walk board.

The most disturbing issue was the absence of a leveling bolt on the street side between the motorized unit and deck module #N1. It created instability of the platform and increased the load

on the bolt on the building side by 100%. This is believed to be the cause of the bolt failure on the building side.

**Figure 4 - Leveling Bolts and Ear on the Main Frame to which deck module #N1 was connected.**

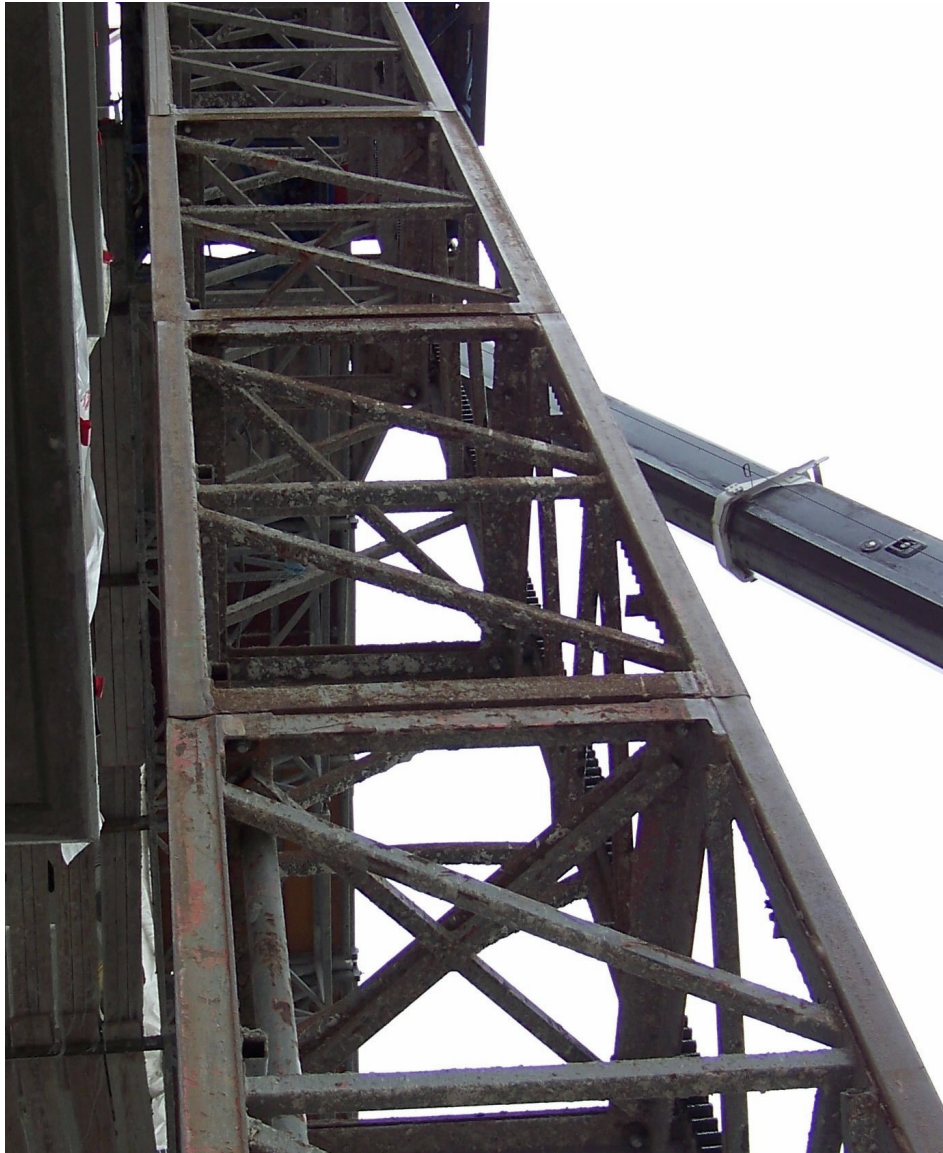
10. The erection of the mast was performed in a manner so that the masts did not align properly. The erectors used hollow structural steel tubing with non-uniform dimensions. In some instances, mast sections were out of alignment by as much as one inch. The maintenance of the mast climbing rollers was extremely poor so that polymeric covers for a majority of the rollers were either completely separated or badly worn out. The combination of misaligned mast sections and worn out rollers could result in erratic movement of the platform.

**Figure 5 - Tower Mast showing non-uniform and rusted sections**

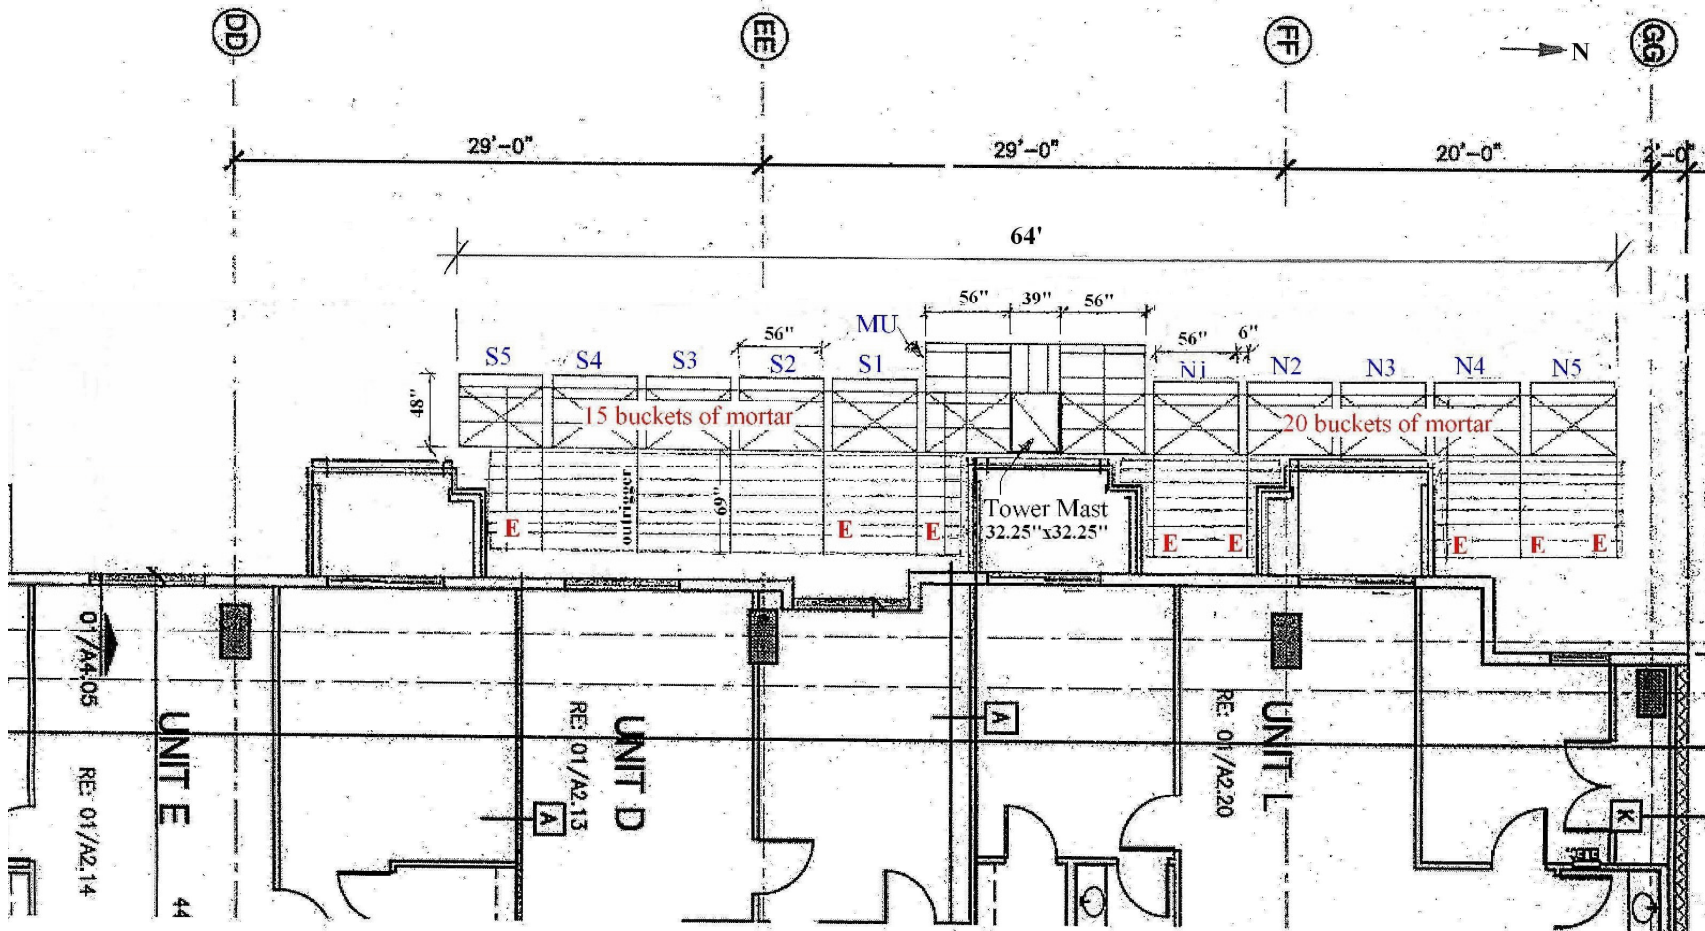
Figure 6 - Location of Platform - Prior to Collapse

- N1-N5 -- North side modules (collapsed)
- S1-S5 -- South side modules
- MU -- Motorized Unit (Main Frame)
- E -- Assumed location of construction employees
