INVESTIGATION OF THE NOVEMBER 8, 2011 PARTIAL COLLAPSE OF A BUILDING UNDER CONSTRUCTION AT 2929 BRIGHTON 5th STREET, BROOKLYN, NY

U. S. Department of Labor
Occupational Safety and Health Administration
Directorate of Construction

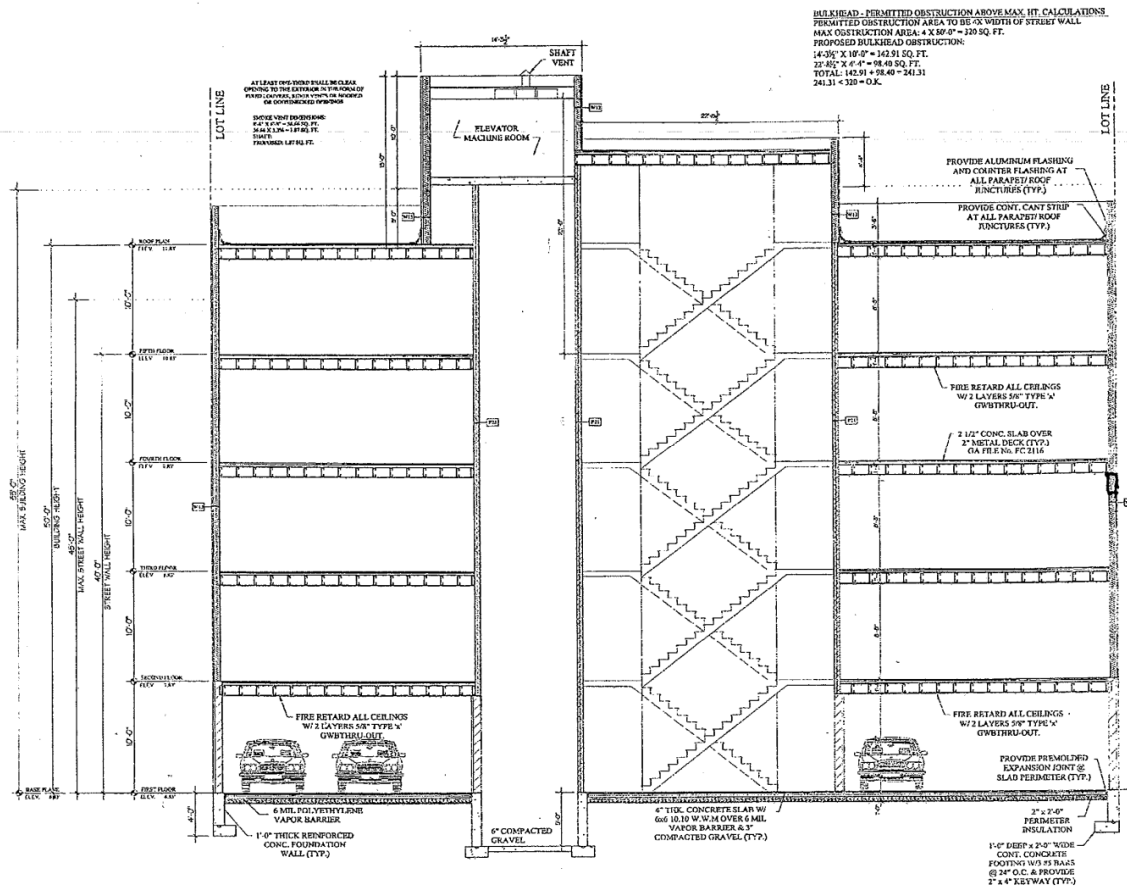
Fig. 3 Vertical Section of the Building.

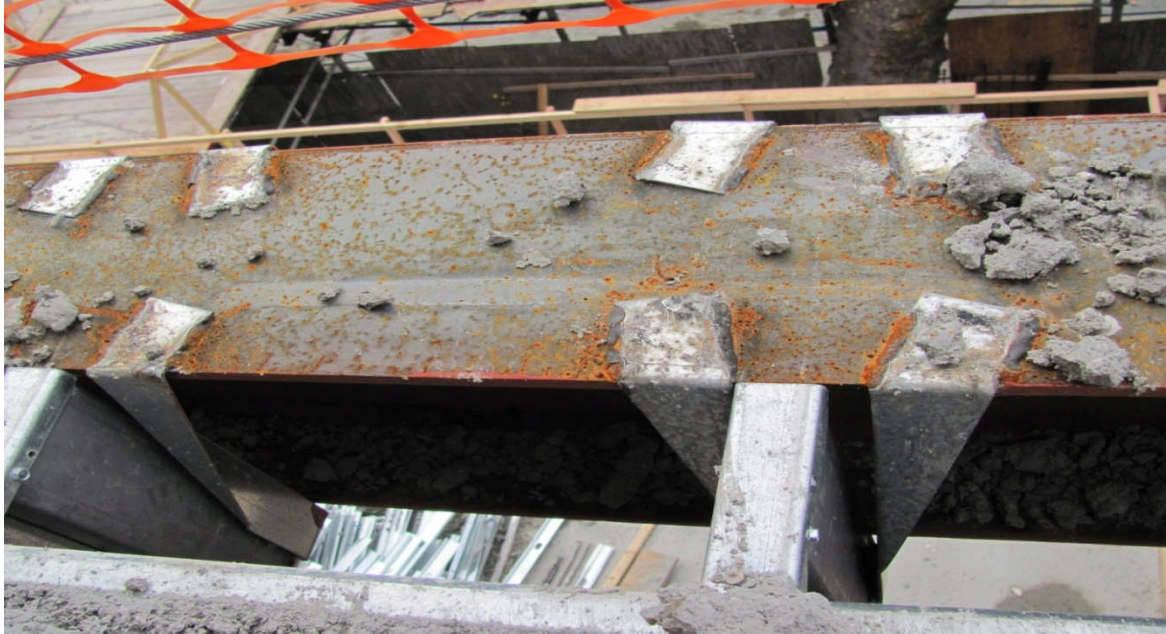
Fig. 4 Bridle hangers welded to a wide-flange steel beam and supporting floor C-joists.

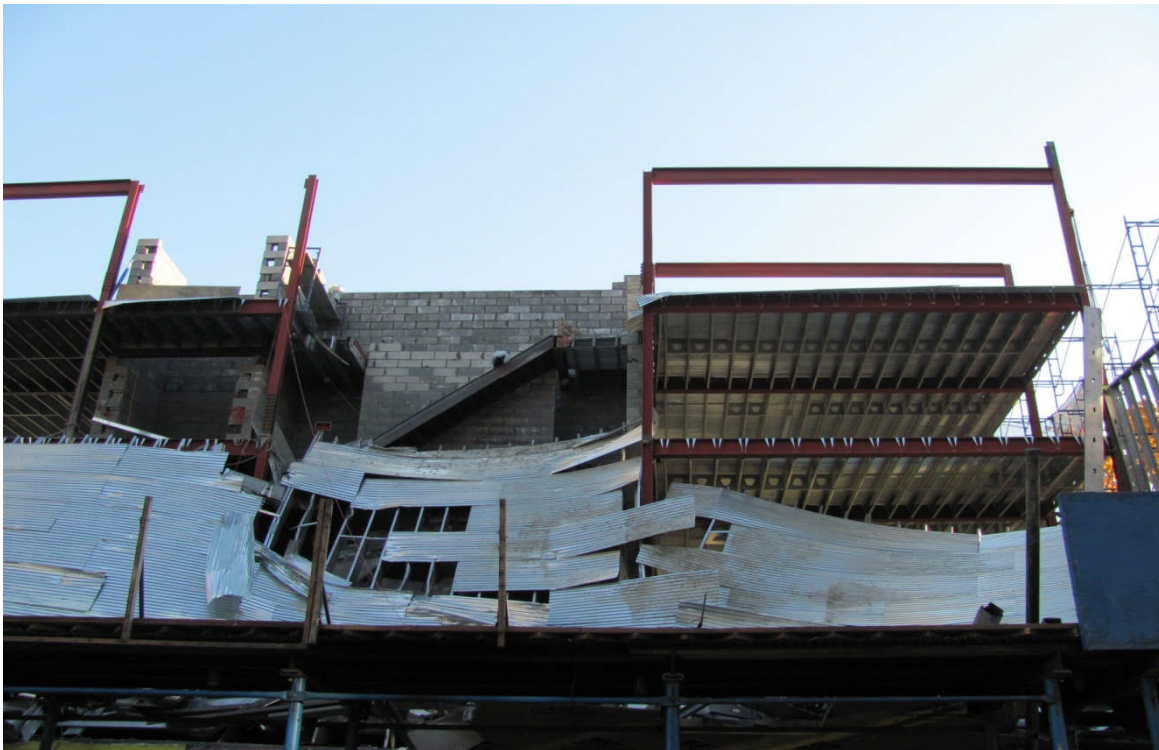
Fig. 5 Collapsed front bay of the building.

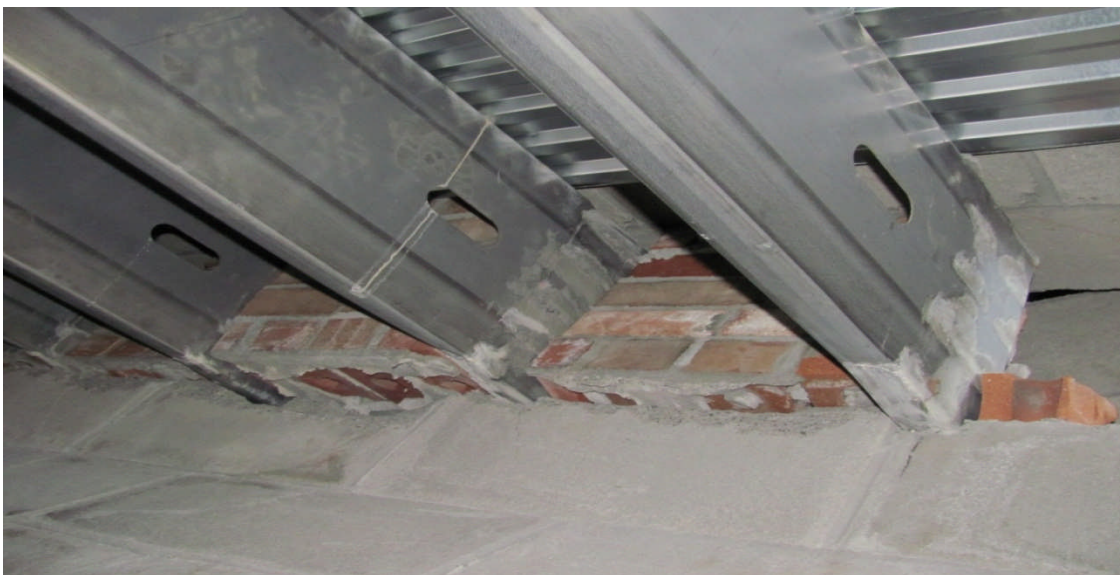
Fig. 7 C-joists blocked in by brick masonry.

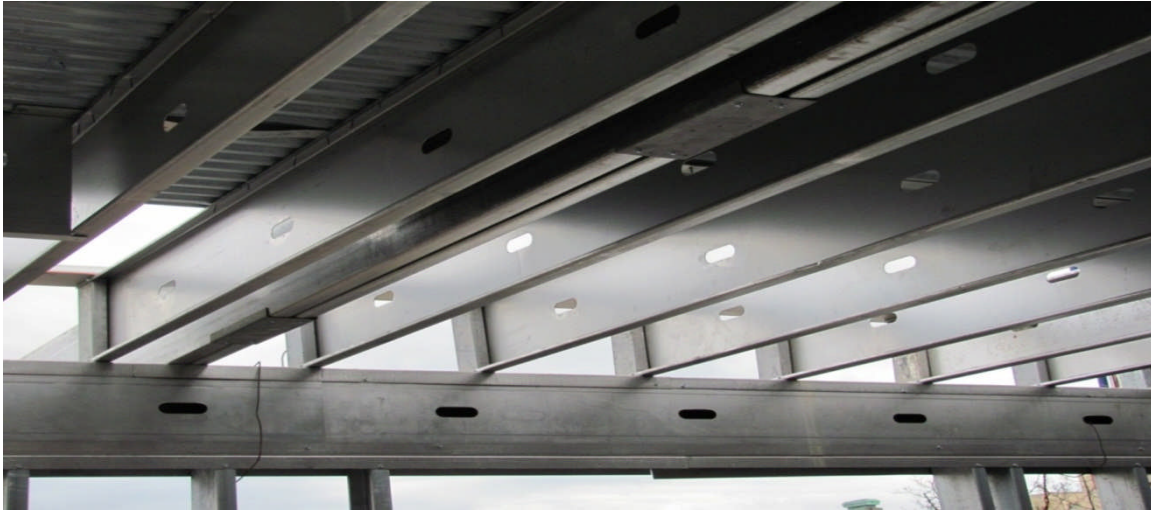
Fig. 8 C-joists resting on an exterior stud wall.

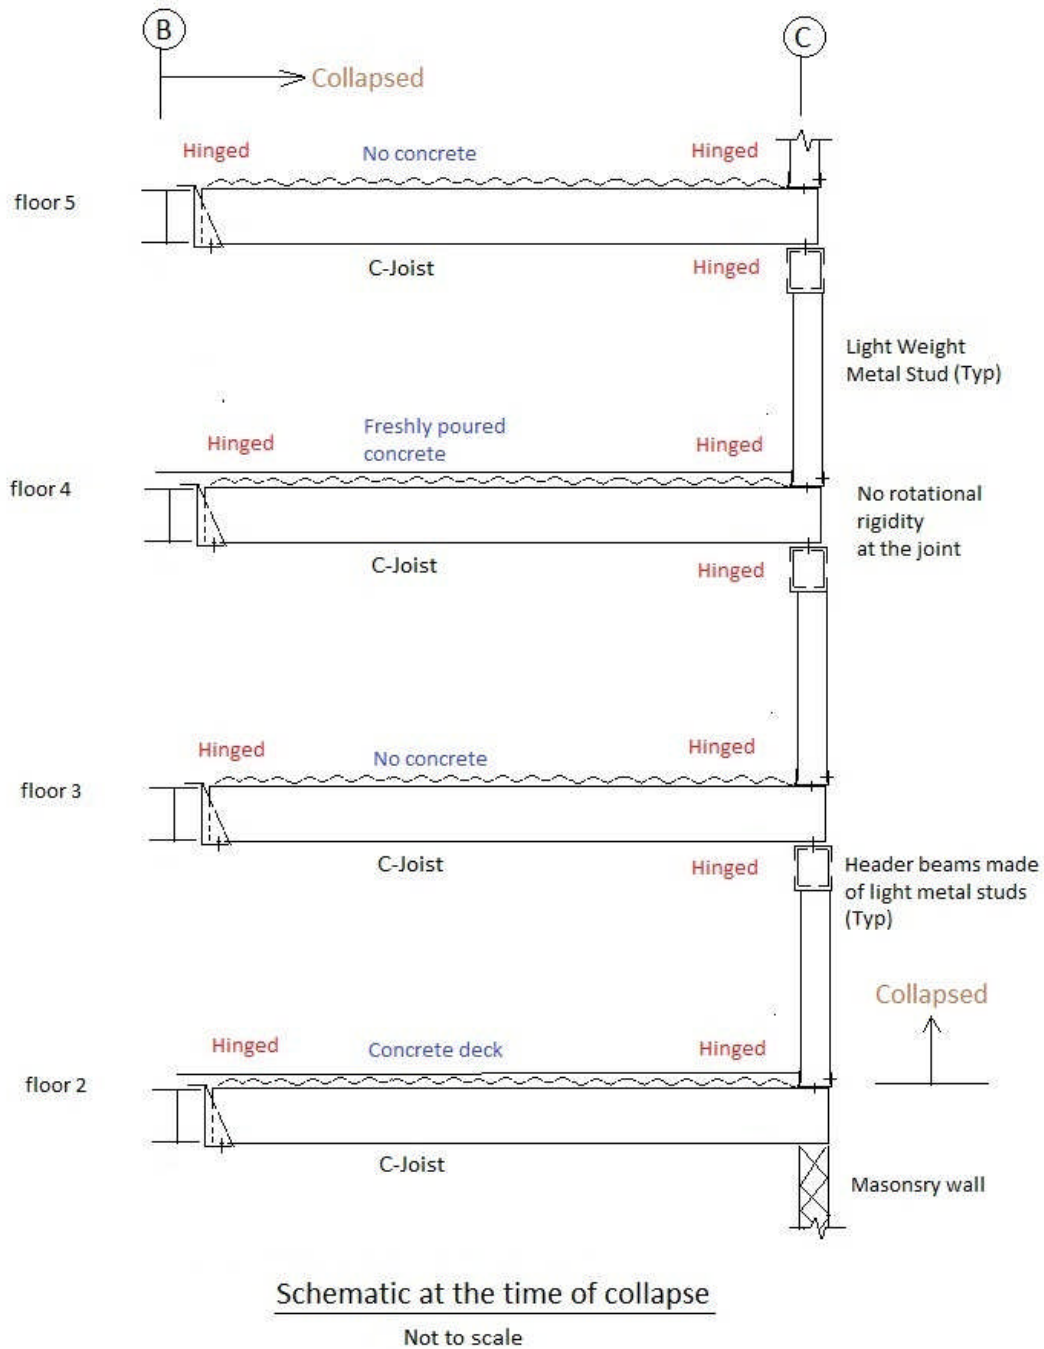
Fig. 9 Unstable frame showing the hinged connections.
