# INVESTIGATION OF THE MARCH 22, 2012 PARTIAL BUILDING COLLAPSE DURING DEMOLITION AT 604-606 WEST 131<sup>ST</sup> STREET, NEW YORK, NY

U.S. Department of Labor  
Occupational Safety and Health Administration  
Directorate of Construction

July 2012

This report was prepared by  
Mohammad Ayub, P.E.; S.E.  
Office of Engineering Services  
Directorate of Construction

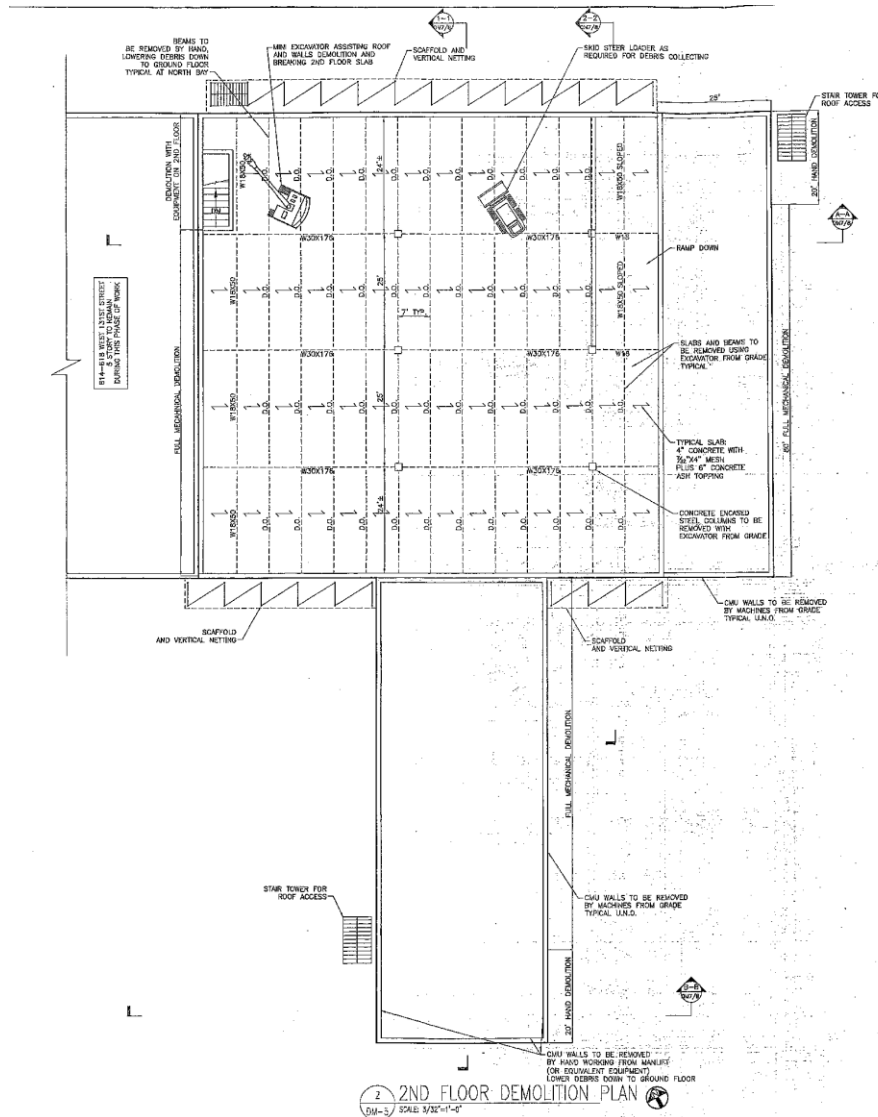
Figure 2 Second Floor Demolition Plan (Mr. Shapiro's drawing DM-005.00)

- Drawings were prepared without reviewing the original building drawings available at the New York City Department of Building (NYCDOB).
- The beam and girder sizes did not reflect the correct sizes as shown on the original document. The original girder size was 30BG200 against an indicated W30x176.

Similarly, the original filler beam size was 18BI48 ½ against indicated W18x50. The discrepancies in the sizes did not create any hazard.

- The girders were shown from column to column. No splice connection on the girder was indicated. This was the major contributing factor to the collapse.
- The concrete floor slab thickness was shown as 4” plus 6” of ash concrete. No core drilling was performed to calculate the actual slab thickness.
- The demolition drawings did not provide specific instructions for removal of individual structural framing members such as beams, girders, and CMU walls. It only specified demolition tier-by-tier.

5. The consultant's drawings showed the framing of the building which did not represent the actual framing, thus misleading the contractor. This contributed to the collapse.

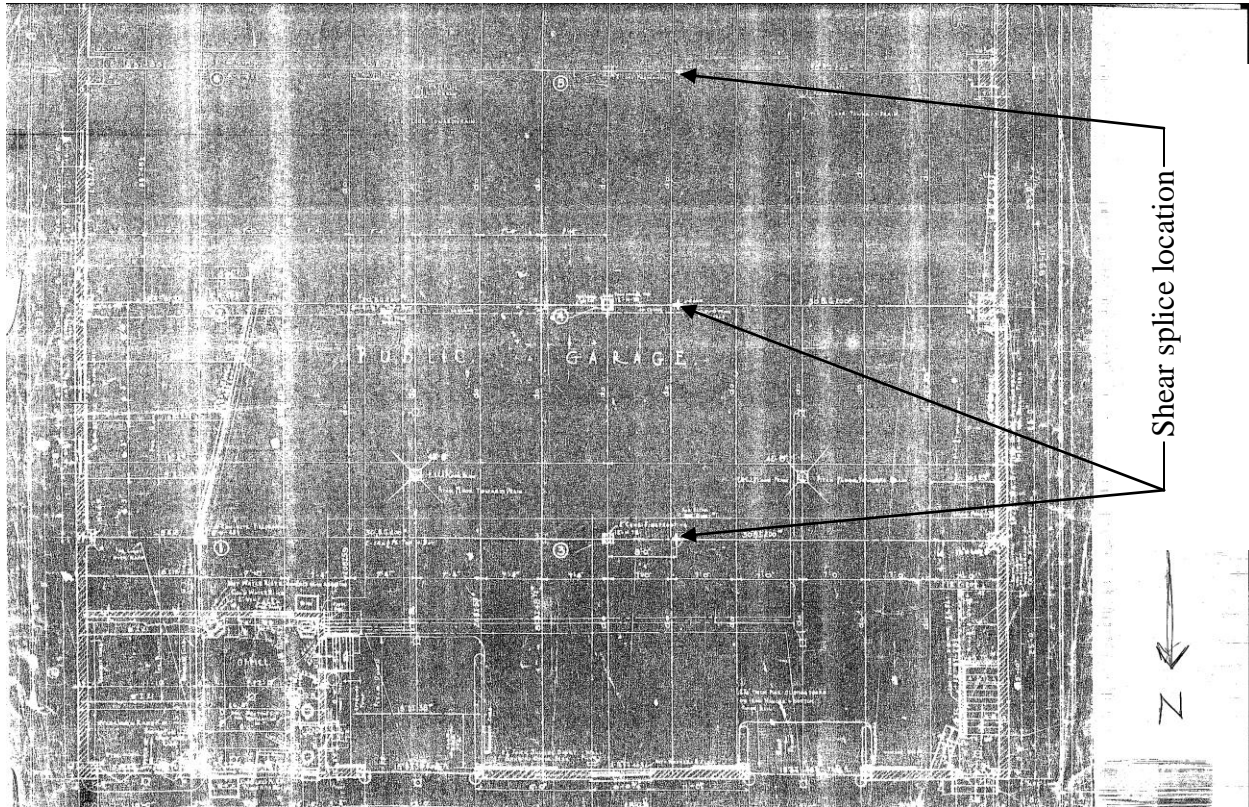
Figure 3 Original Second Floor Framing Plan (from NYCDOB)

The second floor consisted of 6" thick lightweight concrete slab spanning 7'-0" in an east-west direction and was supported by W18 filler beams, approximately 25' long, spanning in a north-south direction. The 18" deep filler beams (from grid line 1 to 3 and A to D) were supported by 30" deep girders, approximately 42' long, in east-west directions. The 18" deep filler beams from grid line 3 to 4 were supported by shallower girders (18" or 15" deep). The girders were supported over steel columns H 8x43½, and H 12x78 with cap plates and 8 bolts. The 30" girders at the west end and 18"/15" girders at the east end were supported by CMU pilasters/steel columns.

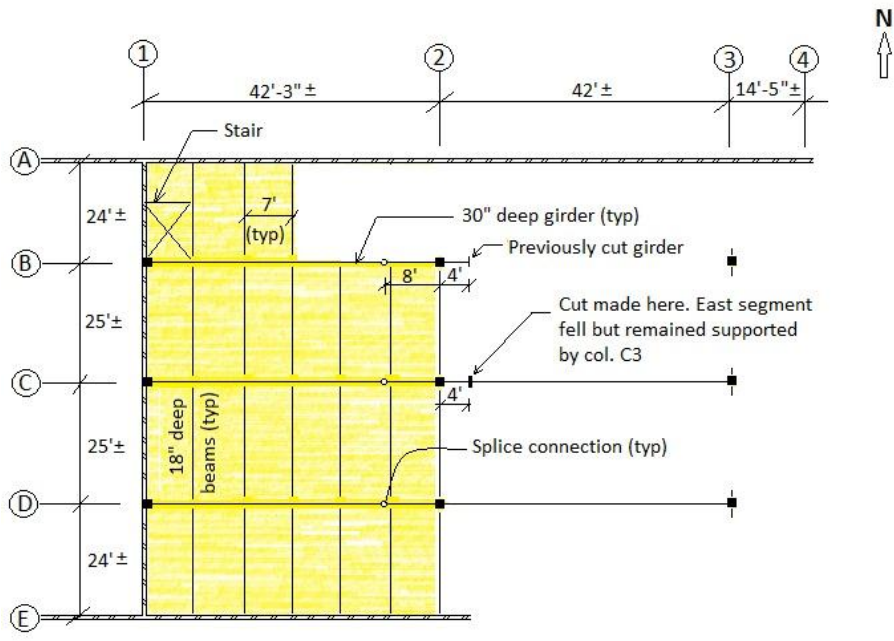
Figure 8 Second Floor Framing Plan (NTS) as it existed immediately prior to the collapse

Having removed some filler beams, the next step was to gradually remove girders on column lines B and C. First, the shallow girders from support column B3 to B4, and C3 and C4 were removed without any apparent difficulty. Next the girders from columns B3 and B2 and from C3 to C2 were to be removed. The contractor assumed that the girders on lines B and C spanned from column to column similar to the shallow girders they just removed. This assumption was incorrect because girders were spliced for shear connections 8'-0" away from the column. The contractor torch cut the girder between B3 and B2 some 4' away from column B2. The longer segment of the girder dropped on the ground leaving, 4' of overhang at column B2. After the cut was made, a wide crack developed at 8 ft. west of the column, which was later discovered to be the splice location, see Figure 10.

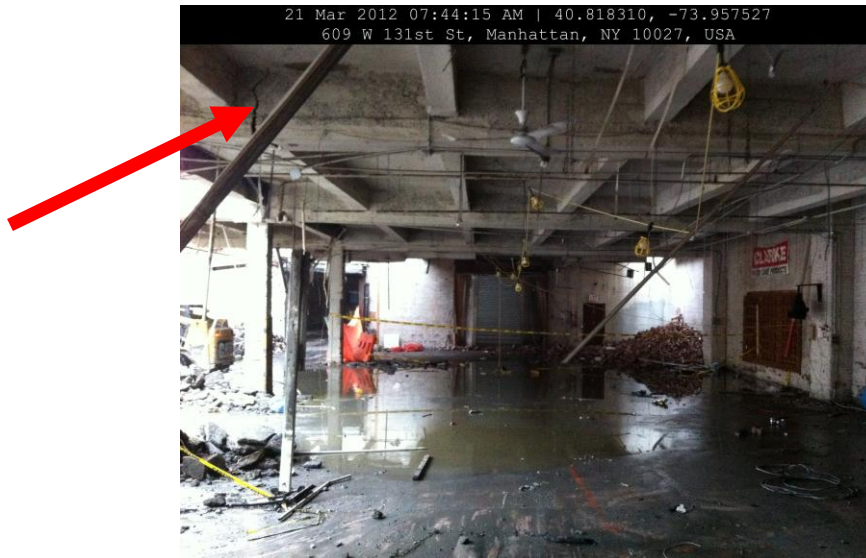
Figure 9 Photo showing crack on grid line B girder after torch cut was made two days before the incident

The existence of splices on column lines B and C were neither known to the contractor nor to the consultant, as they did not obtain the original drawings from the City of New York. The ensuing wide crack had afforded another opportunity to the consultant and contractor to discover the splice. This opportunity was missed. The contractor proceeded to pull down three more filler beams near the location of the girder splice. The operator then suddenly stopped and did not remove any other filler beams. It is highly likely that the crack that he would have noticed when he pulled down three beams prompted him to stop. That was an imminent danger signal, but it was ignored.

3. When the first primary girder was dismembered two days before the incident, a large crack developed in the adjoining span of the same girder in plain sight of everyone. The contractor and his consultant failed to notice the crack, and proceeded to dismember the next primary girder in a similar manner at which time both girders collapsed along with other filler beams. This was a serious lapse of judgment on the part of the contractor and his consultant.

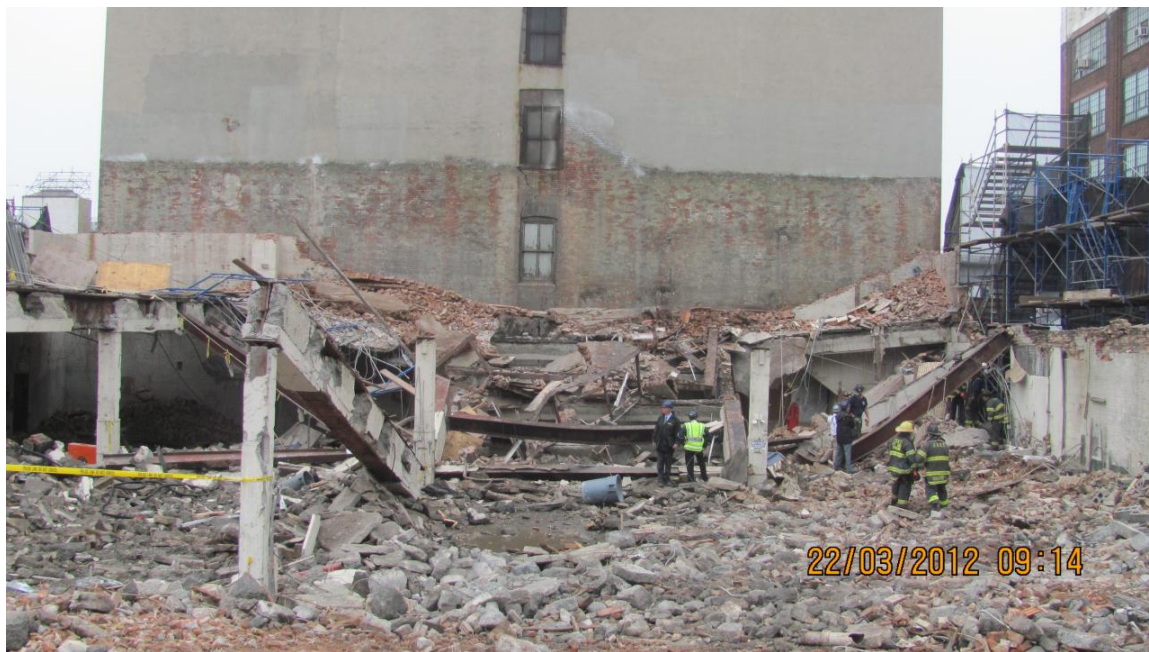
Figure 10 Second Floor Framing as it existed immediately prior to the collapse

Despite the existence of the crack that developed after the girder on grid line B was cut, the next day, the contractor proceeded to torch cut the girder on grid line C some 4 feet away from column C2, similar to the cut made on grid line B. Soon after the cut was made, the collapse occurred, see Figure 10. Columns B2 and C2 remained standing upright but the segment of the girders on grid line B and C up to the location of the splice, along with two filler beams, fell in one piece towards the west. The longer girder segments on grid lines B and C, west of grid line 2, fell to the ground.

After the incident (Figure 10), the following were observed:

- 30” girder at grid line C of the longer segment, east of grid line 2, fell but remained supported at column C3.
- The shorter segments of the 30” girder at grid lines B and C, from the torch cut location to the splice location, fell to the ground below along with two W18 filler beams and flipped over as one piece.
- Structural steel framing including concrete slab located between grid line 1 to 2 and A to D collapsed to the floor below.
- West CMU wall located on column line 1 between grid lines A to D collapsed.
- Of the three employees, one who was carrying scaffold frames across the floor near the west wall was killed and the other two employees, who were performing torch cutting, fell 13 feet below and were severely injured.

4. If all the filler beams were removed sequentially before dismembering the primary girders, then the existing shear splice connections would not have been overstressed. In this manner, the incident could have been averted.

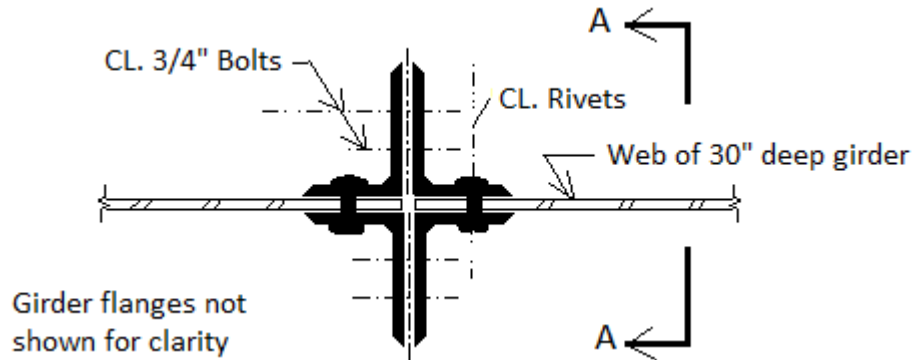
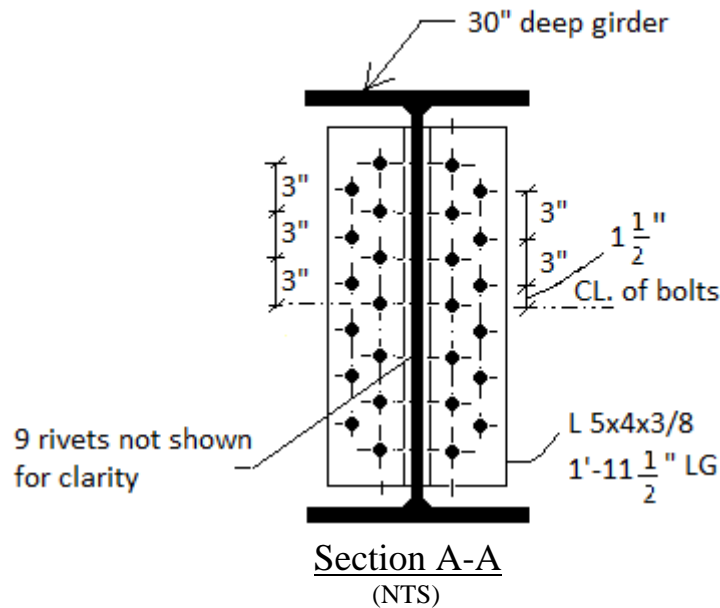
Figure 11 Existing Shear Splice Connection Detail

Post-incident observations from photographs revealed that the 30” girders located on grid lines C and B between column lines 1 to 2 failed at shear splice locations (Figures 11 to 14). The splice connection consisted of pairs of angles (5x4x5/16”x 1’-11½” long) riveted to the girder web and fastened back-to-back with 26-3/4” diameter square-head bolts (two rows of bolts at each angle, one row of 7 bolts and another row of six bolts), see figure below. Top and bottom flanges of the 30” girder were noncontiguous at the splice location.

Of greater interest to this investigation was the analysis of the girders on column lines B and C, between column lines 3 and 1. The girder on column line B was continuous from column 3 and extended approximately 8 feet beyond column 2, where it was connected to another girder that spanned up to column line 1. The girder on column line C had a similar arrangement. The existing structural drawings available did not contain the details of the splice connection between the two girders. However, the splices were preserved at the site and were examined, post-incident, to obtain relevant information. Two angles, 5x4x3/8 were riveted to the web of the girders with 9 rivets. The outstanding 5" legs were bolted back-to-back with 13 bolts, see Figure 10. There were no connections between the flanges of the two girders, rendering the connection devoid of any moment capability. Hence, it was a customary hinged connection.

Next, the capacity of the splice to resist flexure was evaluated. It was determined that although the splice was designed as a hinge, it could have had some capacity to resist flexural moment. It was determined that the splice could only resist approximately 50% of the imposed moment. Under the imposed load, the  $\frac{3}{4}$ " bolts were subjected to shear and tensile loads. The bolts on the column line C girder splice were subjected to stresses well beyond their ultimate capacity of 45 ksi, and hence contributed the failure.
