Investigation of the September 6, 2012 Partial Collapse of a Slab during Construction at Hyatt Place, Omaha, NE

U.S. Department of Labor
Occupational Safety and Health Administration
Directorate of Construction

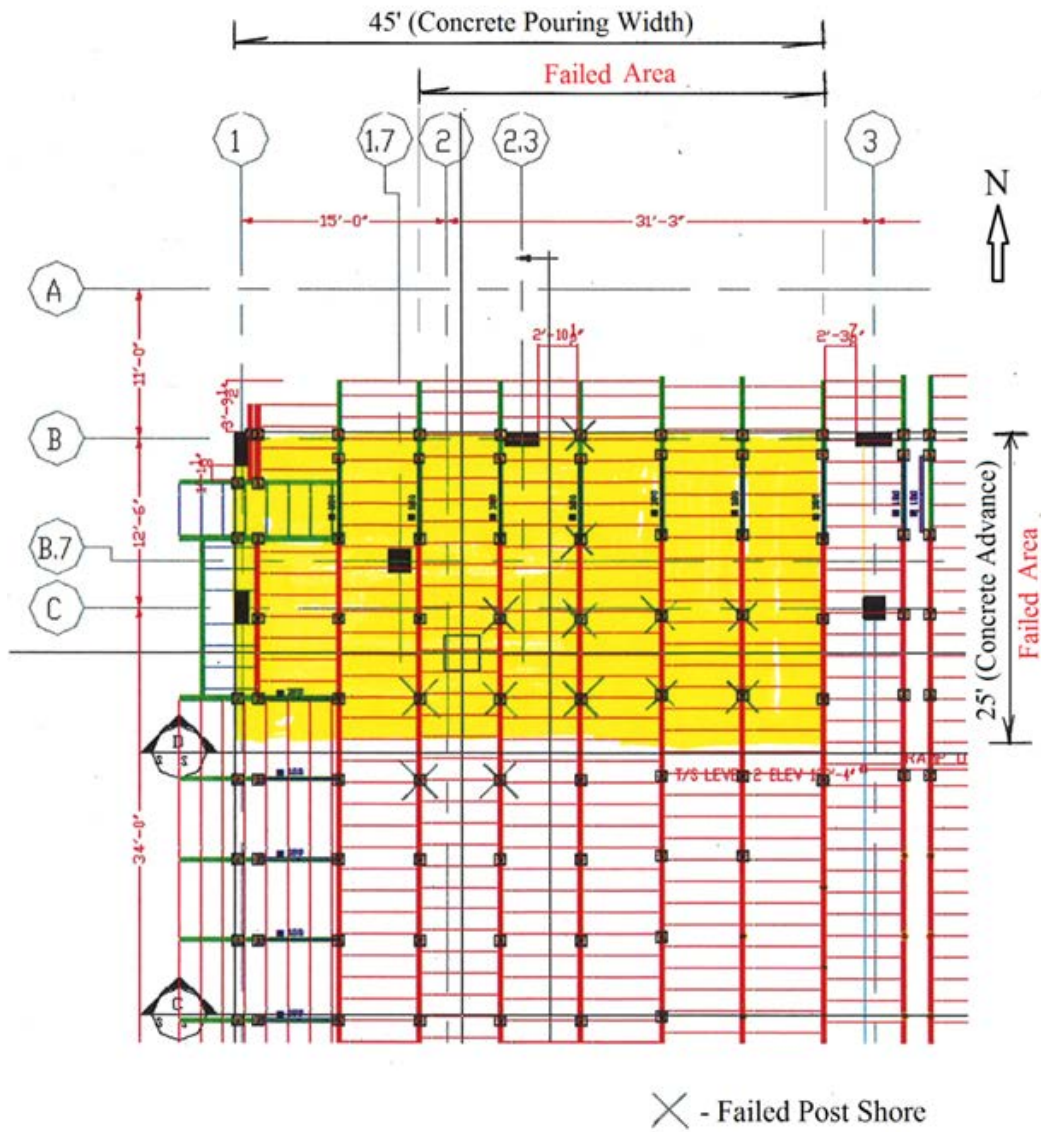
Figure 1. Plan view of the collapsed area (Modified from Ischebeck, 2012). Note that the yellow highlighted area was the limit of wet concrete placed at the time of the incident.

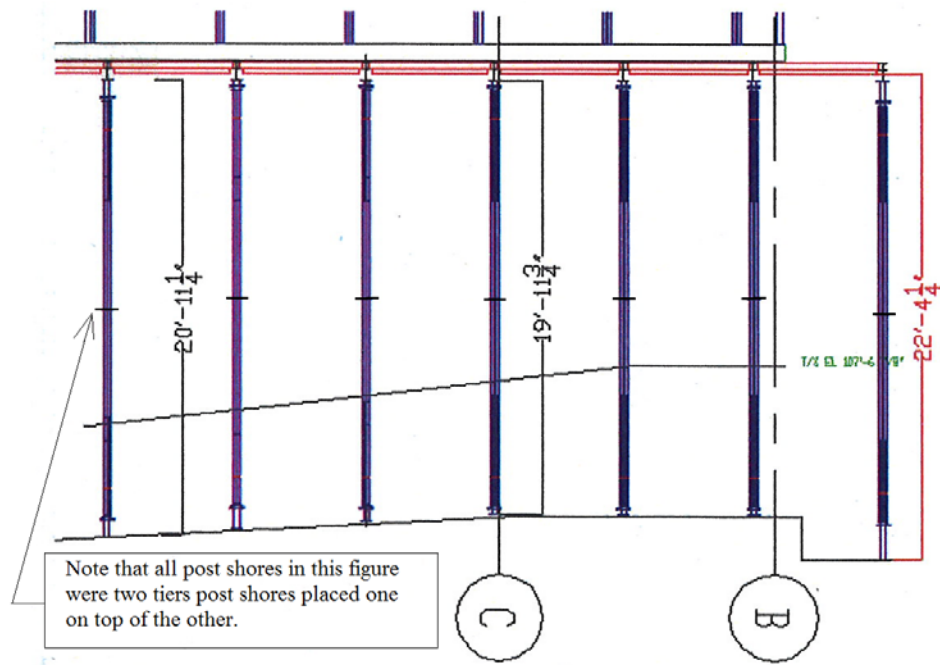
Figure 3. Elevation of the collapsed area as installed (Modified from Ischebeck, 2012).

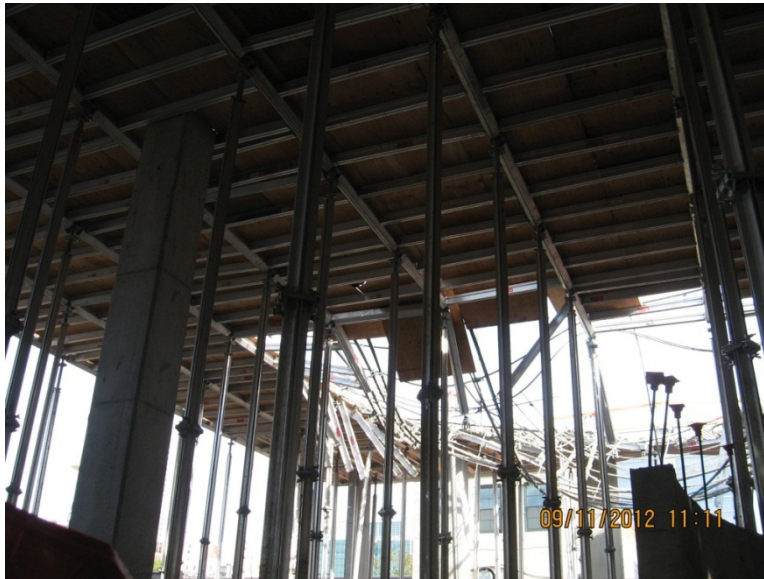
Figure 4. Collapsed shoring (Looking from the ground level toward the north).

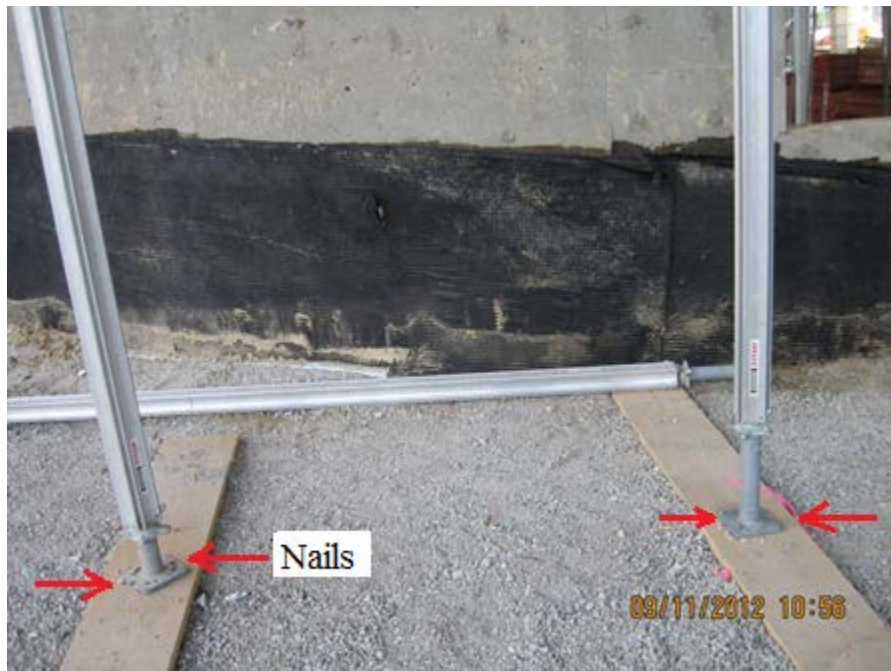
Figure 10. Base support condition of shores near the collapsed area.

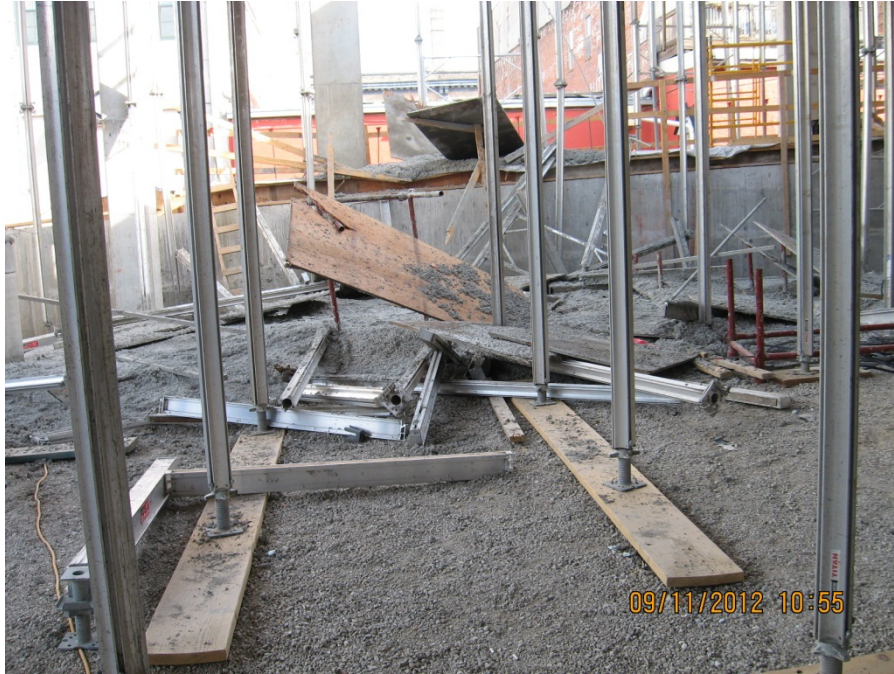
Figure 11. Another view of the base support of post shores.

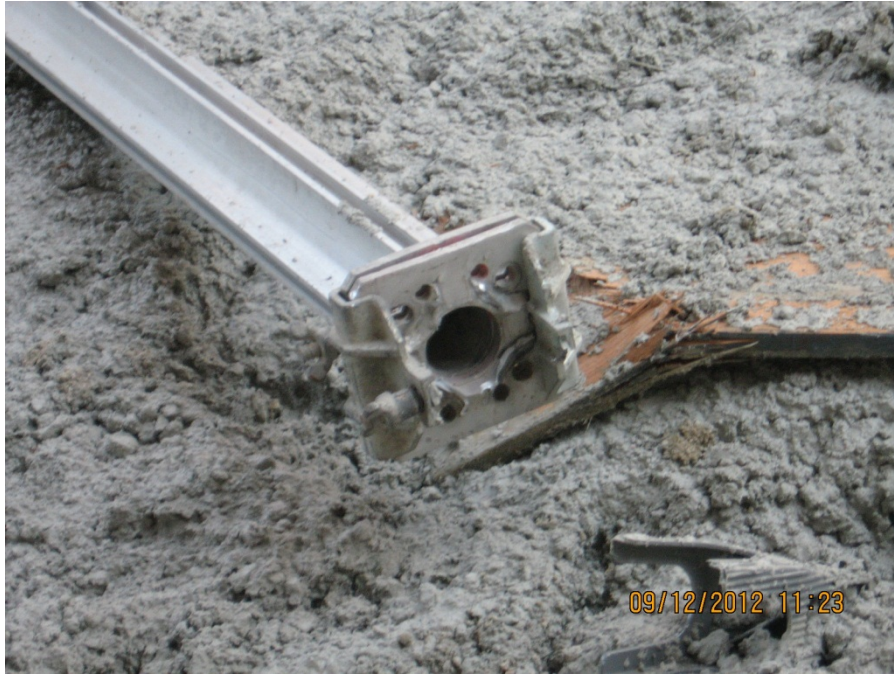
Figure 12. Condition of the splice plates after the failure of the post shore.
Note that the two splice plates were located at the mid-height of the post shore.

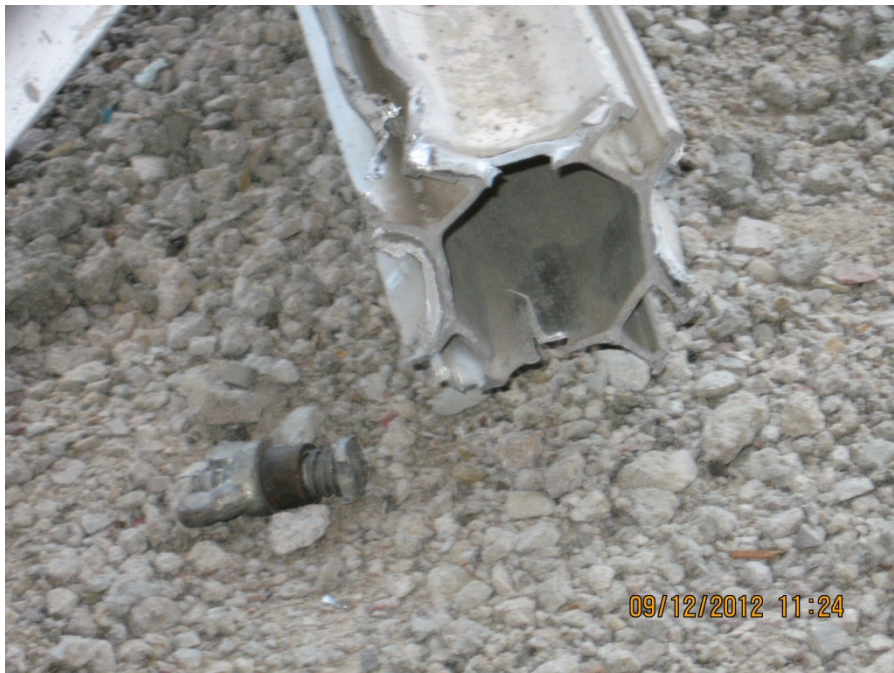
Figure 13. Failure condition of the welded connection at the end of a post shore.

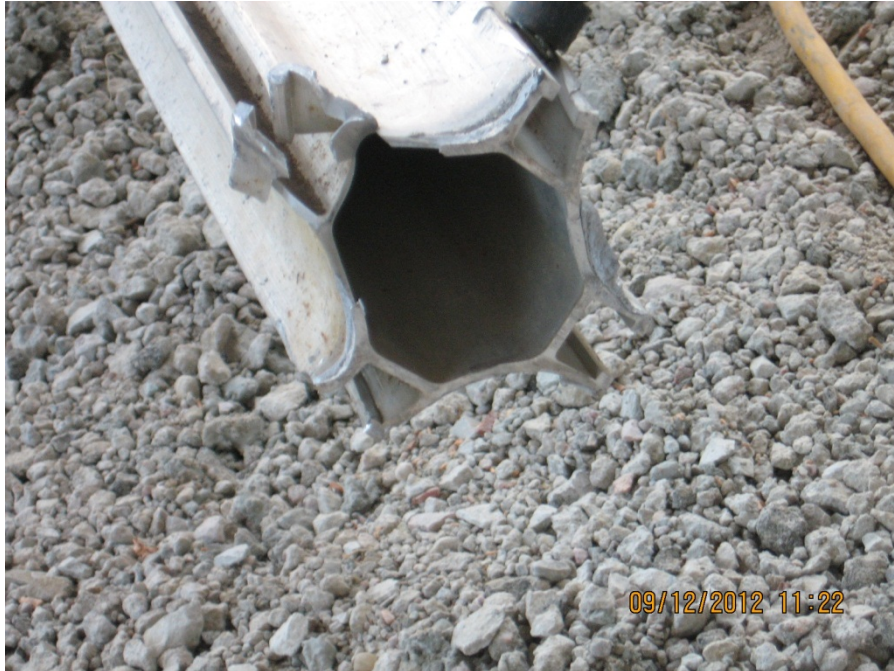
Figure 14. Another view of the failure condition of the welded connection at the end of a post shore.

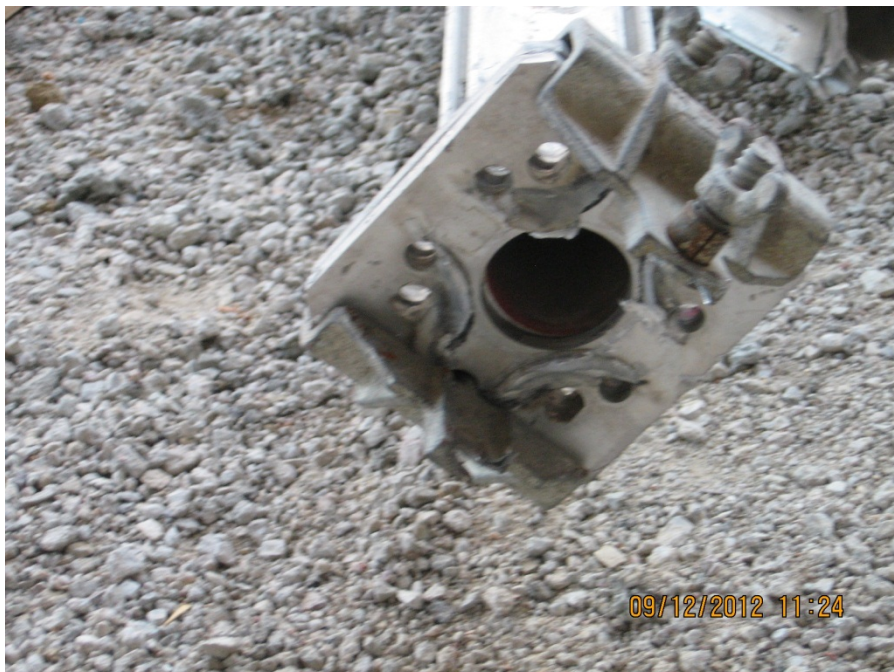
Figure 15. Failure condition of the welded connection at the splice plate.
Note that this splice plate was located at the mid-height of the post shore.

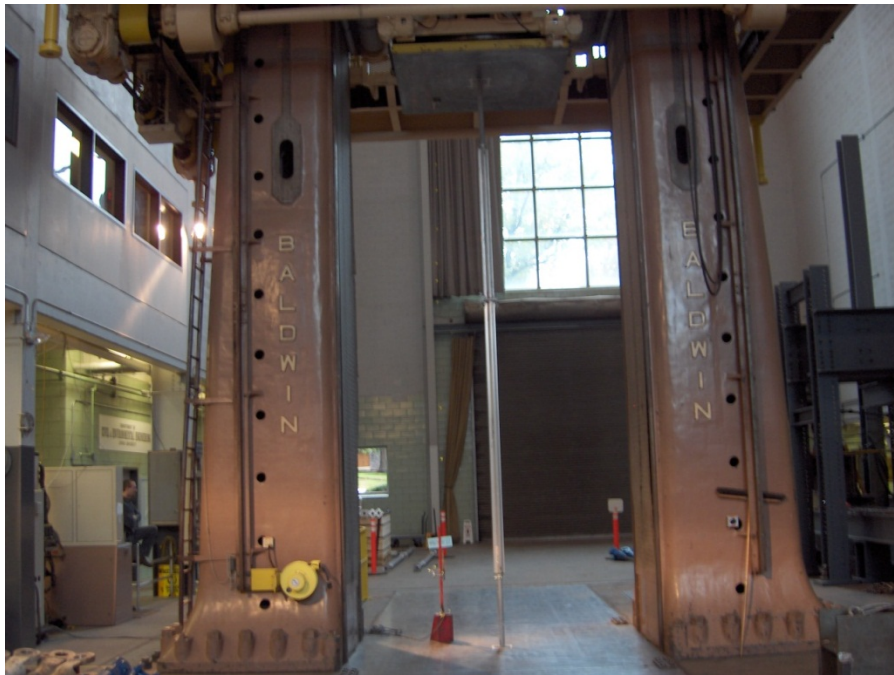
Figure 17. Load test setup of the two tiers post shores at Lehigh Testing Laboratory (Modified from Ischebeck, 2005).
