INVESTIGATION OF THE OCTOBER 10, 2012 PARKING GARAGE COLLAPSE DURING CONSTRUCTION AT MIAMI DADE COLLEGE, DORAL, FL

U.S. Department of Labor
Occupational Safety and Health Administration
Directorate of Construction

March 2013

This report was prepared by
Mohammad Ayub, P.E., S.E.
Directorate of Construction

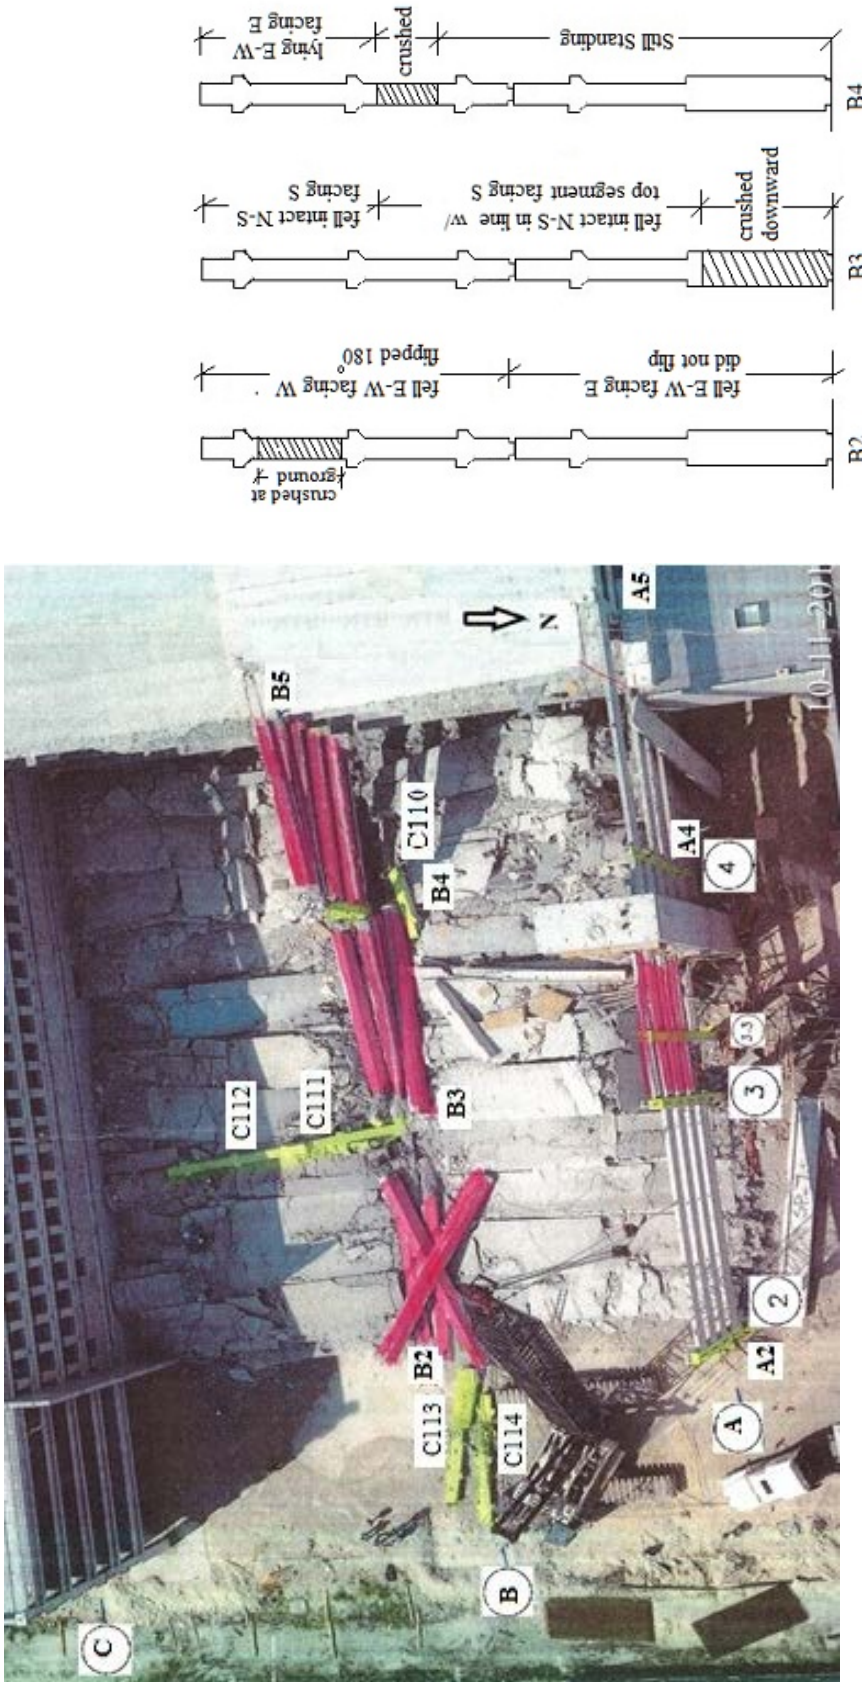
The collapse occurred at approximately 11:30 a.m. on Wednesday, October 10, 2012. At the time of the incident, the crane was loaded with a spandrel beam to be placed on the sixth floor between columns A2 and A3. The load was near, but not at, its final position when the incident occurred. The crane continued to hold the load even after the incident. The precast structural members erected on the same day and on days earlier suddenly collapsed to the ground from column grid line A to C in the north-south direction, and from column grid line 2 to 5 in the east west direction. The area impacted by the collapse measured approximately 132' in the east-west direction, and 122' in the north-south direction, see Fig. 10 thru 16 for aerial view of the collapse. All 111 double tees, from the sixth to the second floor between column grid lines A and C fell to the ground nearly directly below their original position, and pancaked over each other, see Fig. 19. One row of double tees immediately east of column grid line 5, between column grid lines A and C, did not fall but was badly displaced, skewed and leaning.

Fig. 10 – Aerial view of the collapse and details of columns B2, B3 and B4

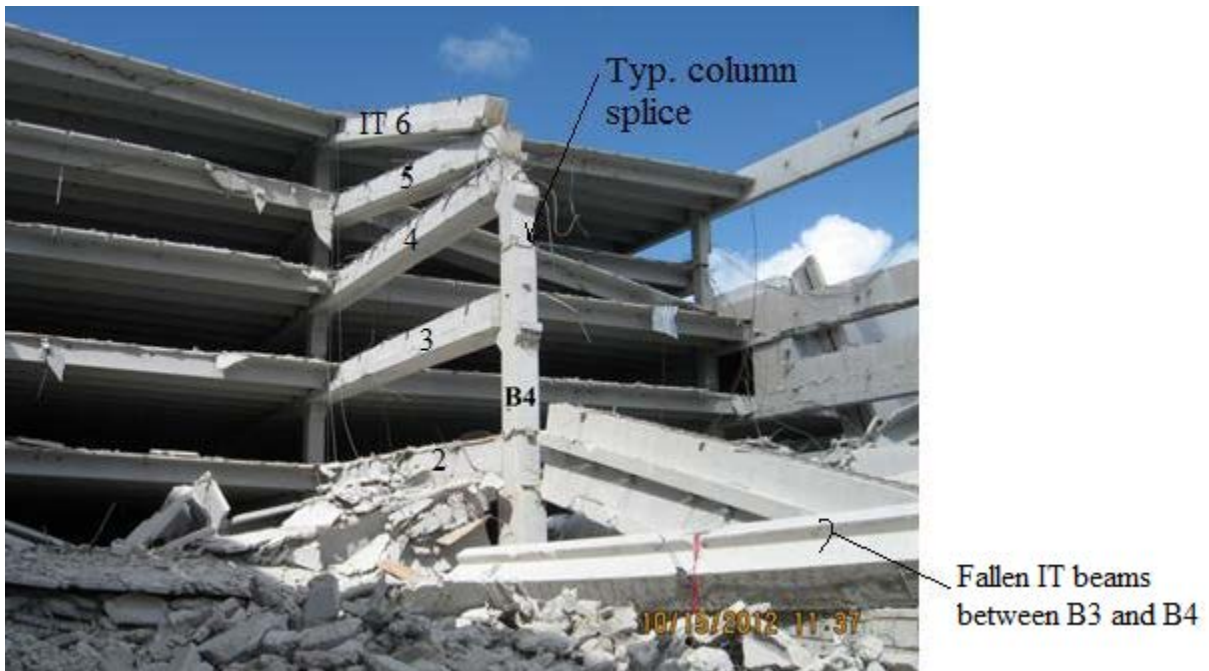
The collapsed double tees weighed approximately 3,000 tons. Two double tees north of grid line B and two double tees south of grid line B between columns B4 and B5 were also displaced. Ten IT beams between columns B2 to B4 from all floors, six to second, fell to the ground slightly skewed from their original position. The ten IT beams weighed approximately 250 tons. The sixth and fifth floor IT beams between columns B5 and B4 did not fall to the ground but sloped and leaned, and rested on the east end of the fourth floor IT beam. See Fig. 17.

Fig. 17 – Column B4 after the collapse

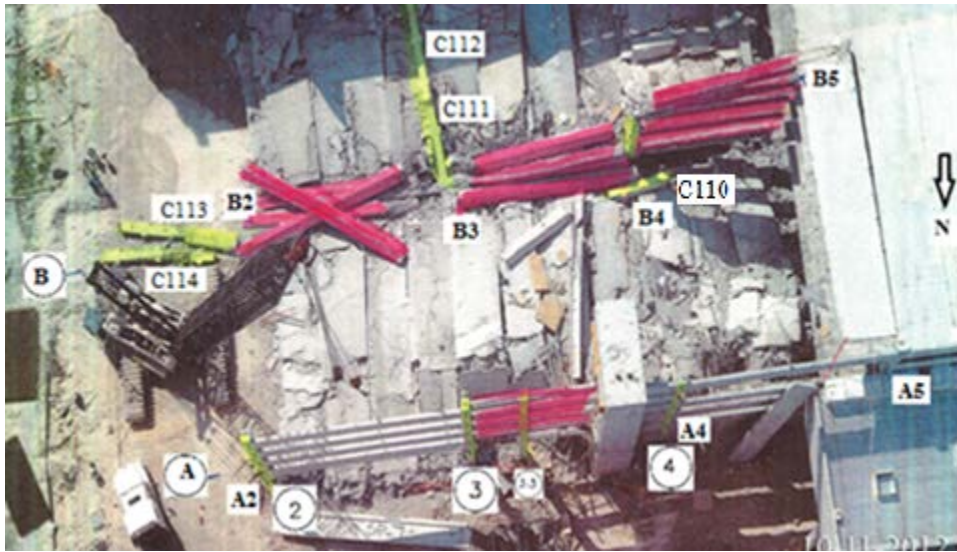
The upper and lower segments of columns B2 and B3 fell to the ground near their bases but skewed in different directions, see Fig. 18. The upper segment of column B4 above the fourth level fell to the ground, but the lower segment of column B4 and the remaining upper segment remained standing almost plumb, still attached to its footing. The splice between the upper and lower segments of column B4 remained intact. The weight of the B2 and B3 columns were approximately 45 tons. Thus, the total weight of concrete members collapsed into grids A to C and 2 to 4 was approximately 3,300 tons. The columns on the A grid lines remained standing but out of plumb, see Fig. 19.

Fig. 18 – Orientation of columns B2 and B3 after collapse

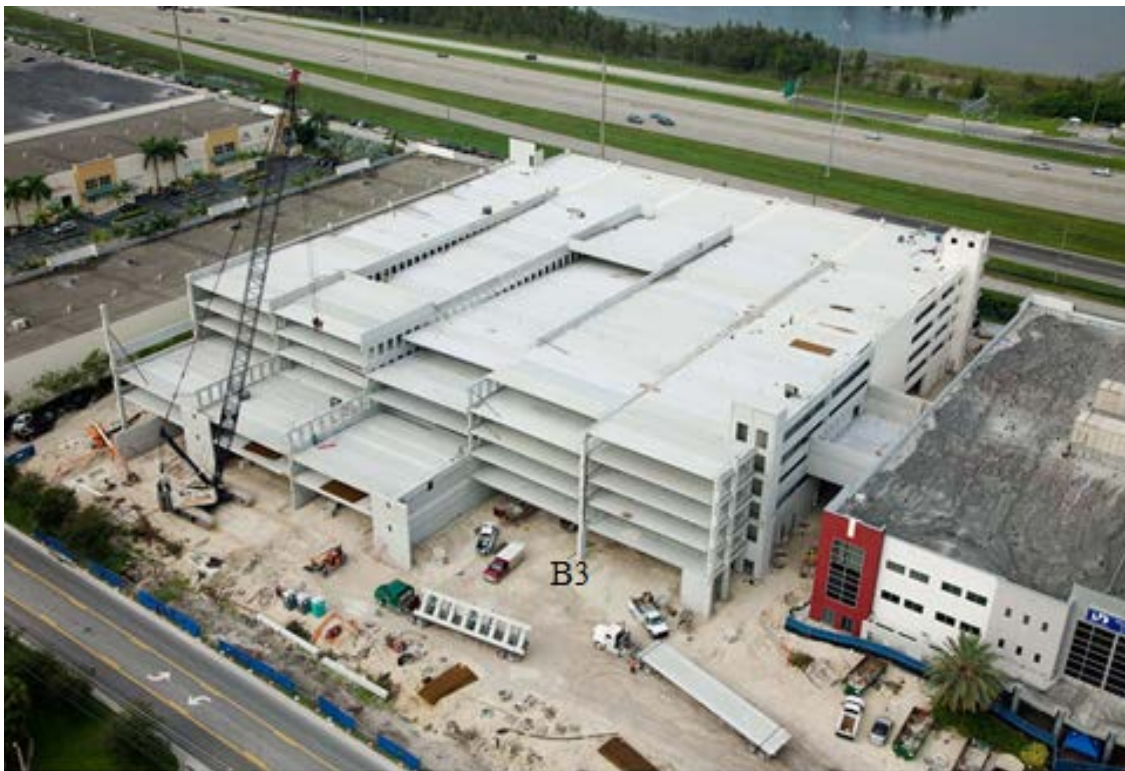
Fig. 20 – Pre-incident aerial photo (Progress as of 09/25/12)

Note B3 column was erected on 9/14/12, 26 days before the incident

The column was erected on September 14, 2012 or earlier. On September 25, 2012 or earlier, the column was loaded with all the structural elements on the west side, with no load coming from the east, see Fig. 20. It is estimated that the total dead load at that time was approximately 730 kips based upon the actual weights of the individual pieces, not considering any load factor. As can be seen from the above table, the range of capacity of the column bearing was 839 to 1,050 kips, and thus failure did not occur.

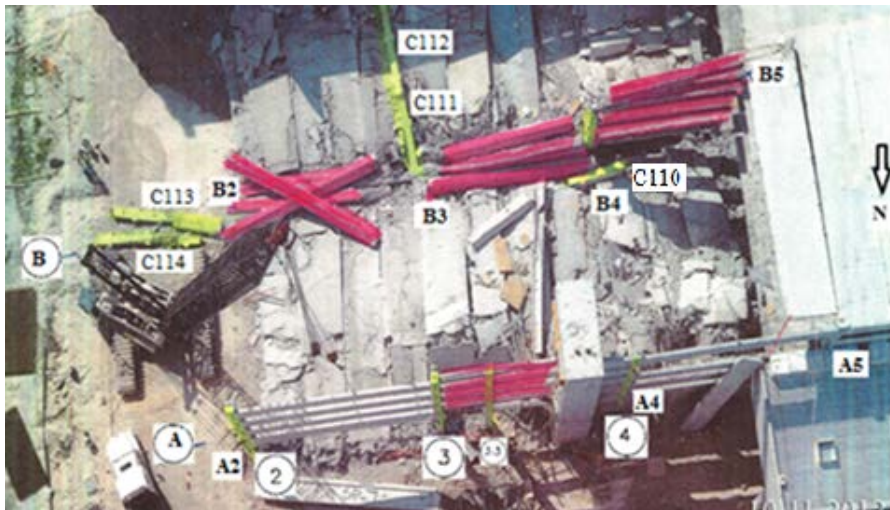
The upper segment of column B2 flipped 180 degrees and fell to the ground in the east-west direction with the tip facing towards the base, approximately 15 ft. away, see Fig. 29. The upper and lower segments of column B2 separated at the splice below the fourth floor. The three corbels remained relatively intact. However, the column between corbel 6 and corbel 5 was shattered, exposing the longitudinal re-bars. This is believed to have occurred after the column hit the ground as broken pieces of concrete were visible near the shattered portion of the column. The upper segment was 24"x24".

Fig. 29 – Column B2 lying in the east-west direction

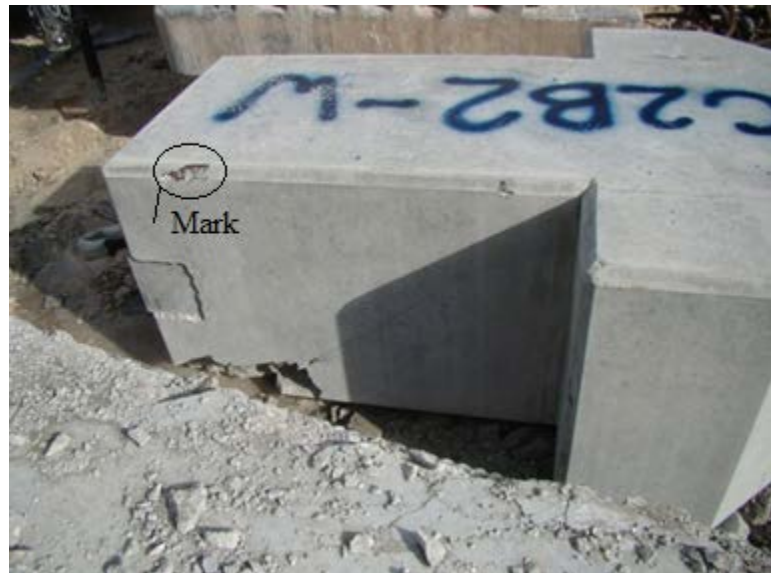
Fig. 31 – Column B2 marks after crane hit

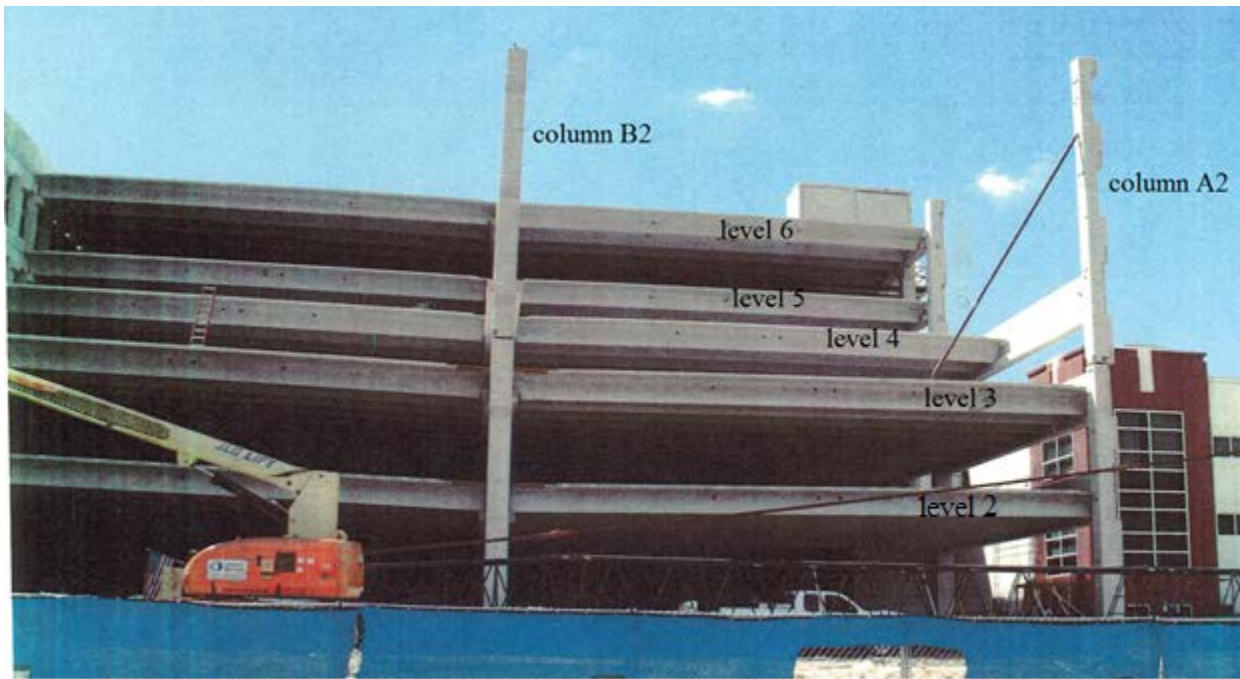
Fig. 32 – Column B2 out of plumb - after hit by crane

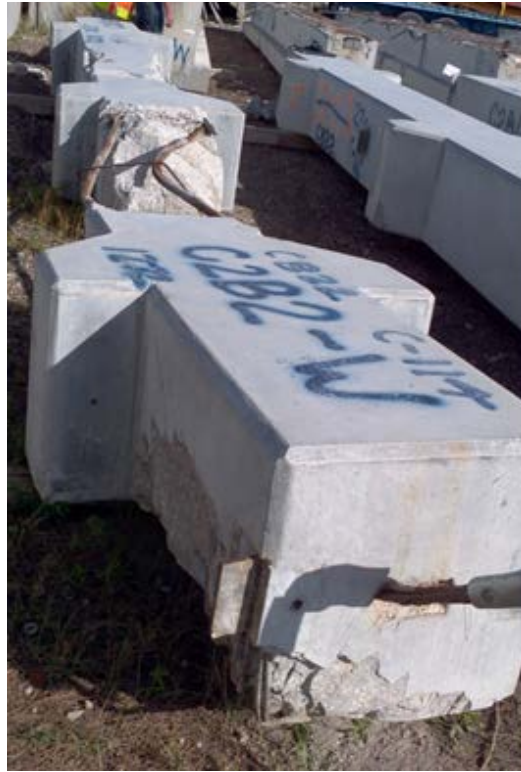
Field observation indicated that the splice was grouted under the splice base plate. The three east corbels were free of any damage as there were no loads placed over them before the collapse. The three west corbels showed signs of distress when the IT beams fell off the corbel. The mid-section of the column between the sixth floor and the fifth floor corbel was shattered, believed to have happened during the collapse, see Fig. 33.

Fig. 33 – Column B2 shattered between level 6 and 5

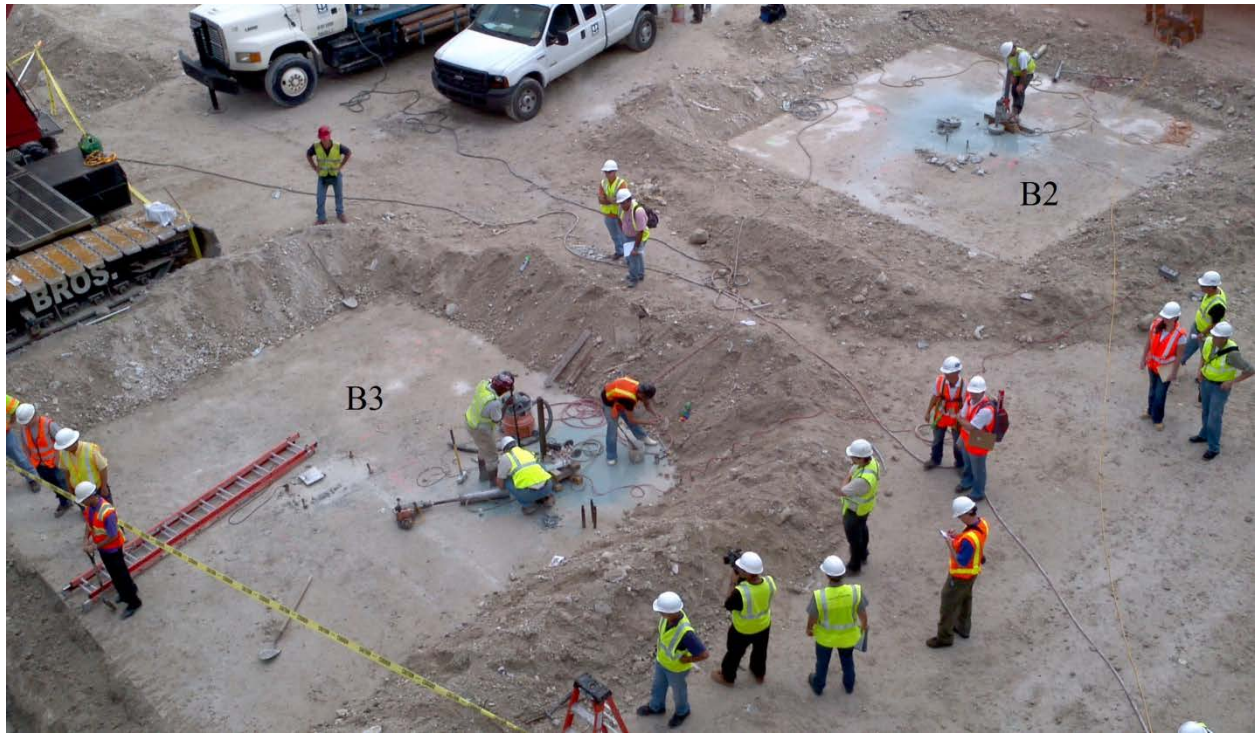
The lower segment of the B2 column fell approximately in the east-west direction nearly parallel to the upper segment of column B2 except it did not flip 180 degrees. The bottom of the lower segment of the B2 column pointed towards the base. The two corbels remained relatively intact. The wider portion of the column remained mostly intact but the column above the second floor was badly damaged during the collapse, see Fig. 39. After the clean-up, see Fig. 34, it was discovered that there was 4" thick grout under the base plate of the column, although it did not cover 100% of the required area. Of the four anchor bolts projecting from the footing, the northeast and southeast anchor bolts were bent towards the east, while the other two anchor bolts remained nearly vertical, see Fig. 35. It was further noted that there were two stacks of steel shims, each containing six shims 6"x6".

Fig. 34 – Foundation of column B2 and B3 after clean-up

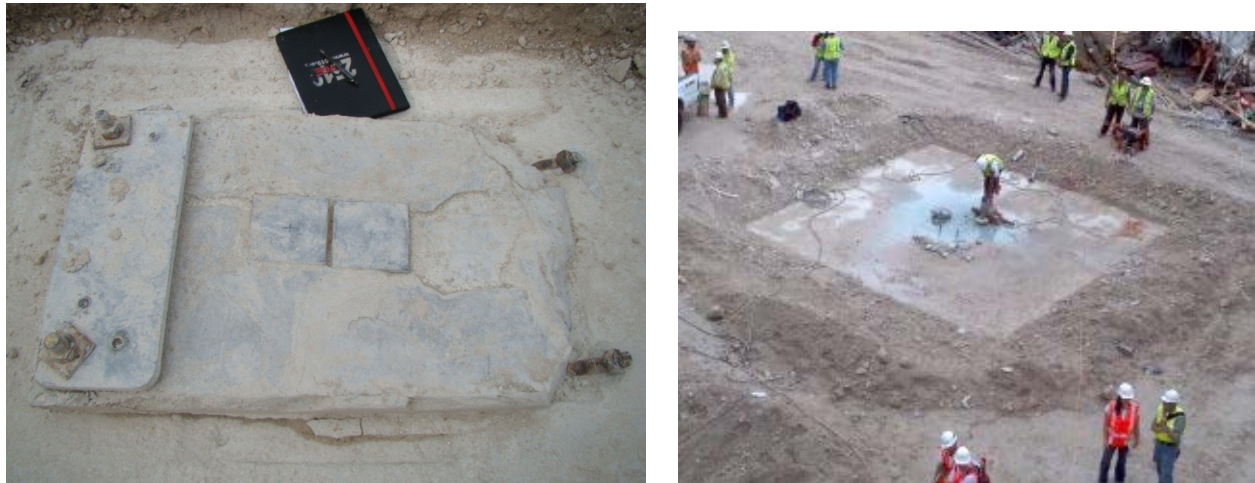
Fig. 35 – Base of column B2 after clean-up

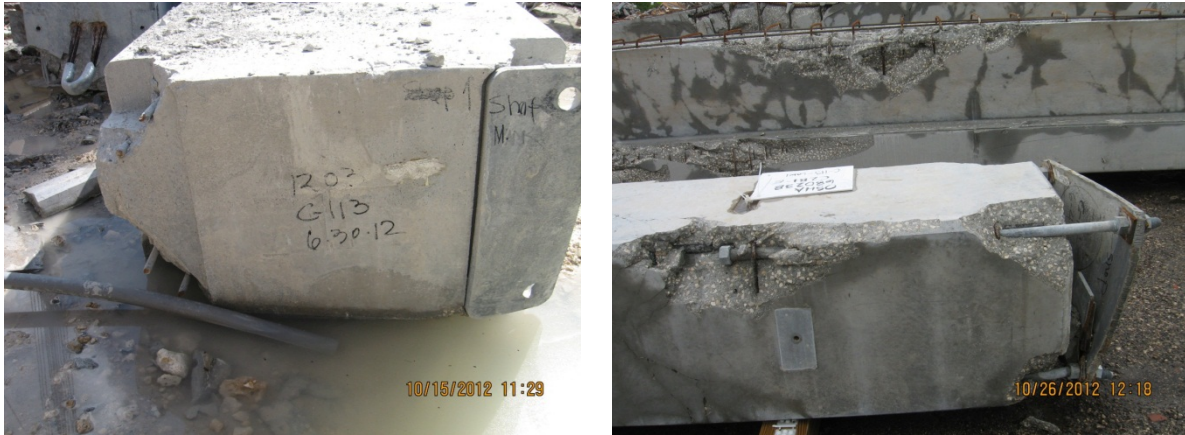
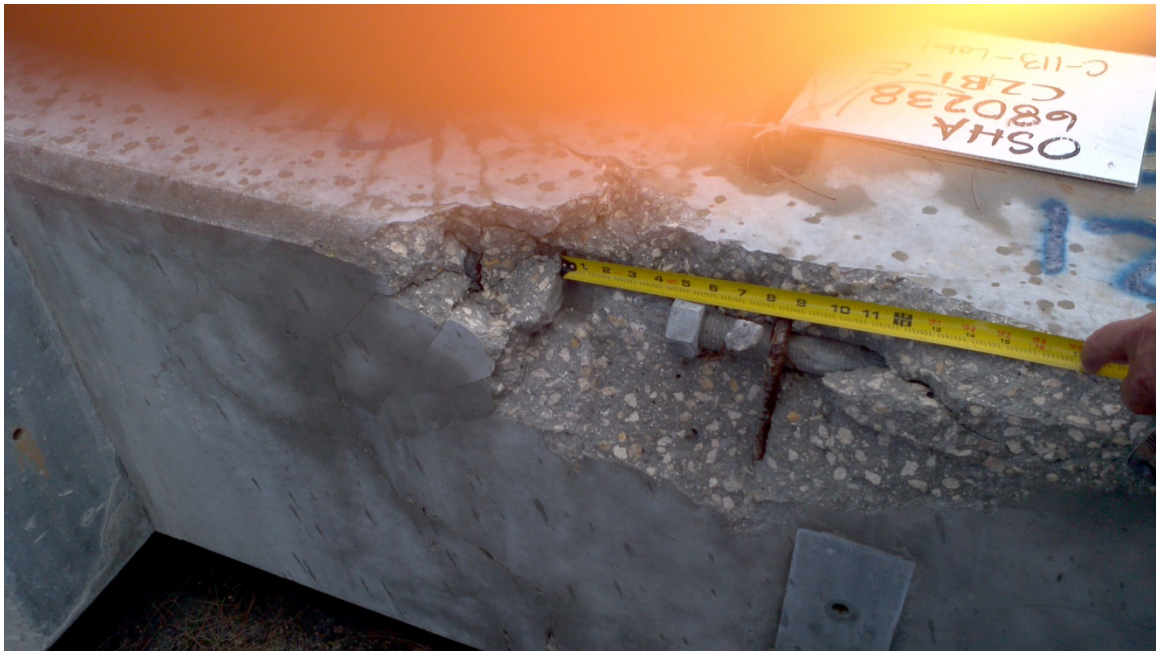
the column, see Fig. 38. The southeast anchor bolt slipped 4½" out of the column without substantially damaging the column, indicating complete bond failure between the anchor bolt and the concrete. There was a localized failure at the bottom of the anchor bolt where a nut was placed, see Fig. 36 and 37.

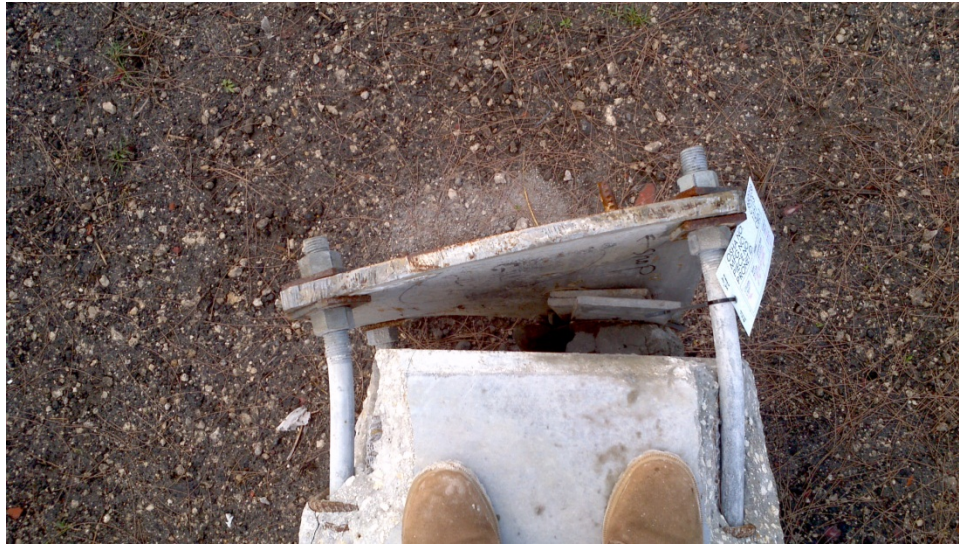
The lower segment of column B2 was relatively intact except for the four anchor bolts at the top of the lower segment which was connected to the base plate embedded in the upper segment of

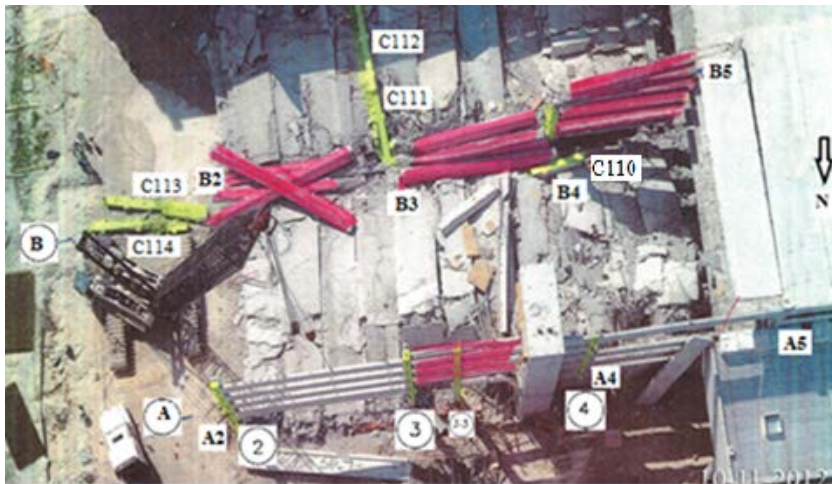
Fig. 40 – Column B3 lying north-south direction

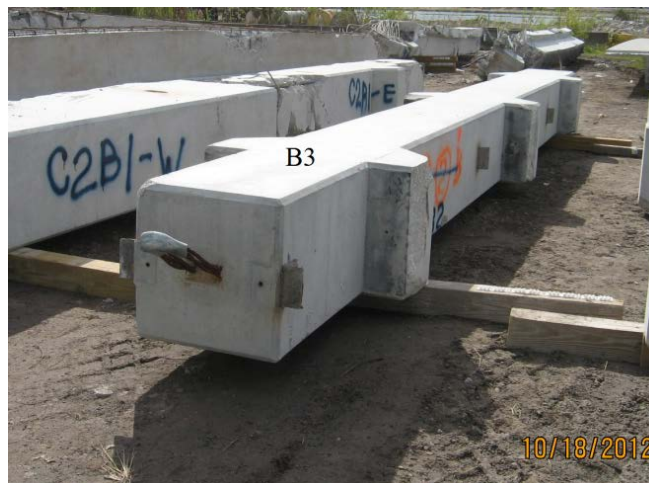
The upper segment of the B3 column remained intact, see Fig. 41 when it fell with little damage to the corbels or to the main body of the column. The column fell towards the south, see Fig. 40. As in the case of B2 column, the splice base plate embedded in the upper segment seceded and slid away with the lower segment of the B3 column after the collapse. The rebars welded to the splice base plate were sheared. There were clear indications that the sixth, fifth and fourth floor IT beams were welded to the column steel plates in both east and west directions. The column was 24"x24".

Fig. 41 – Column B3 upper segment in the yard

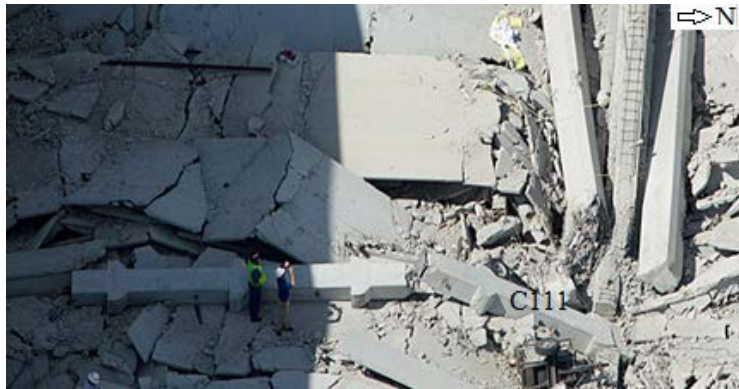
The lower segment of the B3 column, which also fell towards the south, see Fig. 42, aligned with the upper segment, was unremarkable except for the fact that beginning four feet below the second floor IT beam bearing, the column was completely shattered and disintegrated into small pieces. All 8 longitudinal rebars were bent in a cage-like manner and completely exposed, see Fig. 43 and 44.

Fig. 42 – Column B3 lower segment fell towards south

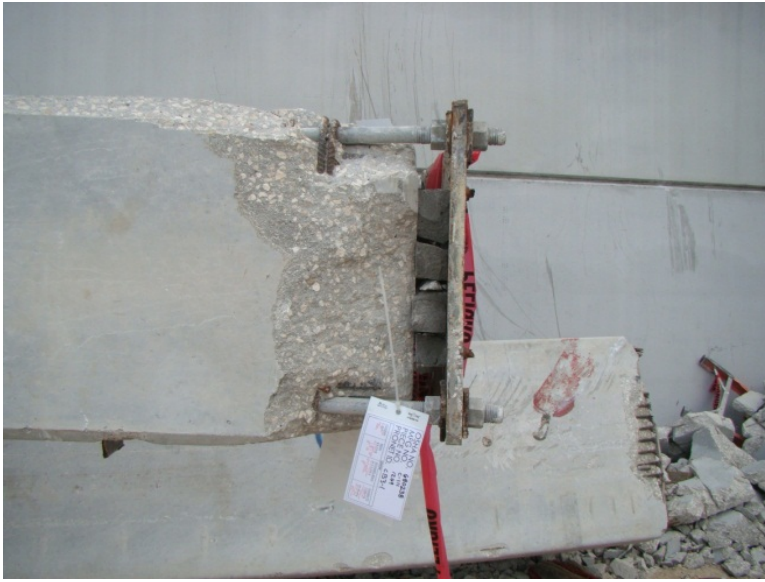
There were indications that the IT beams were welded to the column's steel plates at the second and third floors in the east and west directions. The four anchor bolts at the splice plates were intact but the splice base plate was bent. There were indications that there was grout at the splice between the upper and lower segments.

Note:
Splice plate remained
with lower segment C111

Fig. 45 – Column B3 lower segment splice

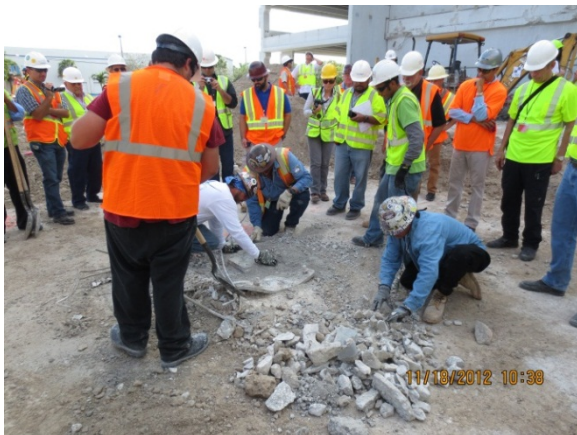
After the cleanup, see Fig. 46, it was discovered that grout was not placed at the footing underneath the column, but there was one stack of six shims 10"x10" placed under the column near its center, see Fig. 47. The shims left a faint mark over the footing without any deformation in the footing concrete. The four anchor bolts were bent like S curves, and were leaning towards each other in the north-south direction, see Fig. 48 thru 51. The two 9"x24" base plates were bent, see Fig. 47. The footing remained leveled within an inch at the four corners.

Fig. 46 – Base of B3 cleanup

value of bearing capacity by a third, and thus the failure occurred. If grout had been placed at the base of column B3, this failure would not have occurred.

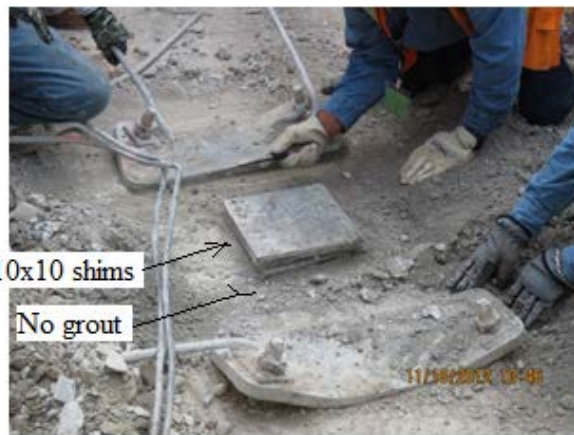
Fig. 47 – B3 column base plate and shims

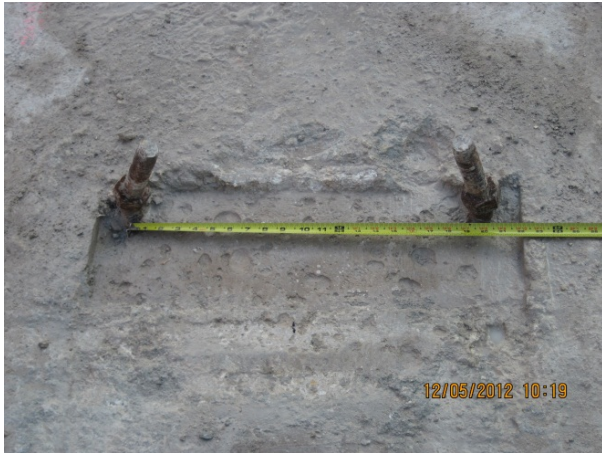
Fig. 48 – Bent anchor bolts

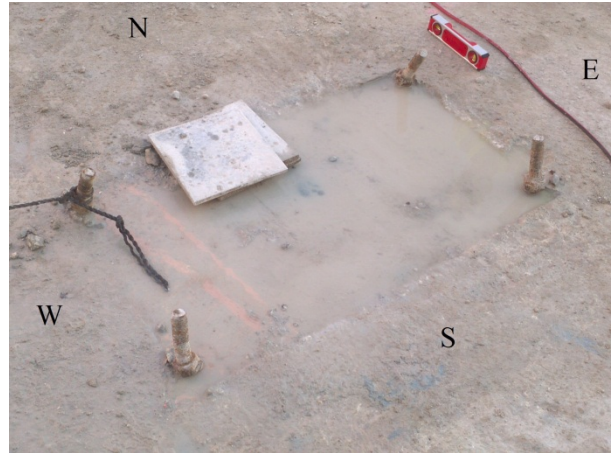
Fig. 49 – Anchor bolts bent towards N-S

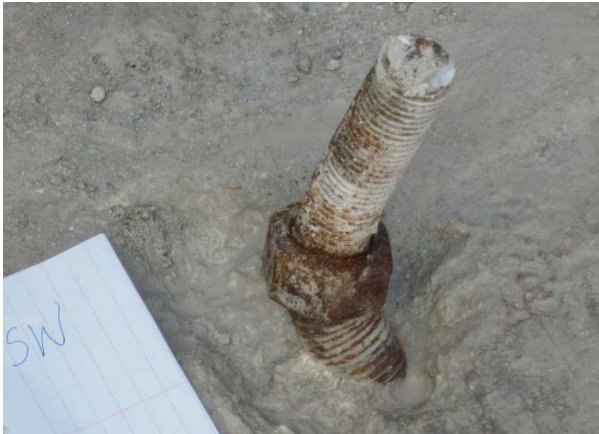
Fig. 50 – Deformed SW anchor bolt

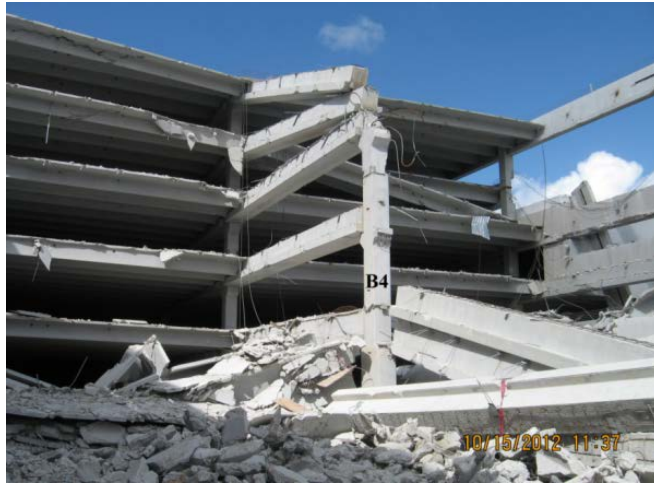
Fig. 52 – Column B4 remained standing after collapse

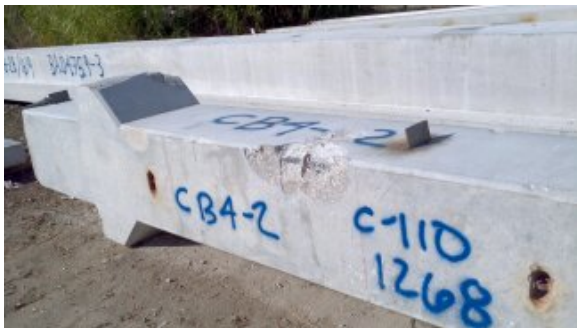
The upper segment of column B4 disintegrated between the fifth level and fourth level corbels. The fourth floor splice remained intact. The remaining portion of the column fell to the ground towards the east-west direction, see Fig. 40. When the column partially disintegrated above the fourth floor and below the fifth floor corbels, see Fig. 53 thru 55, the IT beams between columns B-4 and B-5 supported over the sixth and fifth floor corbels fell over the fourth floor IT beam, and remained there after the collapse, see Fig. 52. The remaining portion of the upper segment remained connected to the lower segment through the splice. The column was 24"x24" reinforced with four #11 bars.

Fig. 54 – Column B4 upper segment

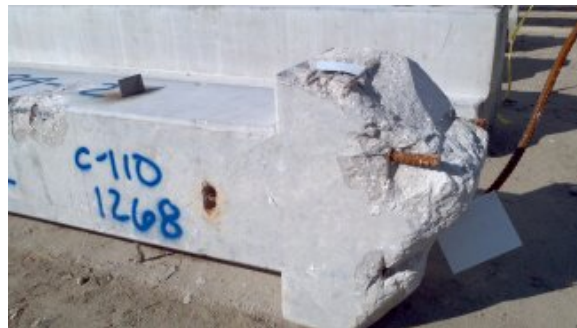
Note: Section missing below the fifth floor corbel

Fig. 55 – Column B4 upper segment

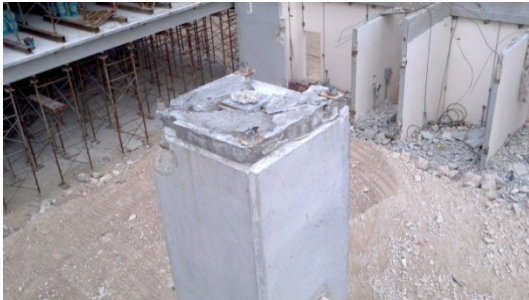
The column was nearly plumb within an inch. The splice between the segments was grouted for $\frac{3}{4}$ of the area but $\frac{1}{4}$ of the area did not appear to have been grouted, see Fig. 56 and 57. Also, smaller shim plates were used at the splice. The four anchor bolts at the splice remained intact, and had to be burnt during the removal phase. The third floor corbel was unremarkable. The column became wider below the second floor to 42" (E-W) x 24" (N-S). The lower segment was undamaged.

Fig. 56 – Grout at splice of B4 column

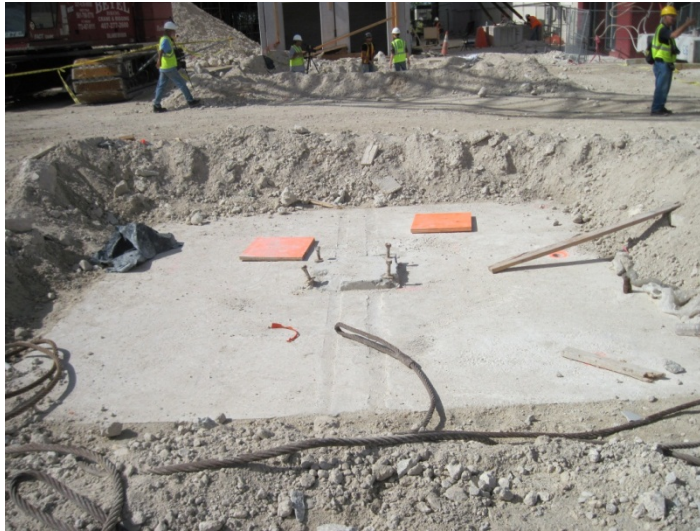
The A2 column remained standing, but was out of plumb. The second floor spandrel beam became disconnected and fell to the ground nearly parallel to the east-west direction. Apart from being out of plumb, there was no remarkable damage to the column. After the cleanup, it was discovered that the base of the column was fully grouted at the footing level. Also two sets of shim plates were used. The two north anchor bolts were intact and not bent. However, the southeast and southwest anchor bolts were bent and leaning towards the south. The anchor bolts were most likely bent during the removal phase.

Note the grout at the base

Fig. 60 – Footing for column A2

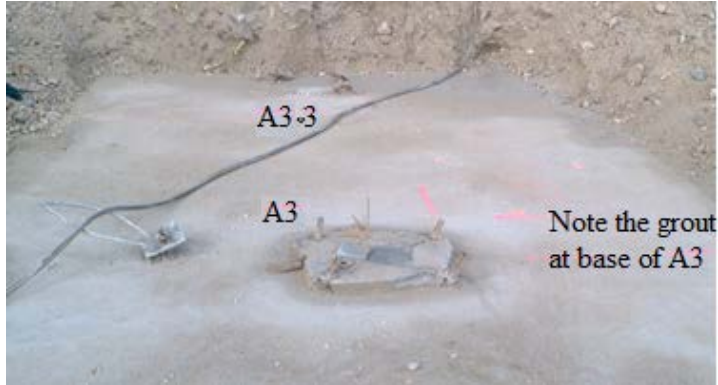
the south, almost 30 degrees to the horizontal. It is believed that the anchor bolts were bent during the demolition/removal process.

Fig. 61 – Columns A3 and A3.3

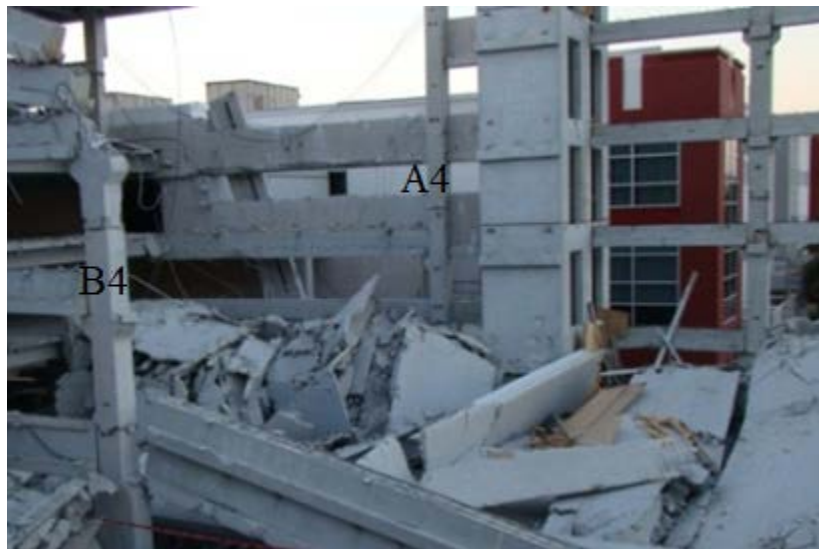
Column A4 remained standing after the collapse but was out of plumb, 11½" towards the north, and 5½" towards the west. Besides, A4 column was cracked near the splice in the upper segment. The fifth floor spandrel beam fell during the incident and ended up standing upright leaning against the other spandrel beams, see Fig. 63.

Fig. 63 – Column A4

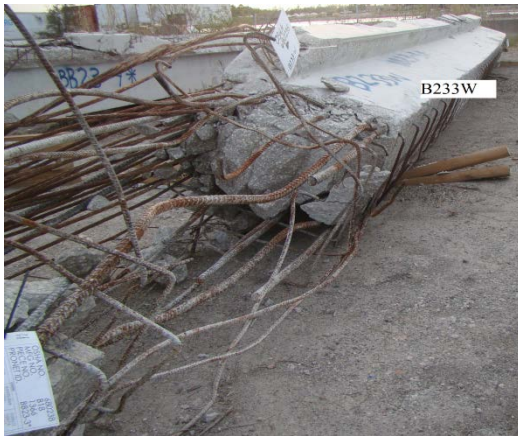
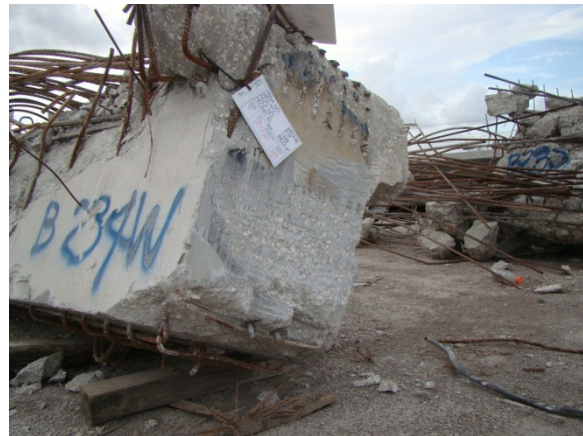
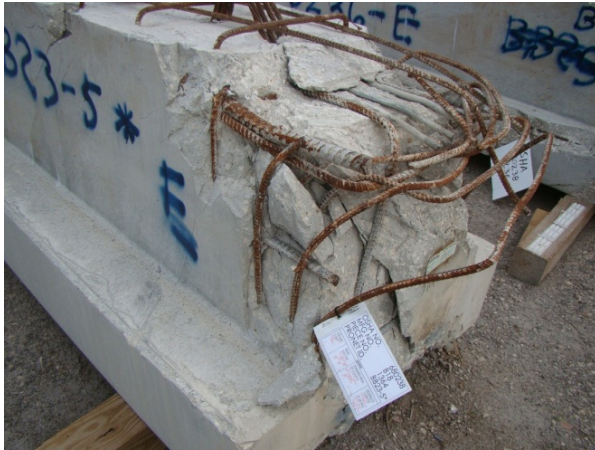
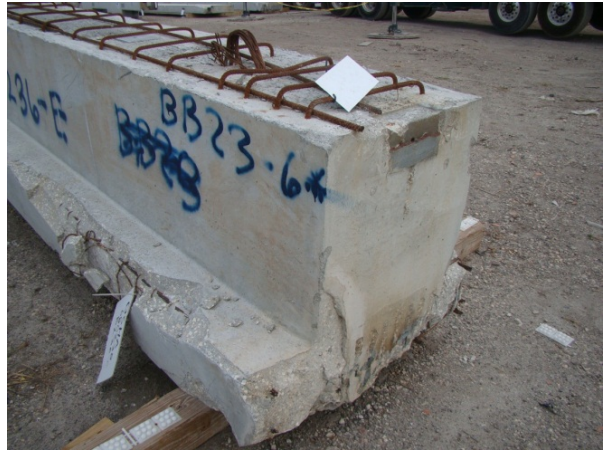
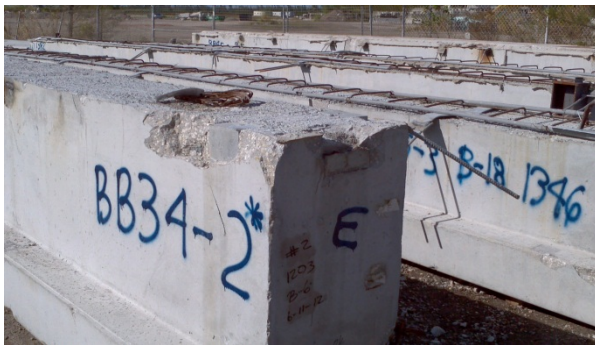
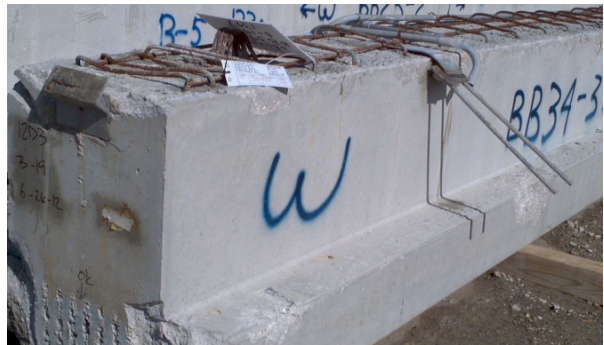
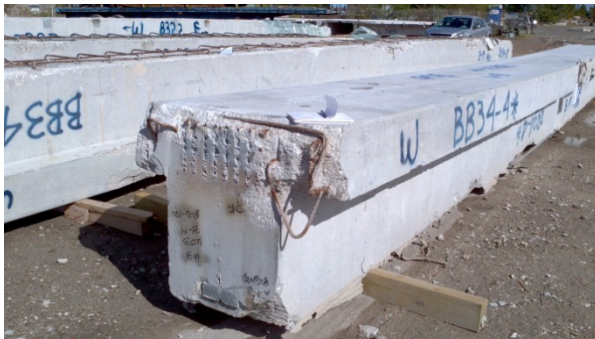
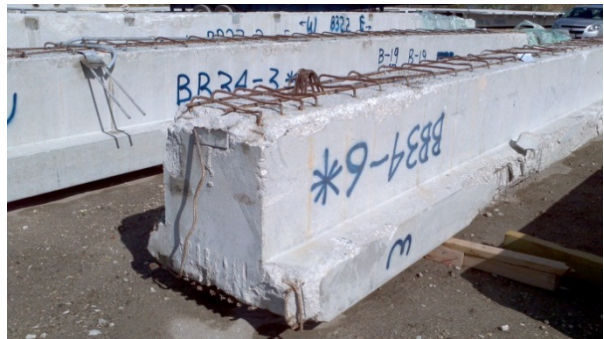
Generally speaking, close examination of the IT beams, see Fig. 64 thru 71, indicated that the IT beams were welded at both ends to the columns, at least partially, approximately three inches as a minimum at all locations. With regard to the welds of the double tees to the IT beams, the field observations indicated that there were certain beams to which the double tees were not welded. Most notable were the fifth and fourth floor IT beams between columns B2 and B3. The contract documents required that welding of connections shall follow closely behind the erection of the units, see appendix A-14. At places, they were welded at two locations out of four, e.g., IT beam on the third floor between columns B2 and B3; and IT beam on the second level between columns B3 and B4. The IT beam on the third floor between columns B3 and B4 was welded on one side only. The IT beam on the second floor between columns B2 and B3 was welded at fewer locations. Similarly, the IT beam on the sixth floor between columns B3 and B4 was welded on one side only.

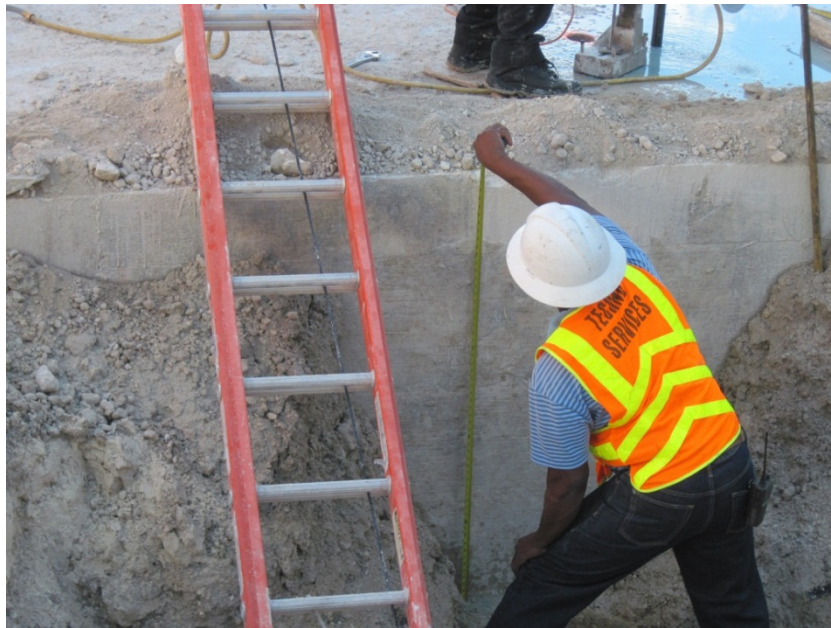
The foundation of the columns consisted of cast-in-place individual footings except for the A3 and A3.3 columns which had a combined footing. The footings were generally 23'-6" x 23'-6" x 5'-0" deep, see Fig. 72. All footings were determined to be within tolerance levels regarding their size and levelness. The footings generally were cast with 3,000 psi concrete. No undue settlements were detected.

Fig. 72 – Exposed foundation for column B3
