# **INVESTIGATION OF THE MARCH 25, 2014 FAILURE OF GIN POLE RIGGING, AND COLLAPSE OF CELLULAR TOWERS AT BLAINE, KS.**

U.S. Department of Labor  
Occupational Safety and Health Administration  
Directorate of Construction

August 2014

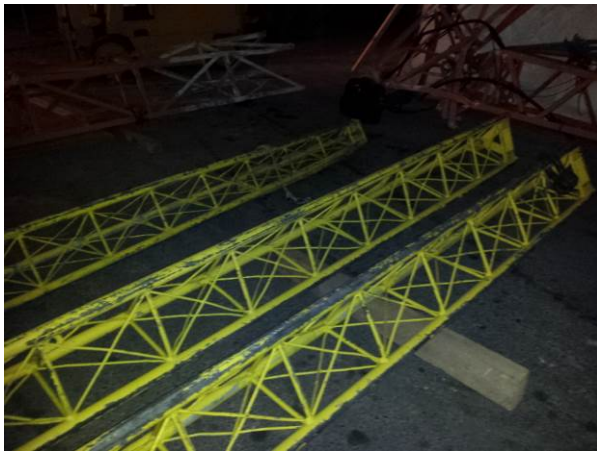
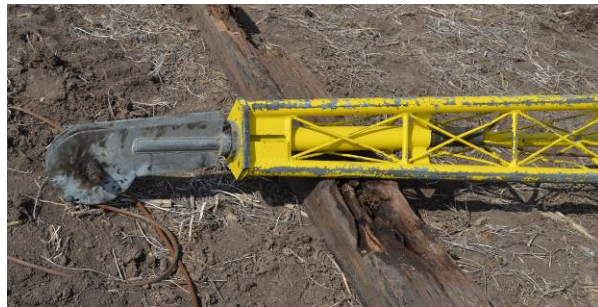
Figure 33 – Gin Pole

Figure 34 – Gin Pole with Rooster Head

The gin pole and rooster head were inspected for identification marks. During an inspection in the storage facility, no identification marks on the gin pole or on the rooster head were observed.

A 12" triangular gin pole and a rooster head shipped to the site did not contain any identification marks on them. This amounted to non-compliance with the industry standard, ANSI/TIA-1019-A-2012.

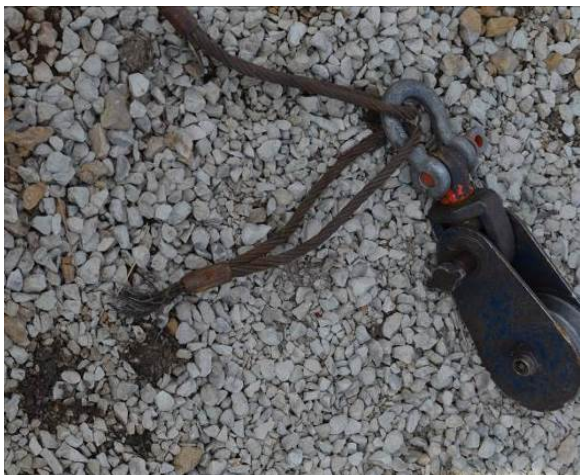
Figure 35 – Broken sling with top block

The top block was subjected to a load of 2 tons. The McKissick top block had a working load rating stamp of 4 tons. The ultimate load capacity from the catalog for the block was 16 tons. The block, therefore, had adequate capacity. The sling was subjected to a tensile load of one ton and it had a breaking capacity of 6.56 tons. The sling was, therefore, properly sized.

Thus the load was not the cause of the failure of the sling wire rope.

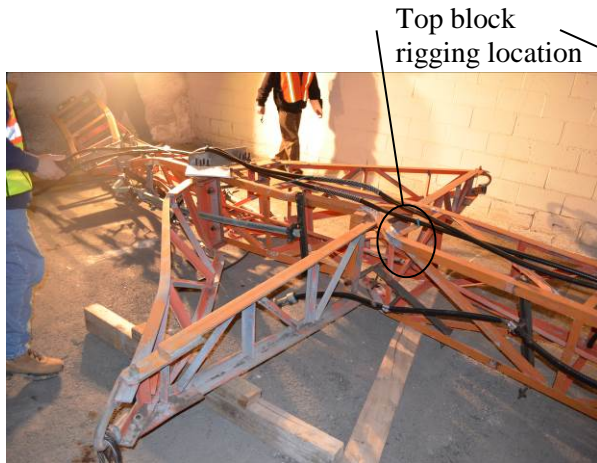
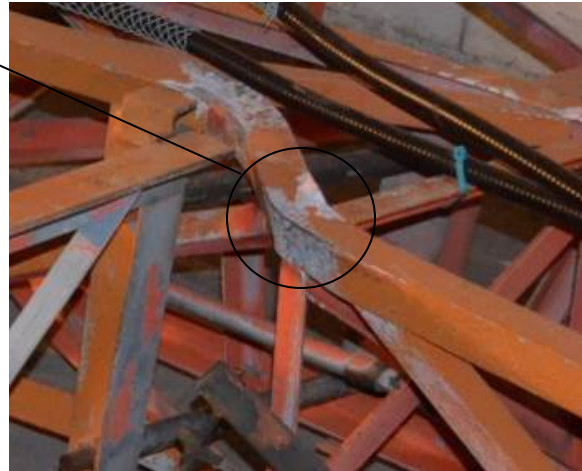
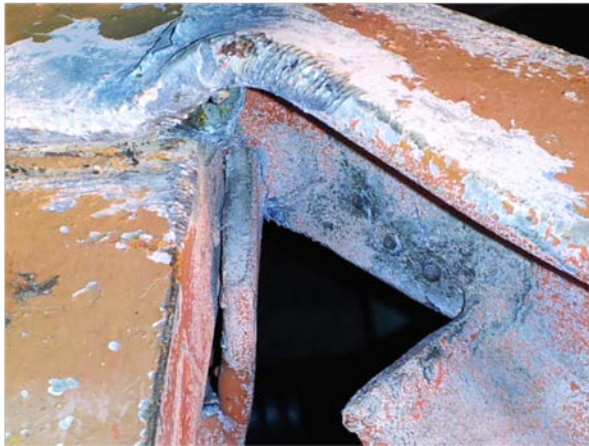
The top portion of the tower was closely examined to identify the rigging location of the sling. There were clear marks of sharp cuts on the steel angles of the tower leg below the torque arm consistent with marks that would be made by wire rope abrasion, see figures 37 to 40.

Figure 37 - Top block rigging location

Figure 38 - Top block rigging location

Figure 39 - Top block rigging location

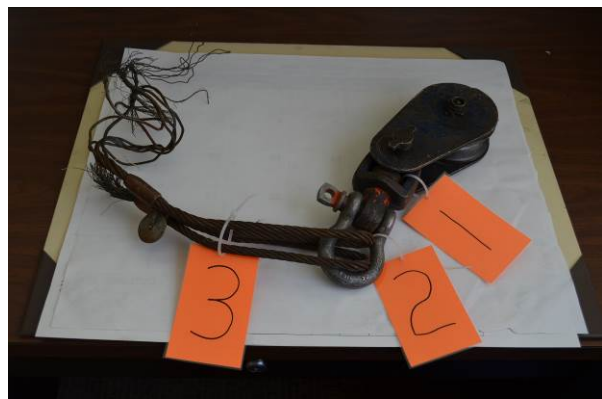
Figure 40 - Top block and broken sling

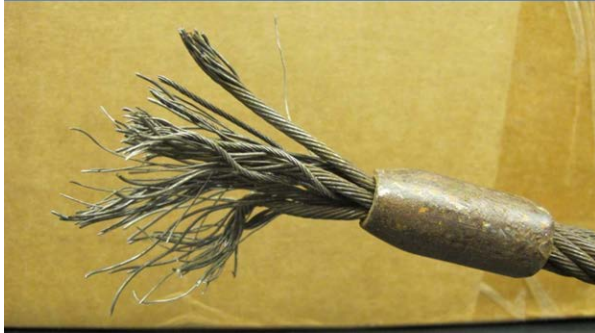
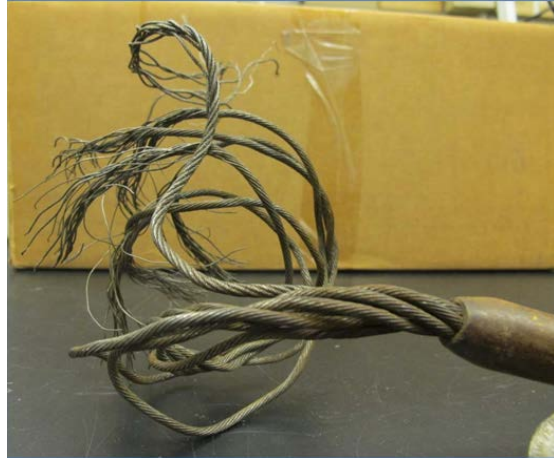
A microscope examination of the sling revealed deformations on failed wire rope ends, which is evidence that the sling was unprotected due to abrasive actions that crushed and gouged the wires

in the rope. Figures 41 and 42 show the wire rope ends at the point of separation on the sling that was wrapped around the tower leg.

Figure 41 - Failure next to swage on the wire rope sling.

Figure 42 - Failed wire rope sling.

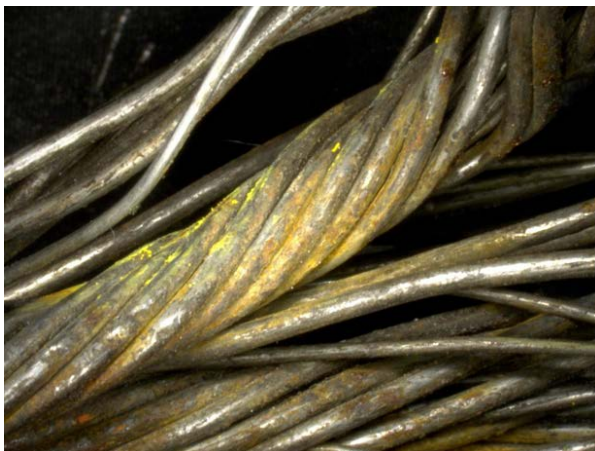
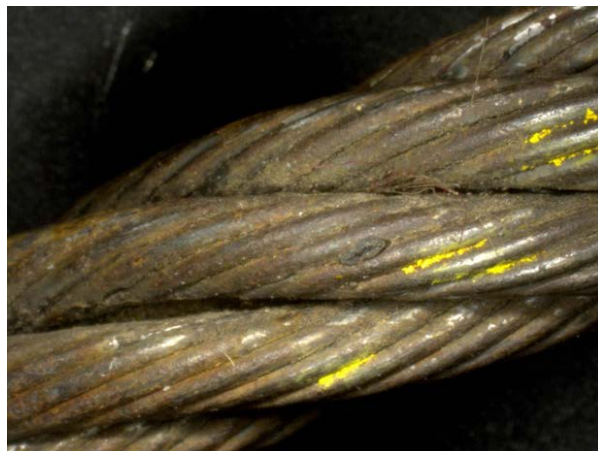
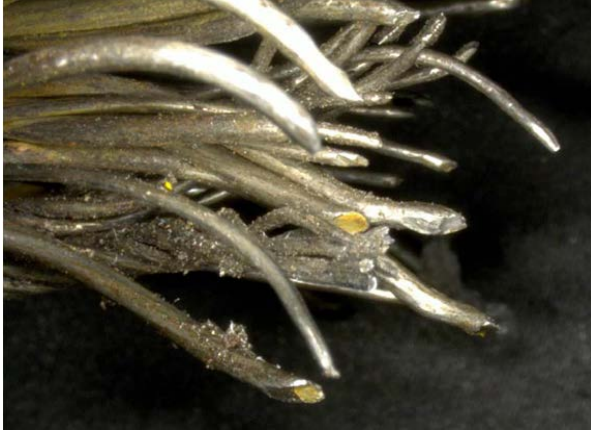
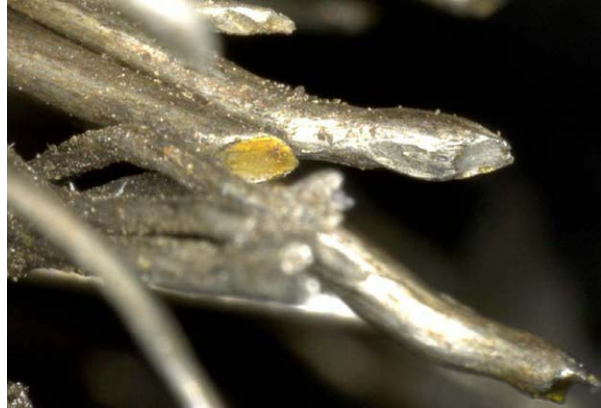
The wire ends were examined using a Keyence Microscope at magnifications from 20-200X. There was some yellow paint-like substance on both the outer surface of the wire rope away from the failure point (figures 43 and 44) and on the fractured ends (figures 45 and 46).

Figure 43 - Yellow paint-like substance on wire rope away from the fracture surface

Figure 44 - Yellow paint-like substance laying in the valleys of the wire rope

Figure 45 - Paint on fractured wire rope ends

Figure 46 - Close-up of Yellow substance on fractured surface

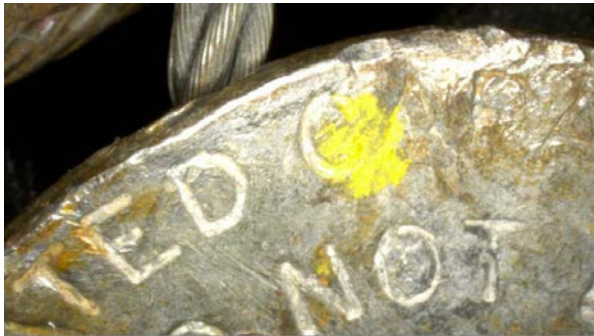
This yellow substance was also on the tag (figure 47). The yellow substance did not have the appearance of having been recently applied. The Yellow paint-like substance observed in the valleys of the wire rope suggested that it was applied prior to the accident. *Paint on fractured wire rope ends suggests that some wires in the strand were damaged prior to the accident. There is evidence of pitting corrosion on the wire rope sling (figure 48).*

Figure 47: Yellow paint like substance on tag

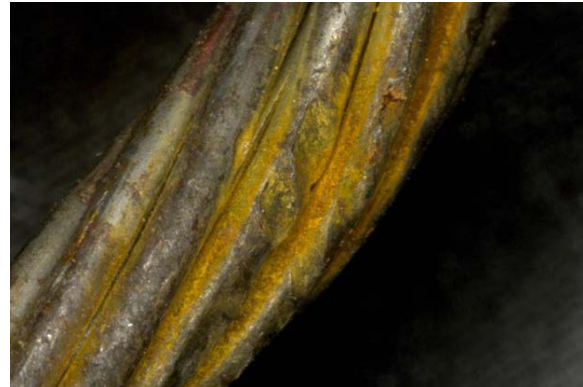
Figure 48: Rust/yellow substance on top of damaged wires

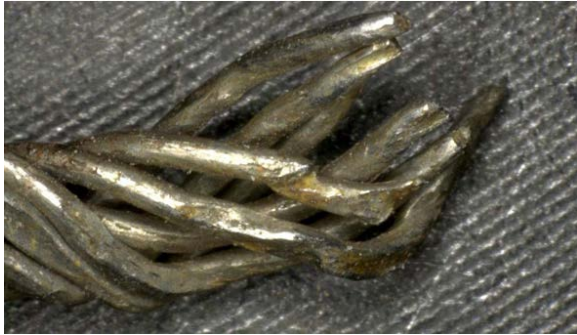
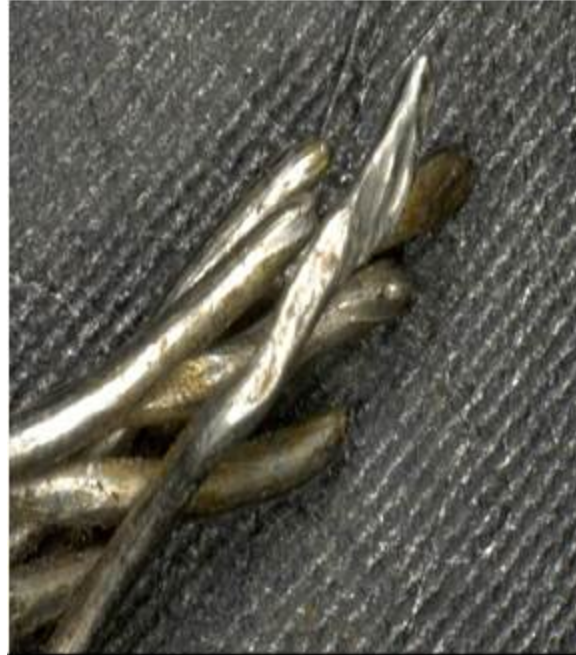
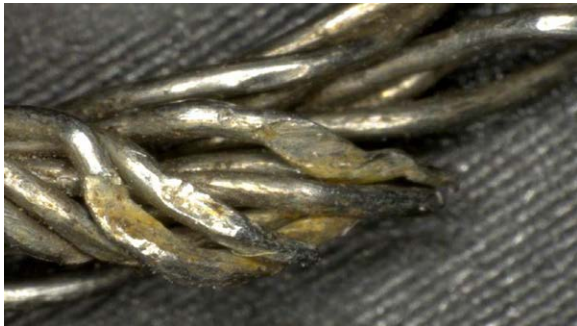
The damage on the 7x7 inner core wire ends was evidence of the scraping, gouging and abrasion that was responsible for the failure of the sling, see figures 49 to 51. Some of the inner core wires were hooked on the end, indicating that they were pulled around a sharp corner, see figure 52.

Figure 49 - Inner core wire ends showing evidence of scraping, gouging and abrasion

Figure 50 - Evidence of gouging, abrasion and crushing on the failed ends

Figure 51 - Gouging and crushing damage on the wire ends at the point of failure

- *The evidence suggests that the rope was damaged prior to the incident.*
- *The failure of the rope was attributed to abrasion, crushing, gouging of the wires that can occur when wire ropes are not protected from sharp corners and edges during use.*

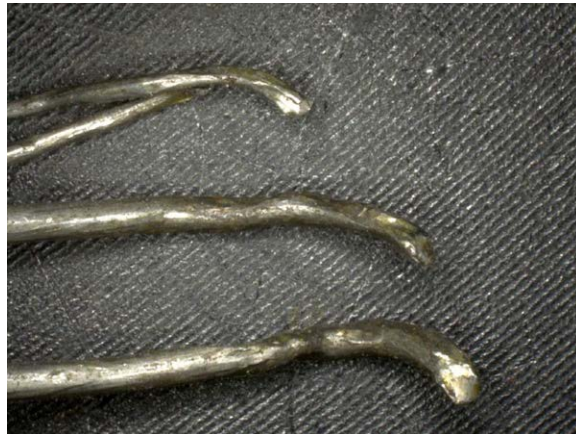
Figure 52- Hooked ends are indicative of being pulled around a sharp corner

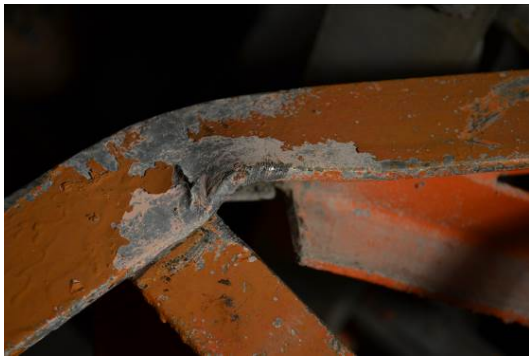
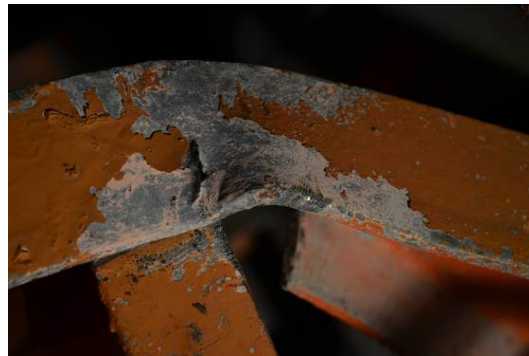
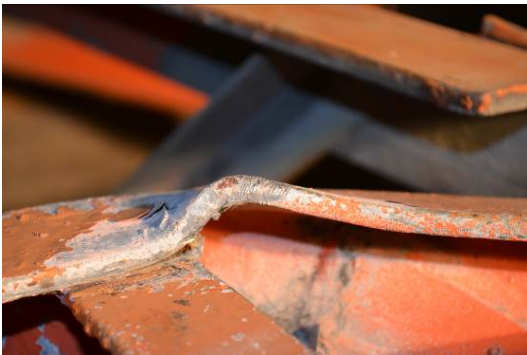
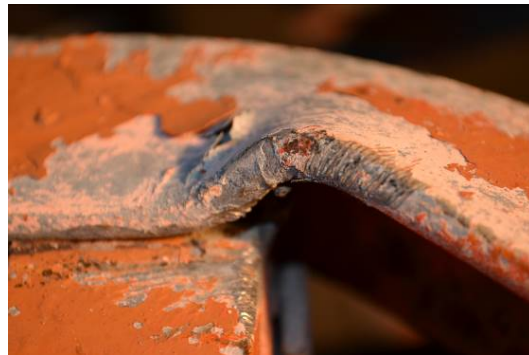
8. Horizon failed to take notice of the fact that the structural members of the existing tower consisted of steel angles (legs, diagonals and struts) instead of round shapes. Steel angles have sharp edges whereas round pipe shapes provide smooth surfaces. The wire rope sling supporting the gin pole top block was wrapped around one of the tower legs consisting of steel angles without providing any protection against abrasion, cuts and gouging. The 3/8" wire rope sling that was subjected to tensile forces was wedged into the 90-degree corner of the leg and the horizontal strut angle, subjecting it to cuts and bruises, see figures 53 to 56 below. The SLTC's microscopic examination indicated: *The failure of the rope is attributed to abrasion, crushing, gouging of the wires that can occur when wire ropes are not protected from sharp corners and edges during use.*

Figure 53 – Cuts and bruises from abrasion of wire rope

Figure 54 – Cuts and bruises from abrasion of wire rope

Figure 55 – cuts and bruises from abrasion of wire rope

Figure 56 – Cuts and bruises from abrasion of wire rope

- *Slings shall be protected from being damaged by sharp corners, sharp edges, protrusions, or abrasive surfaces.*
- *Slings shall not be dragged on the floor or over abrasive surfaces.*

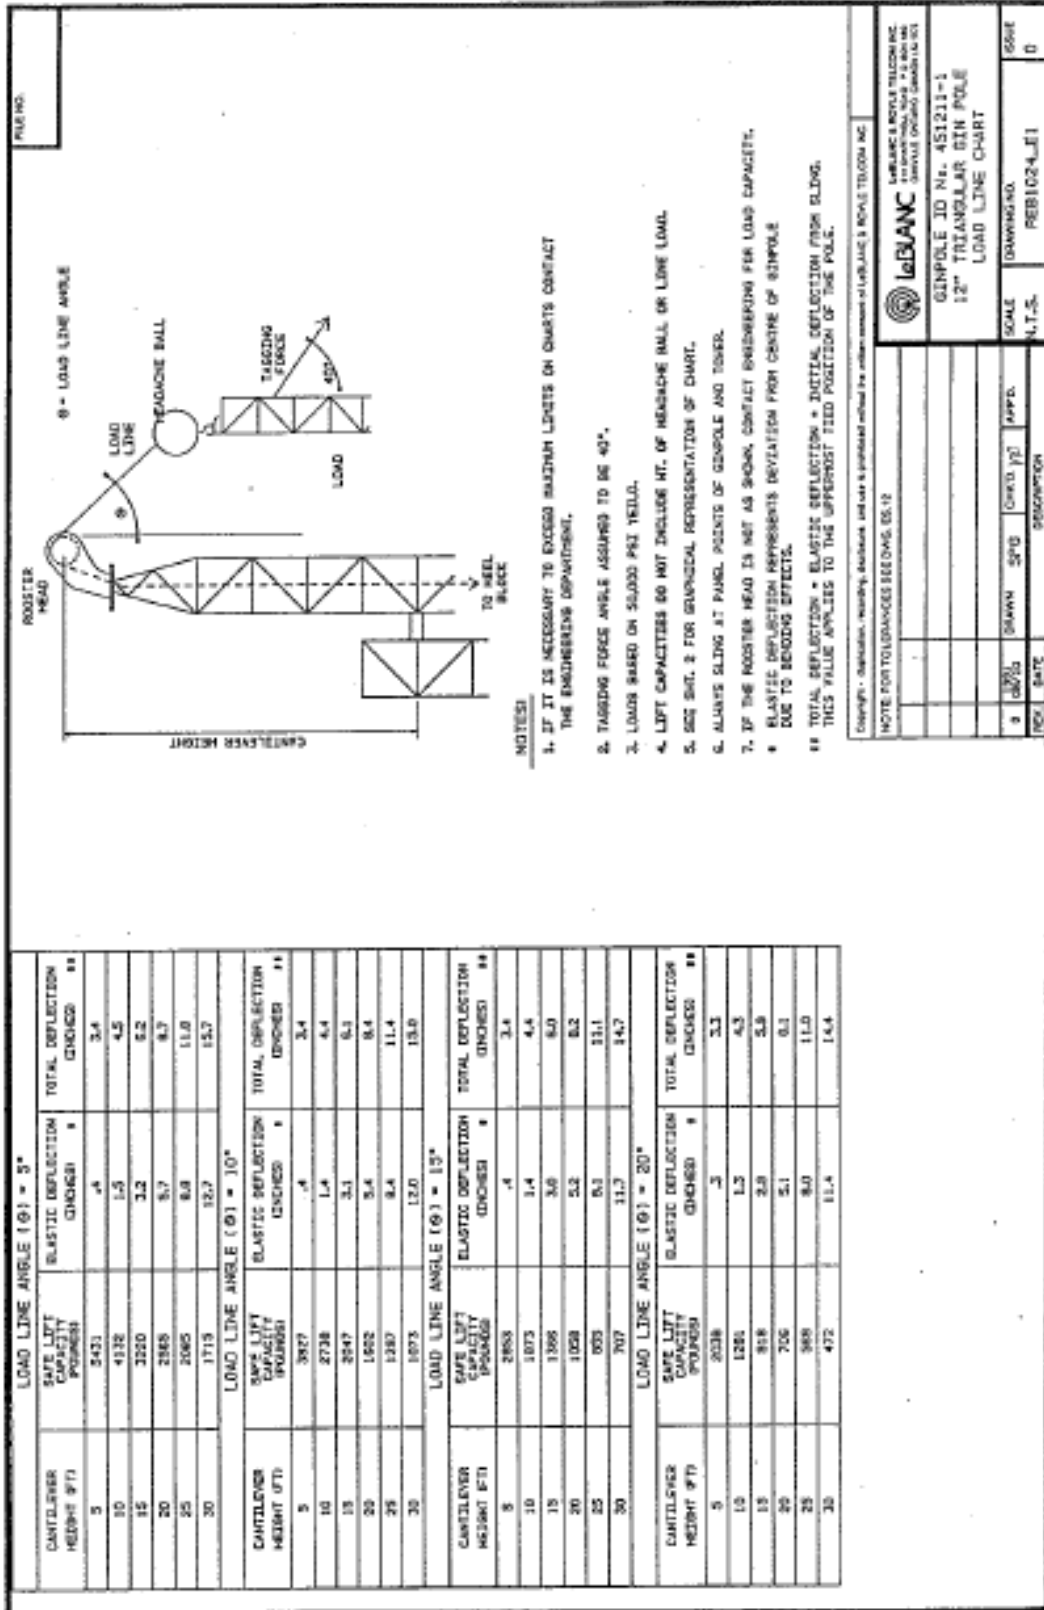
Figure 57 – Gin pole load chart provided by Horizon

No such load chart was available at the site. Horizon's contention that there were other load charts available at the site in the safety manual that did correspond to the gin pole being used indicates a lack of understanding of the standard, and has little merit. A load chart for a 12" triangular gin pole ID No. 451211-1 was provided to OSHA, post-incident, by Horizon, see figure 57, which was in Horizon's office, but the employees at the site were not aware of this load chart. There were three problems with this load chart. First, this load chart was not valid as it did not indicate the overall length of the gin pole for which this load chart had been prepared. Second, the employees could not have verified if this load chart applied to the gin pole in use due to the lack of identification marks on the gin pole. Third, the load chart was prepared for a certain type of rooster head which was different from the rooster head in use at the site. In fact, the load chart cautions that "*if the rooster head is not as shown, contact engineering for load capacity*". In the gin pole inspection report, see figure 58, the model number is shown as 45-813, different from the ID number shown in figure 57.
