Investigation of the December 30, 2014 incident at Ford Kansas City Assembly Plant, Claycomo, MO

U.S. Department of Labor
Occupational Safety and Health Administration
Directorate of Construction

March 2015

Report Prepared by
Mohammad Ayub, P.E., S.E.
Office of Engineering Services
Directorate of Construction

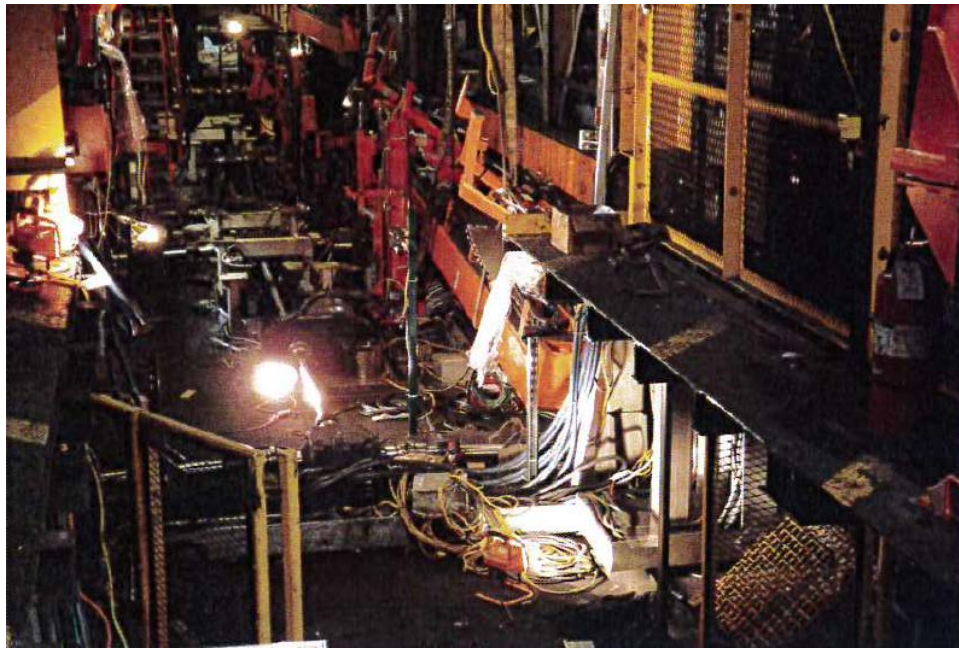
Fig. 2 – Overall view of pit area where workers were working

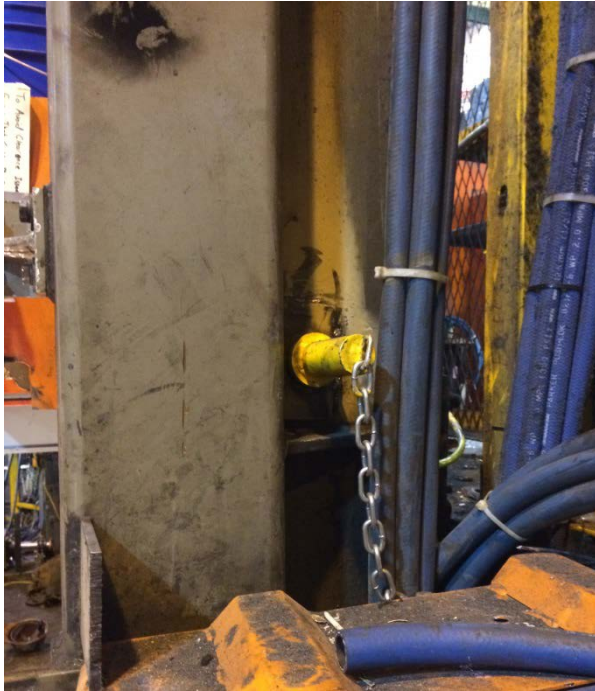
Fig. 3 – Safety pin and the column

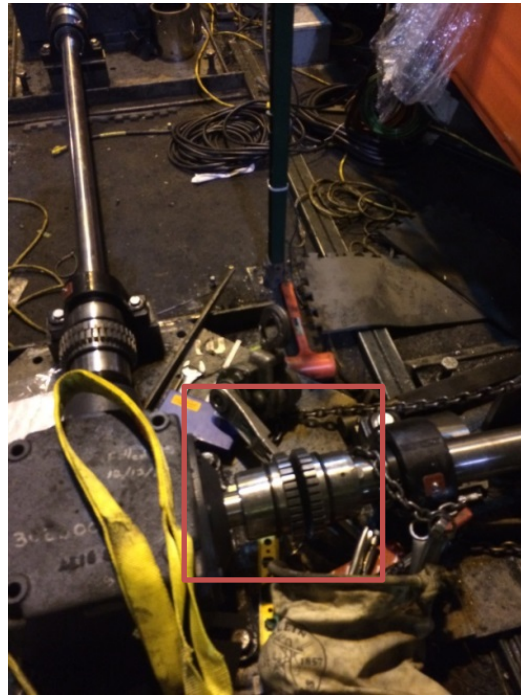
positioned between the two chokers, see figure 4 and 5. It is believed that in addition to the dead load of the carriage, a force of 3,000 pounds was applied through the chokers to the safety pins. The carriage slipped from the safety pins and fell, pinning an employee. The slippage was caused by the failure of the welds of the bracket.

Fig. 4 – Coupling worker was aligning at the time of the incident

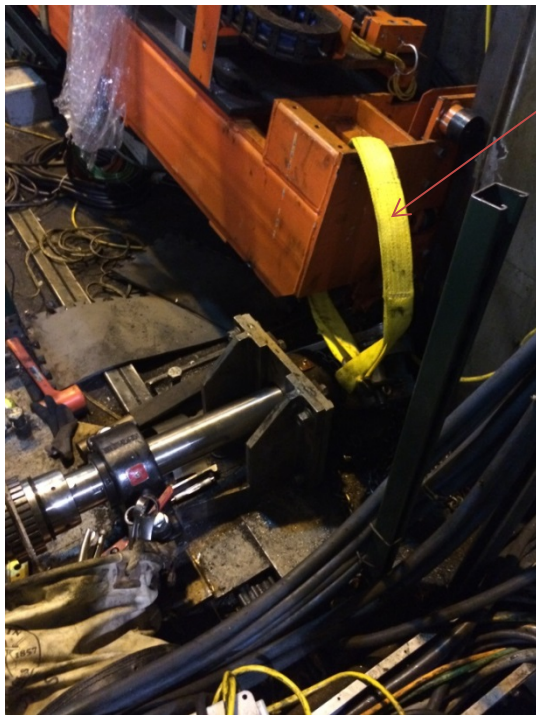
Nylon choker for come-along

Fig. 5 – Attachment point for come-a-long

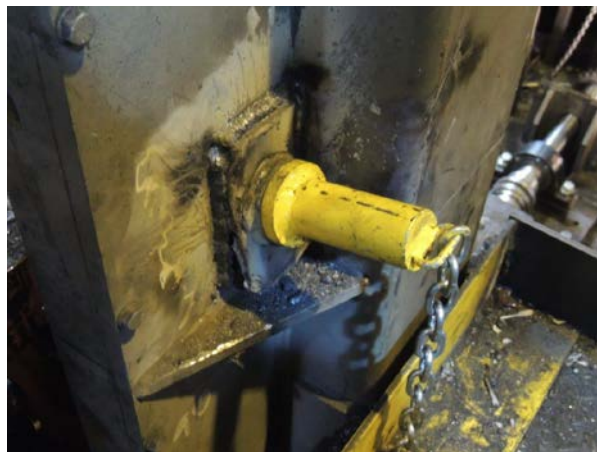
Fig. 6 – Safety pin and the bracket with the weld

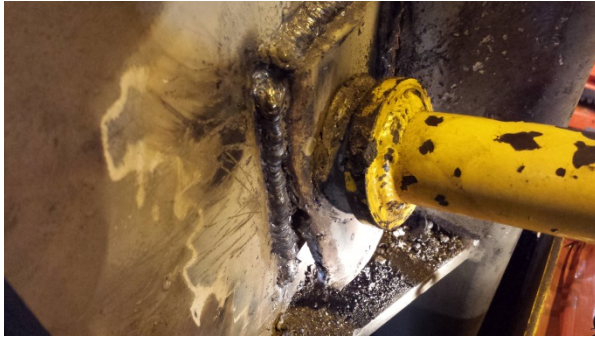
1. The failure occurred due to the inferior quality of the welds on the bracket plate welded to the column. The welds were found to be unacceptable by an independent laboratory, which examined the welds.
2. The hole in the column plate was made larger than required, thus excluding the possibility of distributing the load to the column flange plate.

Fig. 7 - Failed weld, bracket and safety pin

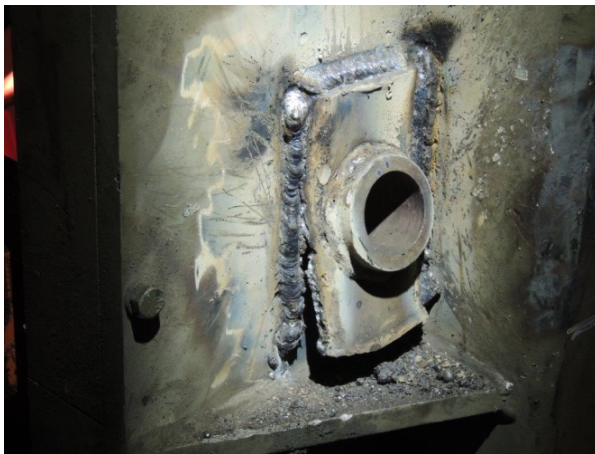
Fig. 9 - Failed weld and the bracket

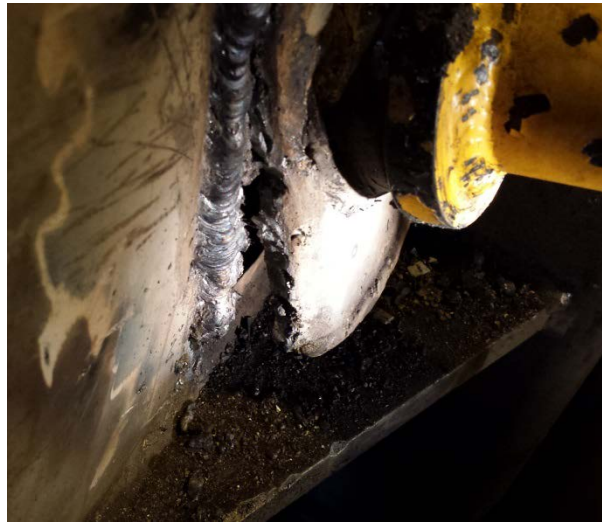
Fig. 10 – Failed weld showing lack of fusion

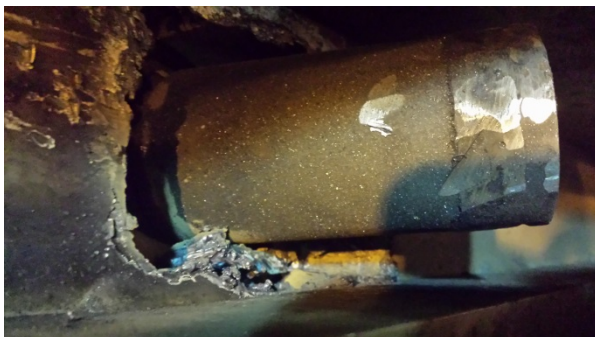
Fig. 11 - Safety pin and the oversized hole

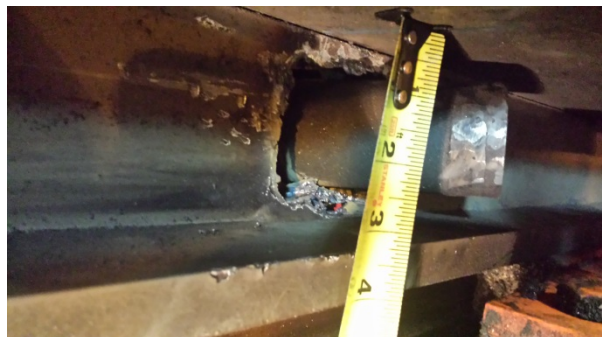
Fig 12 – Safety pin and the oversized hole

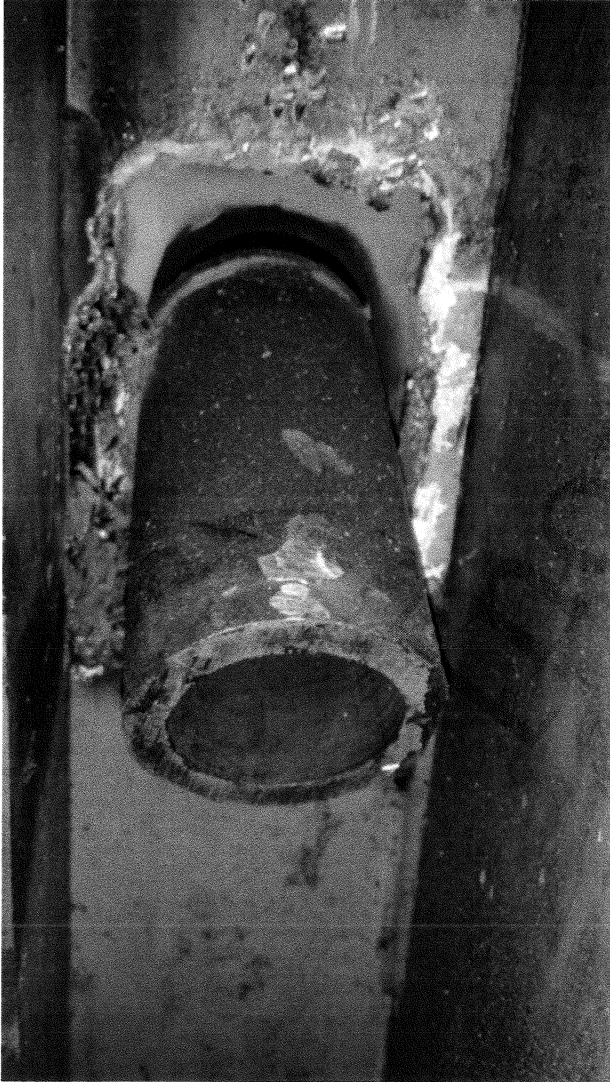
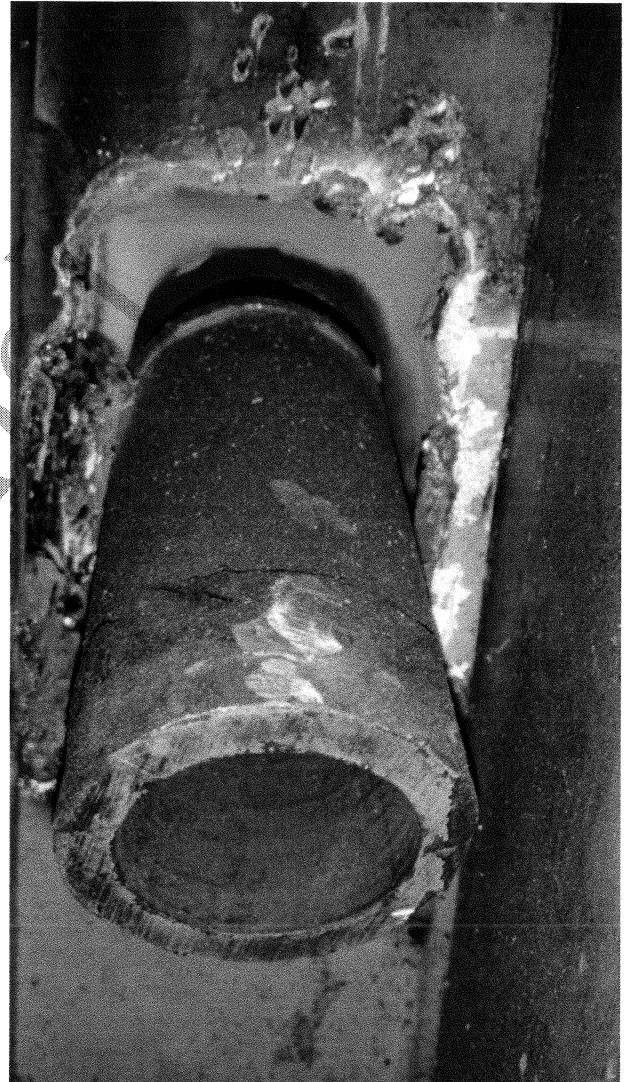
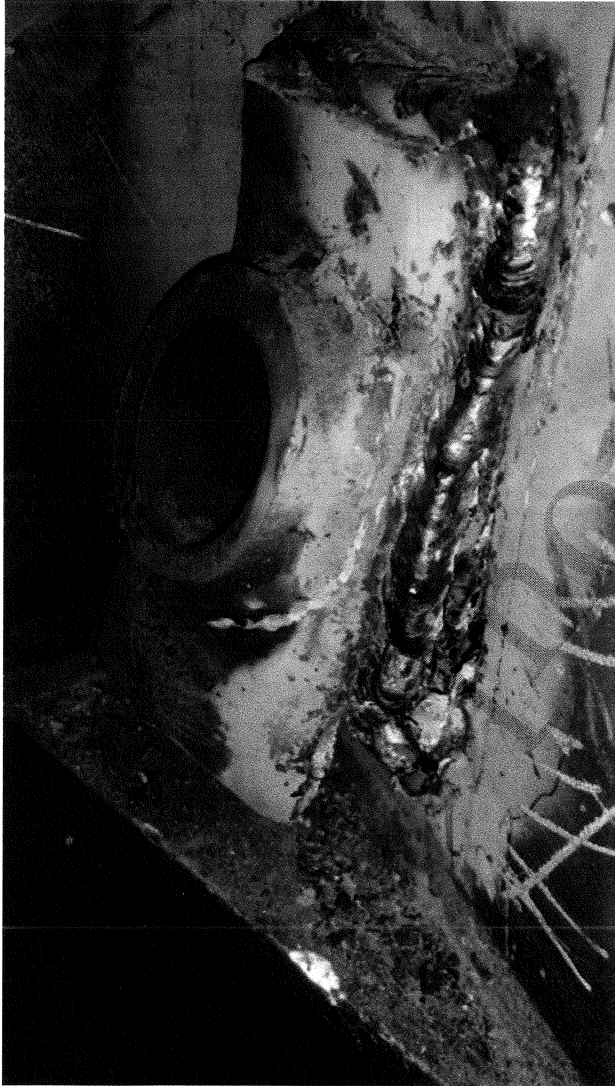
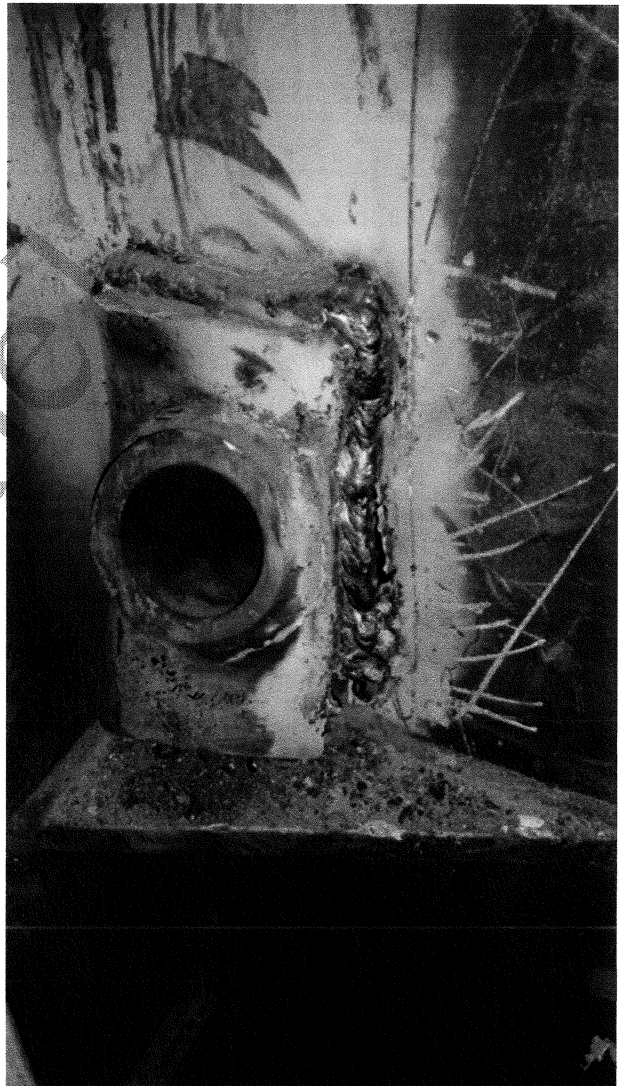
1. The connection was not welded on one of the 5" long sides or on the 3" long bottom area.
2. Welder certifications were not available for review.
3. It appeared that the subject welds had been made over paint.

Item Identification		Accept	Reject
NORTH CELL DECKING MACHINE			
Remaining weldment on catastrophic weld failure			X
			Cold Lap & Lack of Fusion
			See photographs on pages 4 and 5.
