# Investigation of the November 13 and 14, 2014 collapses of two pedestrian bridges under construction at Wake Technical Community College Campus, Raleigh, NC

U.S. Department of Labor  
Occupational Safety and Health Administration  
Directorate of Construction

April 2015

Report Prepared by  
Mohammad Ayub, P.E., S.E.  
Office of Engineering Services  
Directorate of Construction

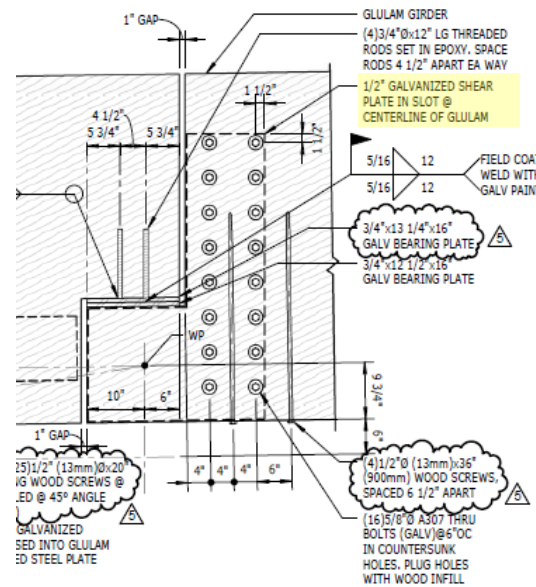
Fig. 17 – Glulam to glulam pinned connection

The main girders of the trusses were designed as a pinned bearing connection at one end and a “sliding” bearing support at the other. The supports at each end for trusses Nos. 5 and 6 were provided by the glulam girders projecting from the V-columns. For trusses Nos. 1 and 2, one end of the trusses had a bearing over the concrete abutment, and the other had a bearing over the glulam girder projecting from the V-Columns. Where the bearings were over the glulam girders, both glulam girders were notched to present the appearance of having one continuous beam. The notched ends of the glulam girders projecting from the V-columns were provided with concealed embedded steel plates, almost for the entire depth, to resist the shear and to alleviate potential

cracking due to notching. There were no cracks observed on those glulam girders projecting from the V-column after the incident. Unfortunately, similar embedded plates were not provided in the glulam girders of the trusses where long horizontal cracks were observed after the incident, and this was a primary cause of the failure.

Notches in wood members have been a perennial concern among structural engineers, and all textbooks and codes recommend against using them unless remedied by providing long lag wood screws crossing the potential line of cracks, or by steel plates bolted to the glulam beams on either side. The well-recognized concern is based upon the reduced section for shear, stress concentration at the notch in re-entrant corners, and the tendency of the notch to induce stress perpendicular to the grain, resulting in tearing of the section where horizontal shear occurs. The potential formation of the cracks is more likely in the tension zone rather than in the compression zone. The end section of the glulam girder underwent a transformation of stresses when the camber initially induced gradually diminished under the application of the dead loads of concrete. In this particular case, the situation was exacerbated by the vertical component of the tension in the cable which could accelerate the tear at the ends. Additionally, the wood near the mid-depth of the section is generally of lower quality laminations, not as high quality as wood near the top and bottom of the glulam contributing to the propagation of the cracks. Both ends were designed as pins with one end having sliding capability. The National Design Specifications (ANSI/AF&PA NDS-2005) permits notches at bearing over a support on the tension side not to exceed lesser of  $1/10$  the depth of the member or 3", and on the compression side not to exceed  $2/5$  of the depth of the member. In this instance, the limits were exceeded.

1. The cause of the failures of bridges Nos. 1 and 2 was the structural design flaw in that the glulam girders were severely notched at each end to facilitate end connections. The notches under the application of a full dead load resulted in the formation of horizontal cracks, eventually leading to the catastrophic failures.

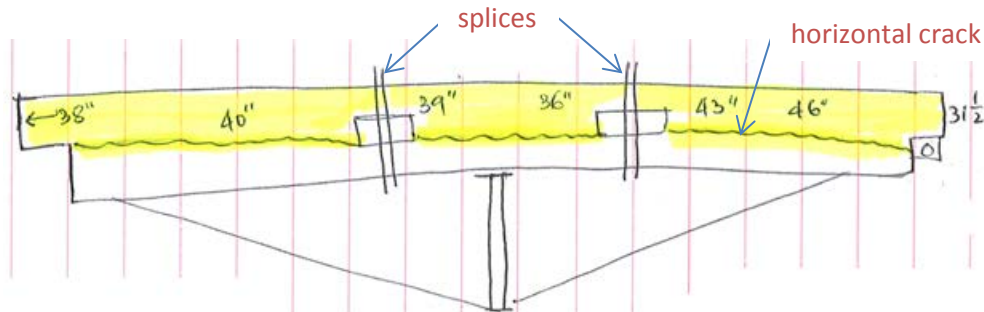
Fig. 21 – Truss TR-5 horizontal crack

The truss TR-5 split horizontally into two sections with a crack emanating from the notched section at the pinned connection towards building F and proceeding towards the two splices near the bottom of the tube inserts, and then ending a few inches below the notch at the sliding joint towards future building L. The truss TR-6 sustained a similar horizontal crack emanating from a few inches from the pinned connection and stopping at the bottom of the first splice near the bottom of the tube insert. The girder remained mostly intact between the two splices. But the horizontal crack again appeared beginning from the second splice ending at the notched section of the sliding joint. In both trusses, the insert tubes at the splice locations were dislodged to varying degrees.

The four threaded rods set in the glulam and welded to the steel embed plates failed. The welds between the threaded rods and the plate generally failed but the bearing plate remained welded to the 1/2" shear plate in the slot of the glulam.

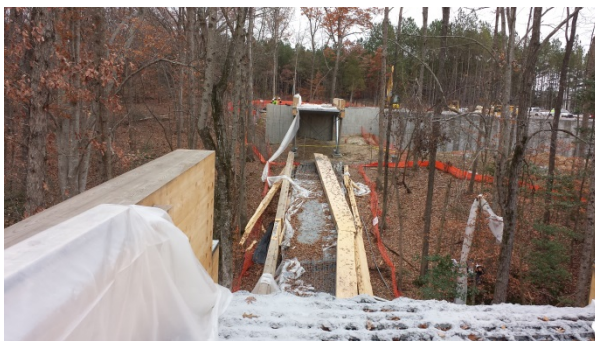
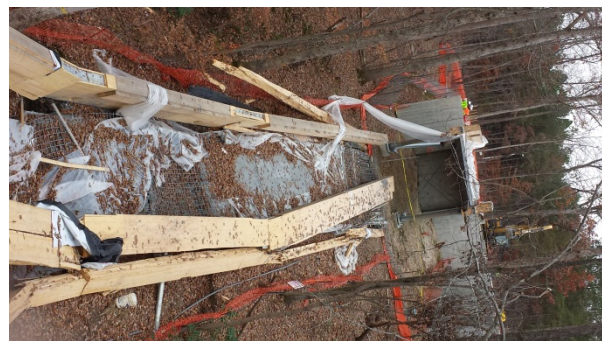
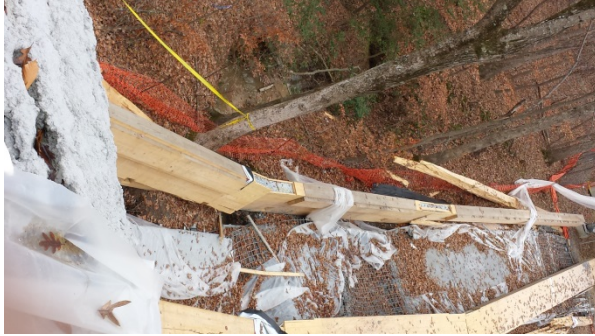
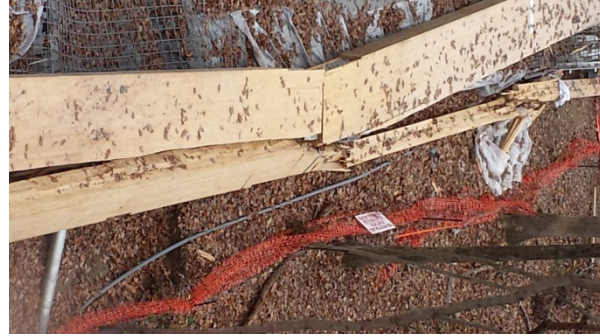
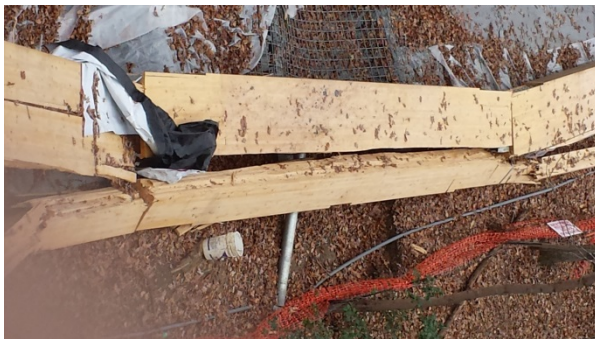
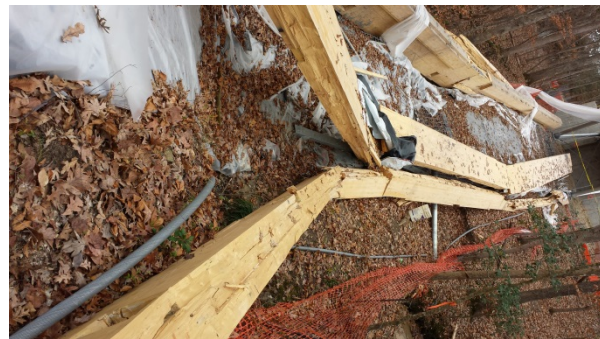
The following photographs show the separation at the notched sections, and the spliced conditions of trusses TR-5 and TR-6.

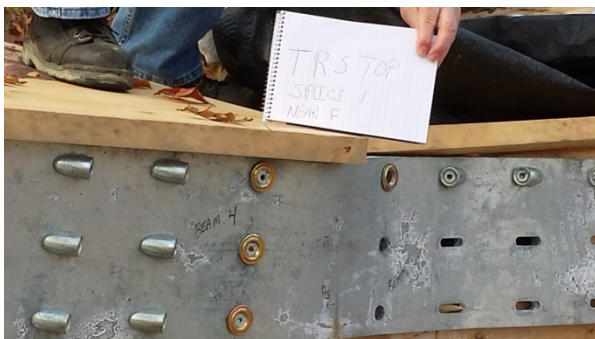
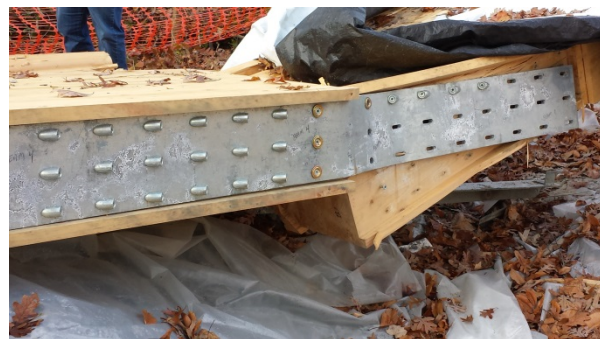
Fig. 29 – View of the top splice plates

Fig. 30 – View of the top splice plates

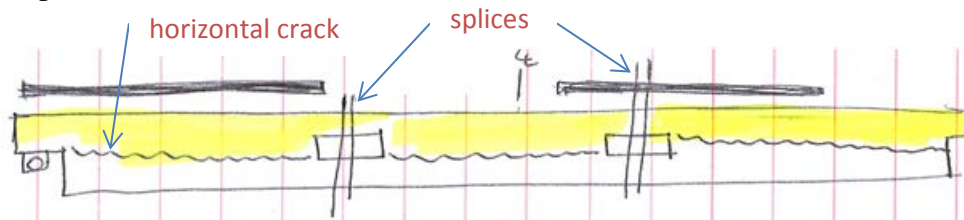
Fig. - 31 Truss TR-1

At the time of the incident, truss TR-1 developed a continuous horizontal crack beginning from the notched section at the sliding joint through the splices and ending a few inches below the pin joint at the far side. Truss TR-2 also separated along a horizontal crack emanating from the notch at the sliding joint, but the crack appeared to terminate at the nearest splice. The following sketches indicate the approximate location of horizontal cracks along the longitudinal axes of the trusses.

The top segment of TR-1 above the fracture remained atop the sliding joint while the bottom segment fell on the ground. Similarly, the top portion of the girder at the abutment remained atop the abutment. The top and bottom segments of TR-2 up to the first splice fell to the ground. The remaining girder from the first splice to the pin joint appeared to remain intact with the girder remaining atop the abutment.
