INVESTIGATION OF THE SEPTEMBER 9, 2015 COLLAPSE OF AIRCRAFT HANGAR NO. 14 AT NEWARK LIBERTY INTERNATIONAL AIRPORT, NEWARK, NJ

U.S. Department of Labor
Occupational Safety and Health Administration
Directorate of Construction

February 2016

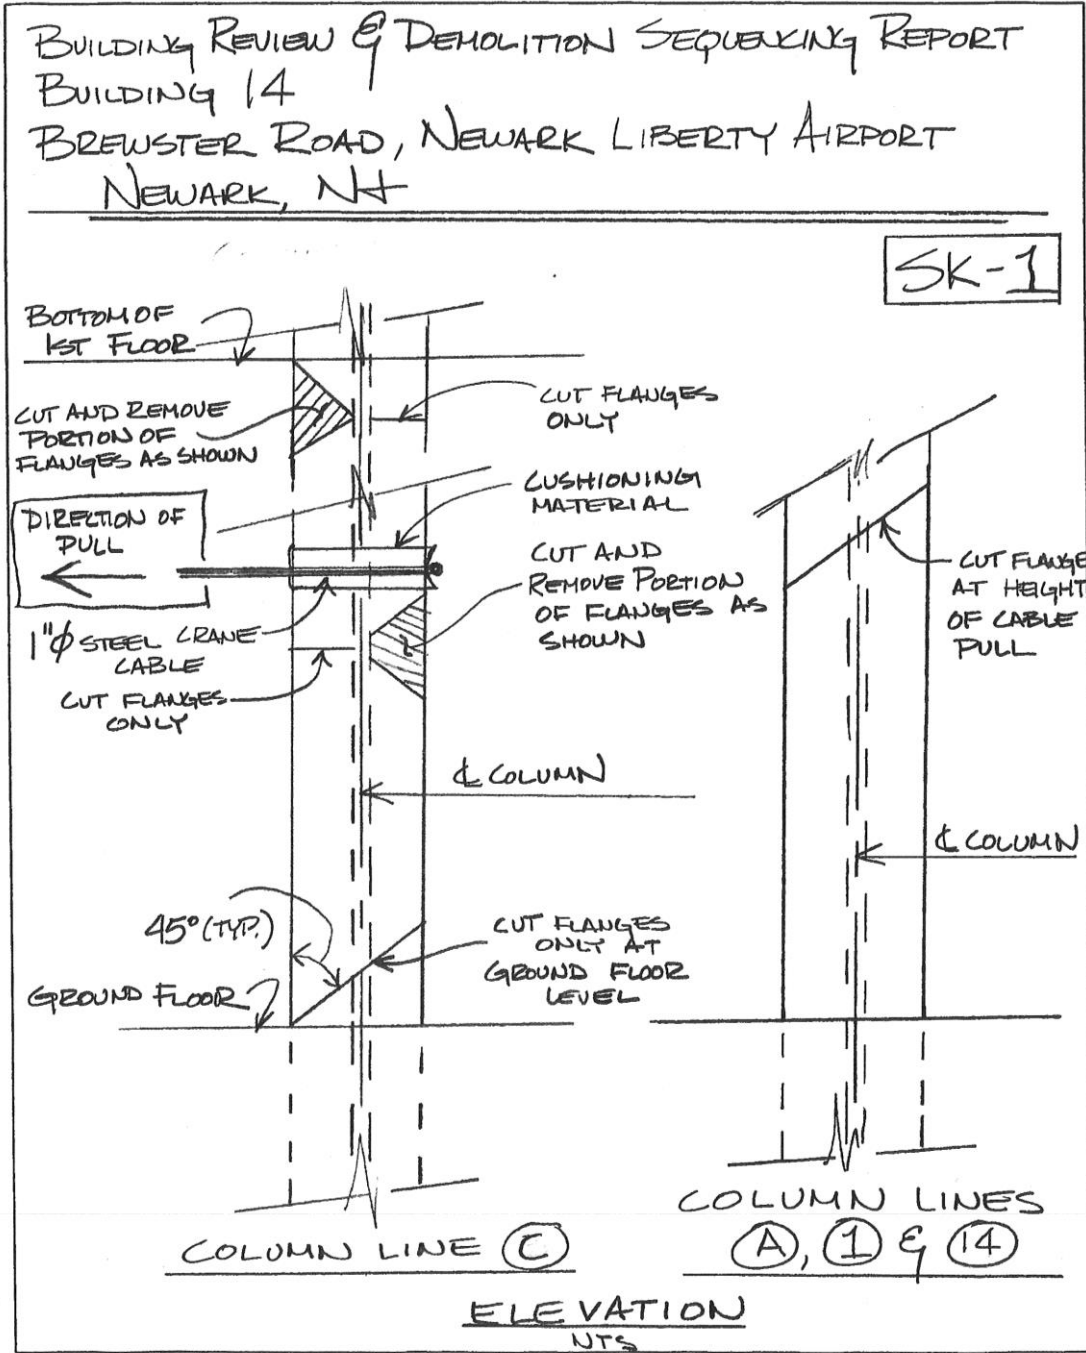
FIGURE 4 (reproduced from Bertin's Report)

- Safety program prepared by the general contractor VRH.
- Procedures for operating, maintaining, and controlling forklifts, hydraulic excavators, steel loader, etc.
- Ladder safety, tool safety, lead safety and guidelines, etc.
- Demolition sketch (see Figure 4) prepared by Bertin.

The demolition report also included systematic removal of dead loads from the roof line of the structure to the floor at grade reversing the sequence used when the building was constructed. However, CATCO required that the steel superstructure and sway bracings remain in place during the removal of the dead loads. After all the dead loads have been removed, the steel superstructure would then be prepared for a controlled collapse. The consultant designated the original first and second floor (Figures 2 & 3) as the ground floor and first floor, respectively in his sketch SK-1 (Figure 4). In this report, the consultant's floor designations have been used. Bertin indicated the following cuts in the column flanges (see Figures 4 & 5).

- Two horizontal V cuts (one above and one below the height of the cable pull) in the flanges of the C line columns above the ground floor. Since no cut was made in the web, each cut would result in a hinge support for the column.
- One 45 degree cut in the flanges of the C line columns at the ground floor level.
- A 45 degree cut (at the height of the cable pull) on all perimeter column flanges located above the ground floor (see Figure 4).
- No cuts were indicated for the flanges above the first floor columns.

In addition to the above cuts, a CATCO employee started to make a horizontal V cut at the bottom of column C-13 at the ground floor, and within a few seconds the roof along with the first floor collapsed on the ground floor (see Figures 7 to 29), trapping nine workers working beneath the roof and the first floor. It is noteworthy that the horizontal V cut performed by CATCO at ground level on column C-13 was in violation of the 45 degree cut recommended by Bertin (see Figures 4 & 5).

CATCO made top and bottom cuts on flanges of the columns at the ground level as well as at the first floor instead of only at the ground floor columns as specified by Bertin in his sketch (Figures 4 & 5) for the demolition report of May 20, 2015. The cuts on the flanges at the ground and first floor columns severely weakened the load carrying capacity of the columns by introducing “hinges” in columns at each cut in the flanges of the column (see Figure 6). In addition, CATCO made a horizontal V cut instead of a 45 degree cut at ground level on column C-13, which further weakened the column and initiated the collapse of the entire building. If CATCO had provided cuts as specified by Bertin in his sketch (see Figures 4 & 5) for the demolition report, the strength of the columns would not have weakened to cause the collapse. The horizontal V cuts and 45 degree cuts as shown on Bertin’s sketch would have softened the structure and brought down the roof and first floor at a lower level so that CATCO could demolish the remaining structure using mechanical equipment.

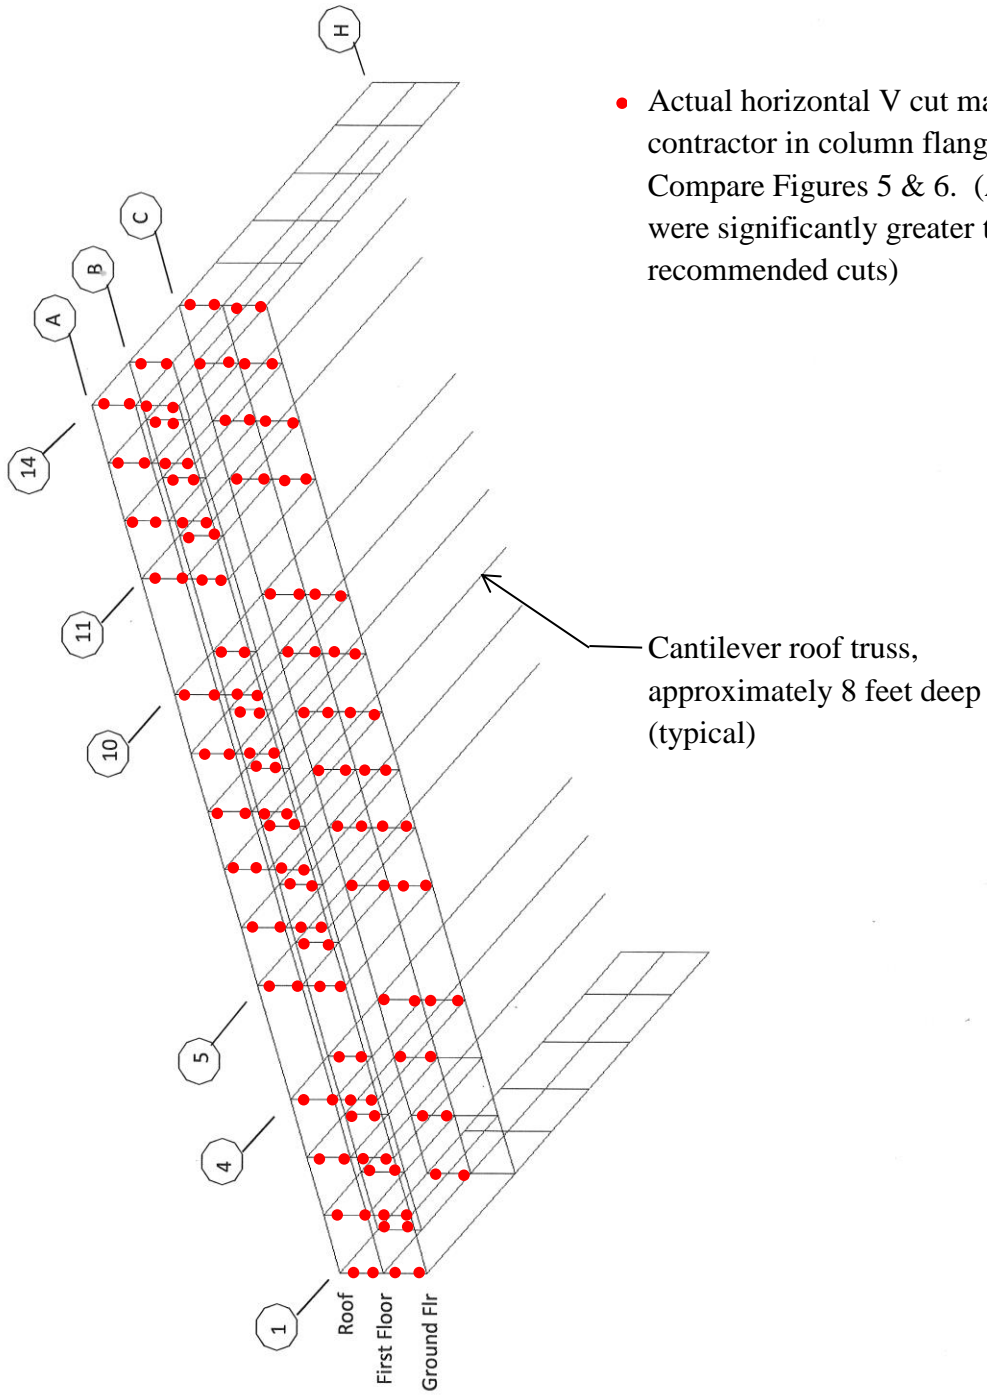
FIGURE 6

- The cuts were made at the following locations on columns located above the first floor (see Figure 6):
 - Columns located on grid line “C”, “B”, and on the perimeter columns located on grid line “A”, line “1”, and line “14”. Even though cuts at these locations were not mentioned by Bertin in his sketch (Figure 4), they were performed by CATCO. It appears that CATCO did not follow the documents provided by Bertin. In addition, the superintendent indicated in a meeting that he did not review Bertin’s demolition drawings prior to or after the cuts were made.

- The cuts were made at the following locations on columns located above the ground floor (see Figure 6):
 - Perimeter columns located on column line “A”.

- Top cut only on column C-4.
 - Cut above and below the direction of the cable pull on column C-5, C-6, C-7, C-8, C-9, C-10, C-11, C-12, C-13, and C-14.
