Investigation of the July 19, 2016 Crane Collapse during Pile Driving for New Tappan Zee Bridge over Hudson River, Rockland County, NY

U.S. Department of Labor
Occupational Safety and Health Administration
Directorate of Construction

January 2017

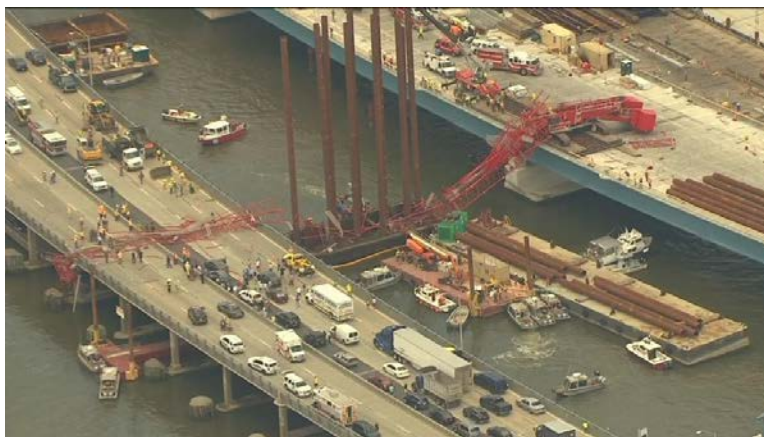
Fig. 1 – View of the fallen crane across the river and existing bridge

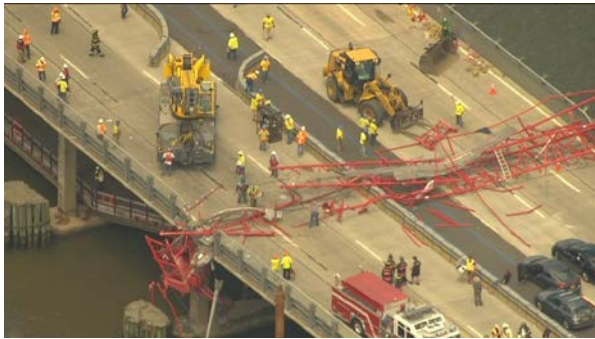
Taken from WestchesterNews
Fig. 18 – Shows crane collapsed onto the existing bridge

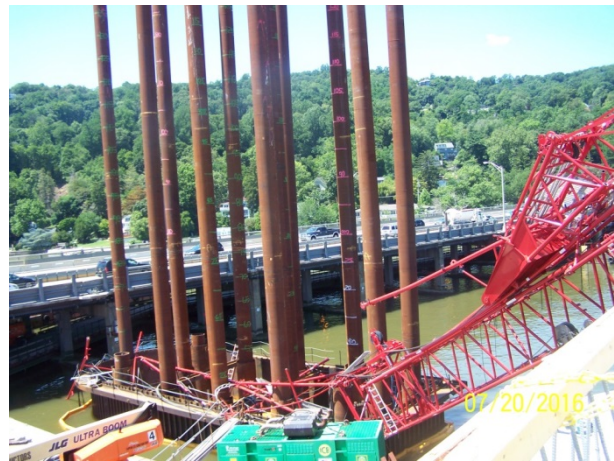
Fig. 19 - Shows the collapsed crane, piles and cofferdam

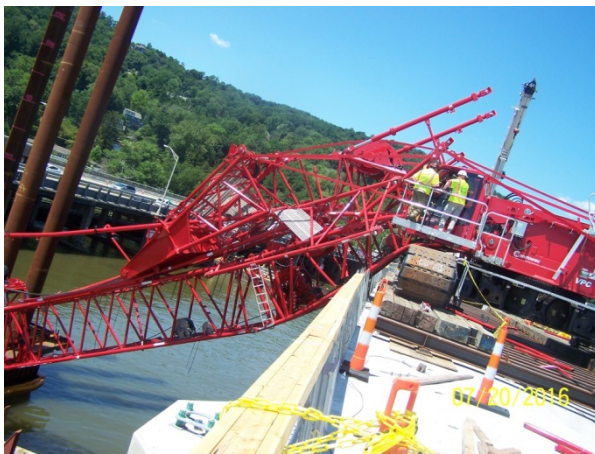
Fig. 20 – Shows the collapsed crane

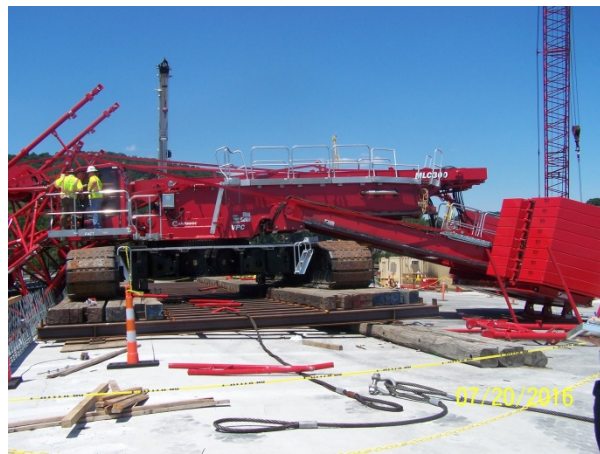
Fig. 21 – Shows the collapsed crane

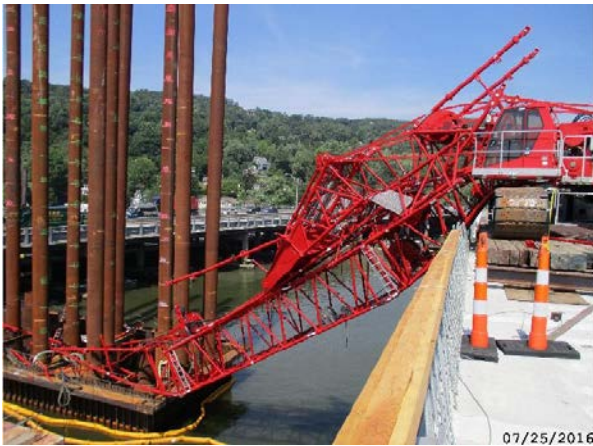
Taken from Thornton Tomasetti inspection report
Fig. 22 – Shows the collapsed crane

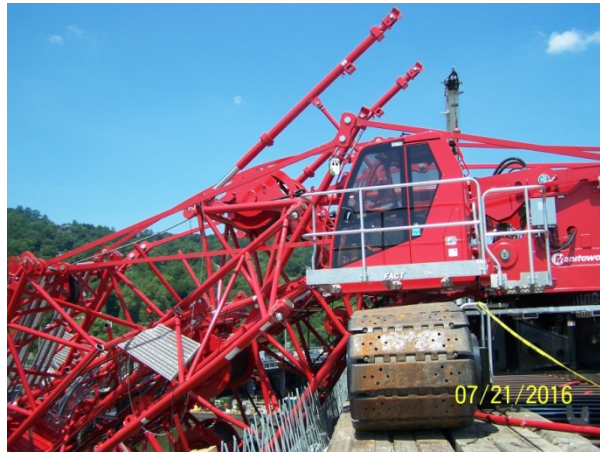
Fig. 23 – Shows the collapsed crane

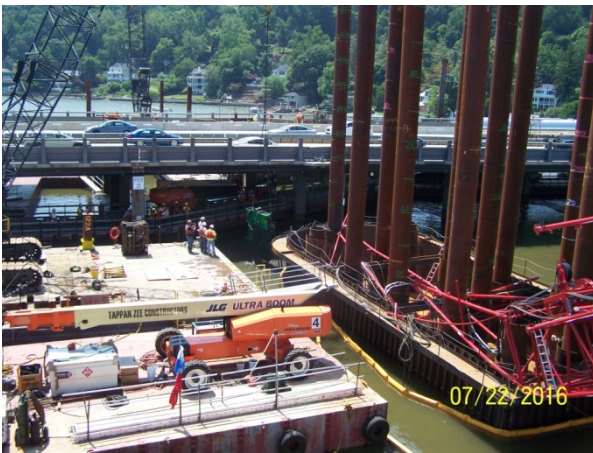
Fig. 24 – Collapsed crane, piles and cofferdam

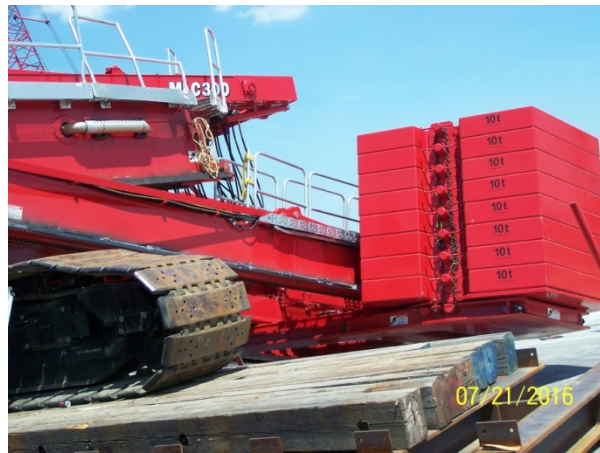
Fig. 25 – Collapsed crane with counterweight

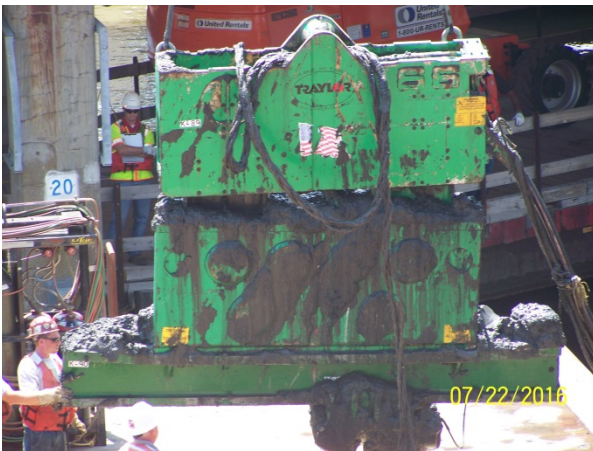
Fig. 26 - Vibratory Hammer recovered from water

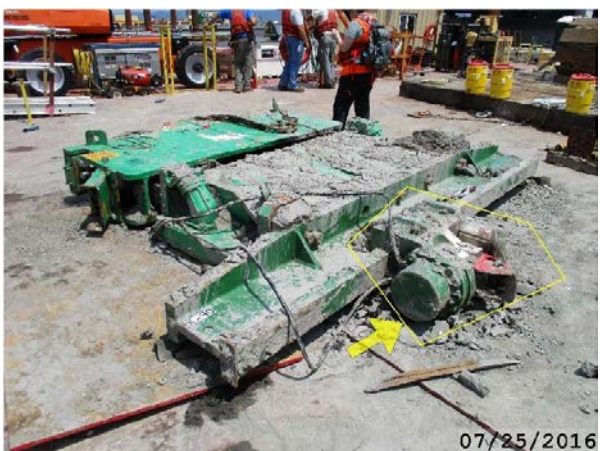
Taken from Thornton Tomasetti inspection report
Fig. 27 - Vibratory Hammer recovered from water
(Note: one clamp is missing)

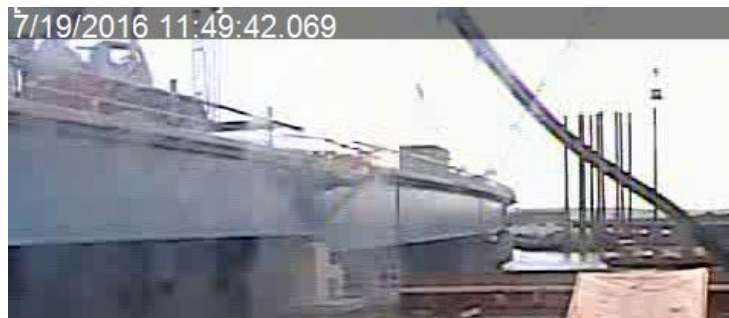
Fig. 28 – Surveillance Camera frame

(shows that the Hammer was not attached to the pile at 11:49:42 a.m.)

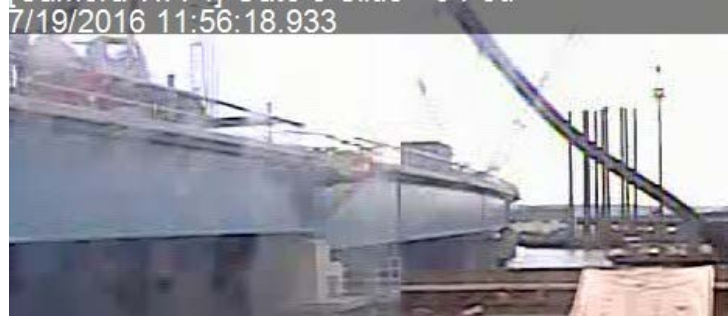
Fig. 31 – Surveillance Camera frame

(Shows Pile extraction.)

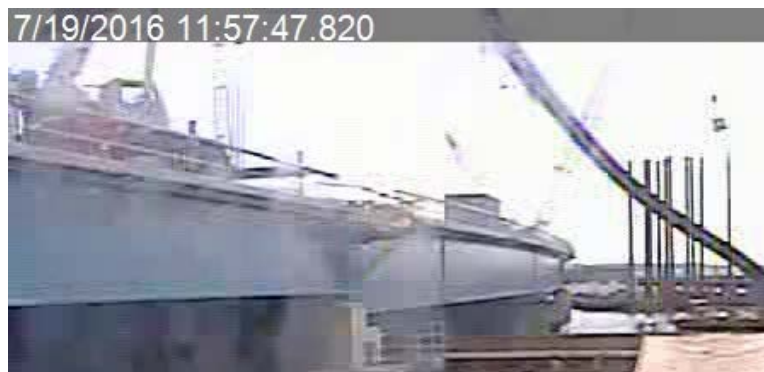
Fig. 32 – Surveillance Camera frame

(Vibratory hammer released and swinging towards the boom at 11:57:47 a.m.)

It is not understood why the crane operator suddenly switched from the load-up to boom-up mode. It is suspected that the pile got stuck either in the sleeve or in the muddy soil, and the crane operator acted to free it by booming up. With the sudden release of the load, the mast of the crane failed, followed by the boom failure. The sequence of the crane failure shown in the appendix was prepared by Manitowoc, the crane manufacturer.

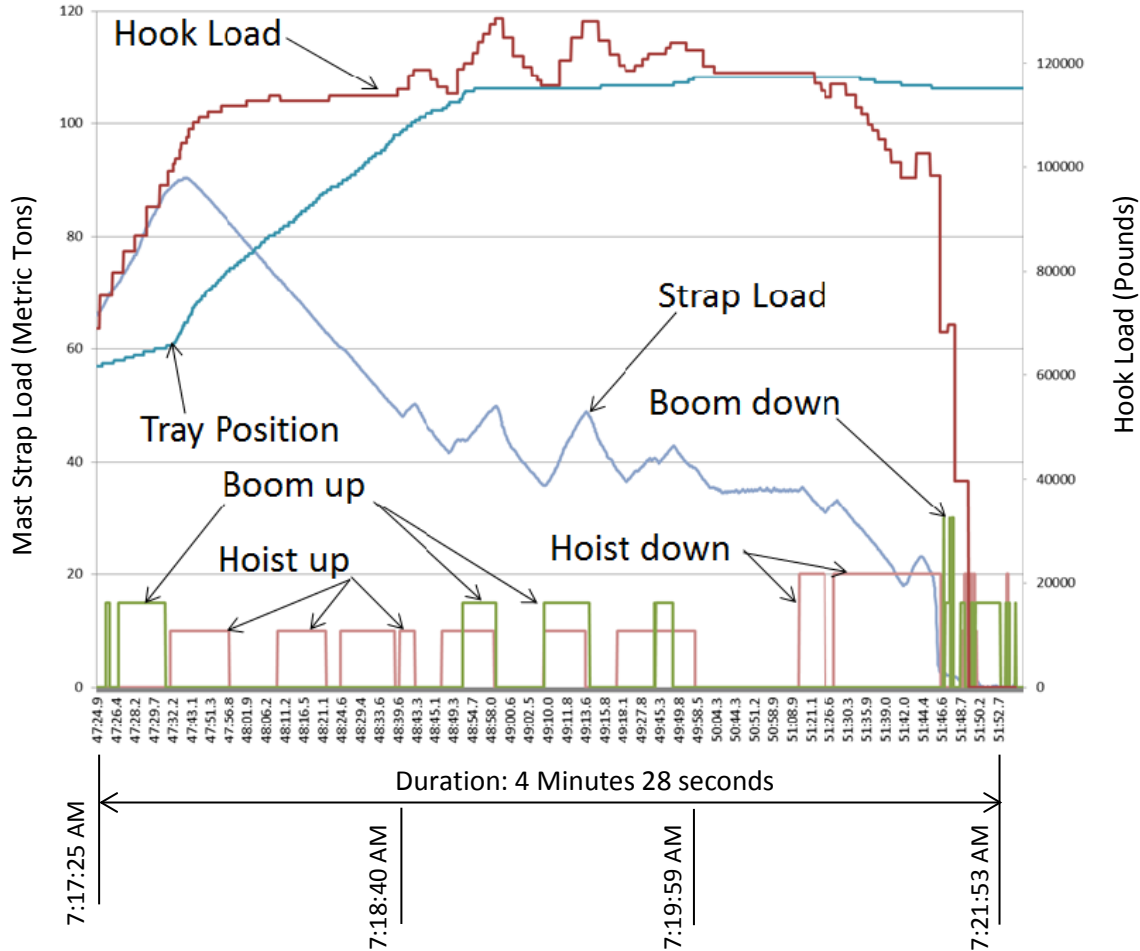
Fig. 33 – Data logger information at time of incident

The crane was equipped with a data logger. The hook load, mast strap load, boom up/down operation, hoist up/down operation, and other information are provided in the data logger. For each second, there are more than ten lines of entry, and the data logger file provided by Manitowoc contained more than 398,000 lines of entry. A plot of approximately five minutes of data, preceding the time at which the hook load and mast strap load became zero, is shown in the plot below (see figure 33). The plot is for duration of 4 minutes and 28 seconds (The data logger time from 7:17:25 AM to 7:21:53 AM). The date and time in the data logger did not correspond

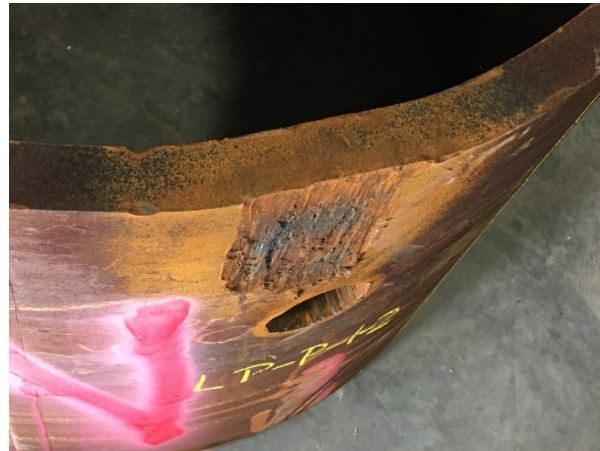
Post-incident examination of the top three feet of the pile indicated indentations on the south and north tips where the grip cylinder and the bearing plates of the vibratory hammer were clamping the pile. The mark on the south side is a significantly deep groove indentation measuring half the thickness of the pile wall. On the north side there are scratching marks, but not deep gouging as observed on the south side, see figures 34 to 37. This appeared to be consistent with the boom-up action by the crane operator, as it will exert higher force on the south side compared to the north side. An additional reason for the deep gouging on the south side of the pipe is the fact

Fig. 35 – Mark on the north side of pile #1

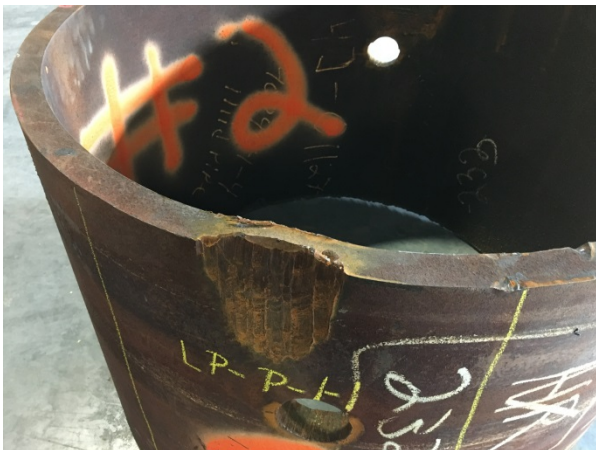
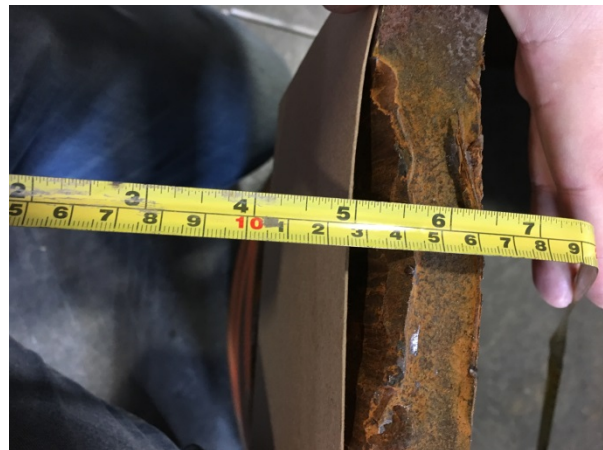
that the grip cylinder had a flat contact surface with the pipe. This caused a large concentrated force where the cylinder contacted the pipe, resulting in permanent deformation of the pipe. The vibratory hammer clamp and the removable bearing plate are shown in figures 38 to 41. The replaceable “Fixed Jaw Plate” part from J&M manual is shown in figure 42.

Fig. 36 – Deep indentation on the south side of pile #1

Fig. 37 – Deep indentation on the south side of pile #1

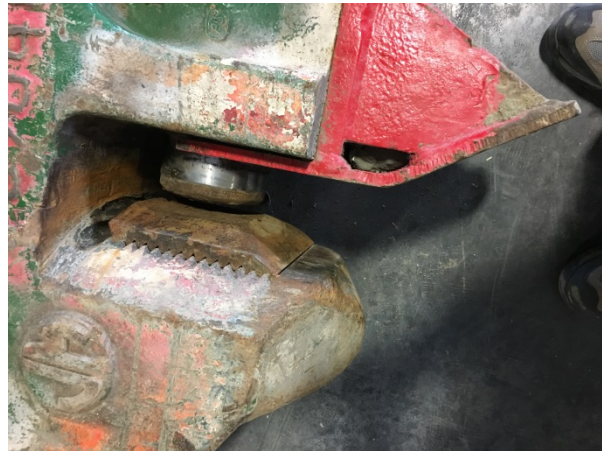
Fig. 39 – Close-up of Clamp removable bearing plate

2. Tappan Zee Bridge Constructors, LLC used a corroded and damaged bearing plate located against the clamping cylinder on the vibratory hammer - a deviation from the standard industry practice.

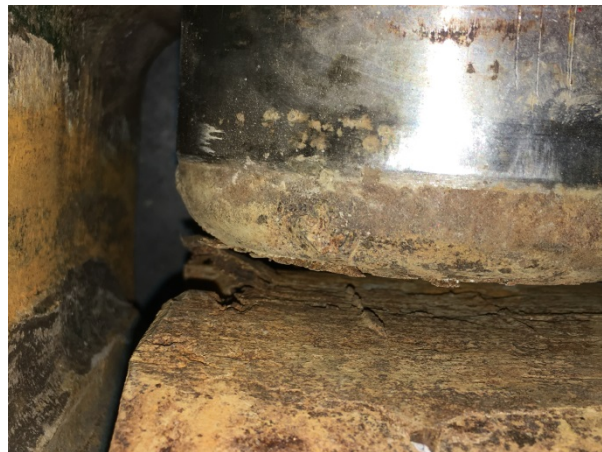
Fig. 41 – Close-up of corroded removable bearing plate

5. The bearing plate of the clamp did not contain jawed teeth as required by the vibratory hammer manufacturer.
6. It is believed that the Tappan Zee Bridge constructors, LLC operated the vibratory hammer without possessing its operating manual. Tappan Zee Bridge Constructors, LLC could not produce the manual to OSHA in spite of repeated requests from OSHA.

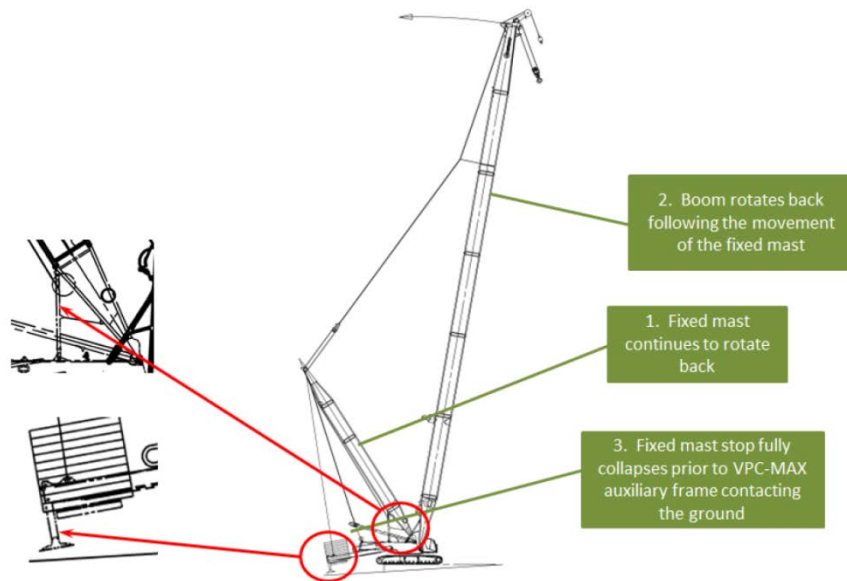
Figure 6: Backward motion of boom and lattice mast

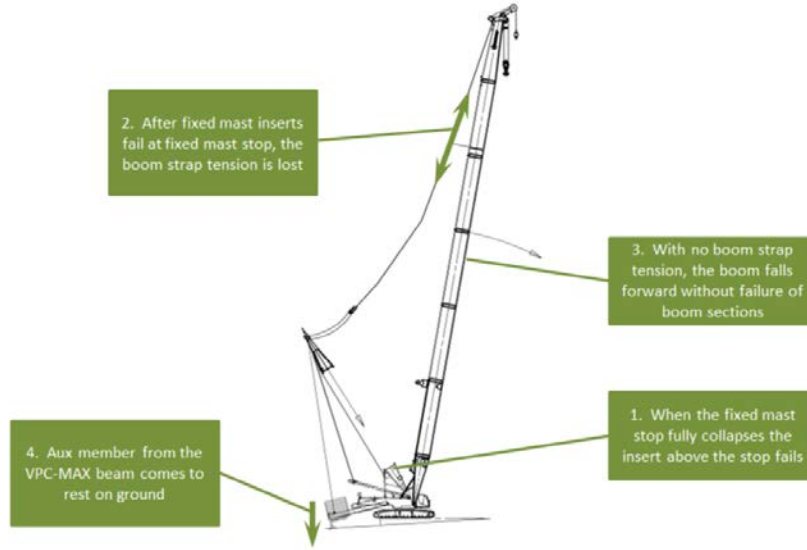
Figure 7: Mast failure
