Investigation of the September 1, 2016, Formwork Table Collapse in West Palm Beach, Florida

U.S. Department of Labor
Occupational Safety and Health Administration
Directorate of Construction

February 2017

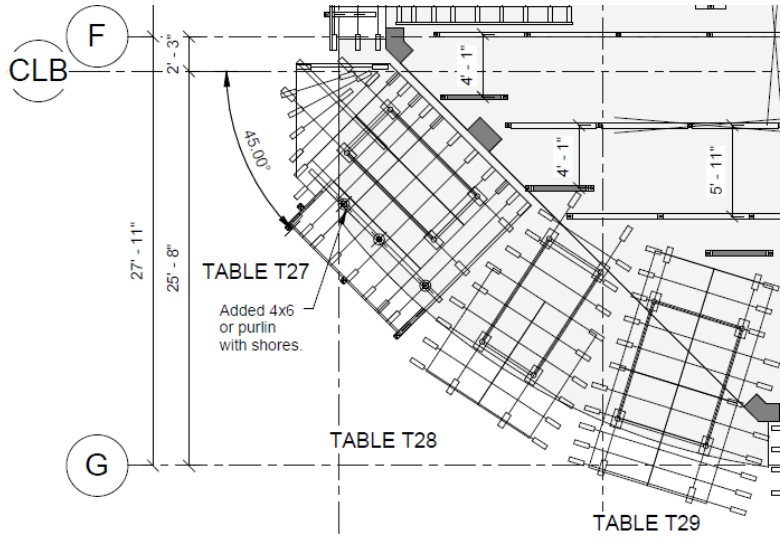
Fig. 4 – Formwork plan showing Table T27. (From CECO drawing F8.0 – see fig. 3)

Table T27 was different from other tables used at the site. It was distinctive because it had a six-foot of cantilever on two sides. Three additional shores were added in the PE stamped drawing F8.0 to limit the cantilever (see figures 3 and 4). The table-setting crew

did not add the three additional shores, and the table was installed with a cantilever of 6 feet on two sides (see figures 4 and 26). The table setting-crew was working from an unsigned makeup drawing (see figure 5) where the additional shores were not shown. CECO did not design the formwork and its anchoring system for different phases of construction. The field crew did not have proper coordination with the design drawings. The crew did not have proper instructions for anchoring the tables. CECO did not check the stability of the individual tables at different stages.

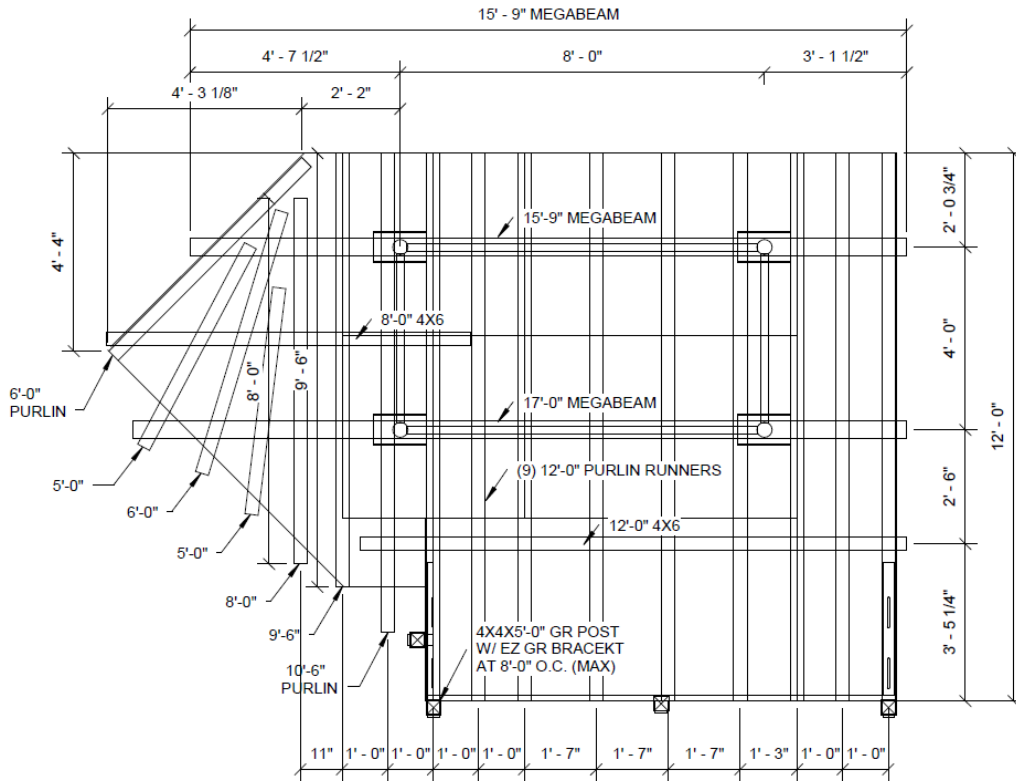
TABLE T27
 WEIGHT: 2000 LBS
 MAKE 1 ASSEMBLIES
**ONE 6'-0" EFCO POST, SHORT
 SJ TOP, LONG SJ BOTTOM**

Fig. 5 – Makeup drawing for Table T27. (From CECO drawing MU1.4)

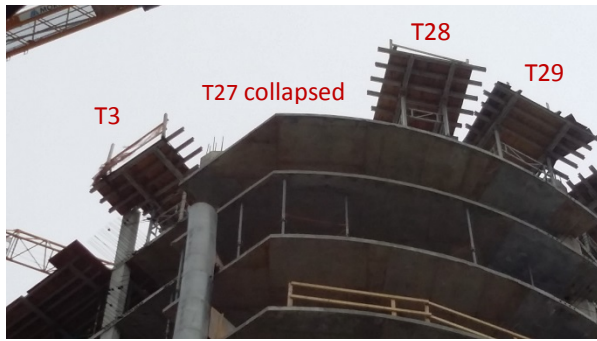
Once Table T27 was placed on the floor, it needed to be leveled. The table-setting crew performed the levelling and finished anchoring the Table T27 legs. Then the foreman signaled the unhooking of the crane. Later in the afternoon, under high winds, Table T27 bounced off the floor and fell to the ground (see figures 11 to 14). While the table tumbled over, it became entangled on one of the employee's PFAS. The PFAS (see figure 15) snapped and the employee fell from the 15th level to the ground and was fatally injured. The wind gust that afternoon was over 30 mph.

Fig. 11 – After Collapse.

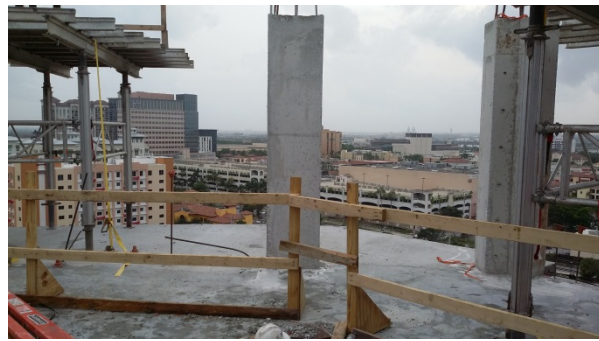
Fig. 12 – After Collapse.

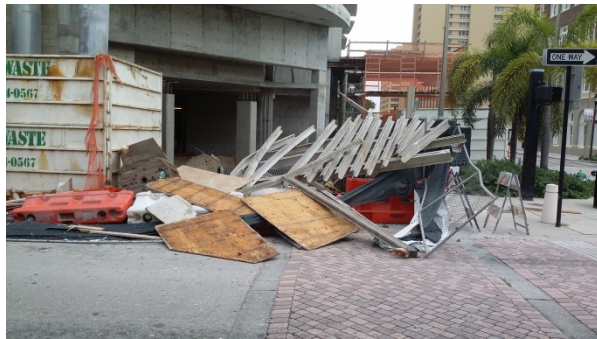
Fig. 13 – Collapse photo. (T27 after collapse)

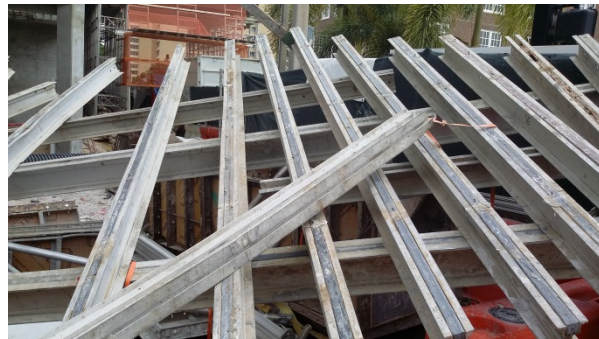
Fig. 14 – Collapse photo. (T27 after collapse)

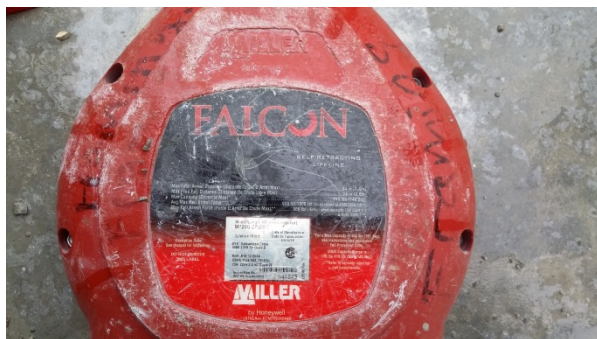
Fig. 15 – Miller Falcon MP20G-Z7/20FT cable lifeline used by employees.

The table-setting crew was wearing a self-retracting Miller Falcon MP20G-Z7/20FT cable lifeline. According to the Miller Falcon website, the lifeline wire rope for this Personal Fall Arrest System (PFAS) was 7x19, 3/16" in diameter. The maximum working load is 310 pounds and maximum arresting force is 900 pounds. The wire rope catalog states that the breaking strength of a 7x19 galvanized wire rope is 4,200 pounds. The deceased employee's self-retracting lifeline got entangled with the falling Table T27 weighing approximately 2,000 pounds severing the 3/16" wire rope (see figures 27 to 29).

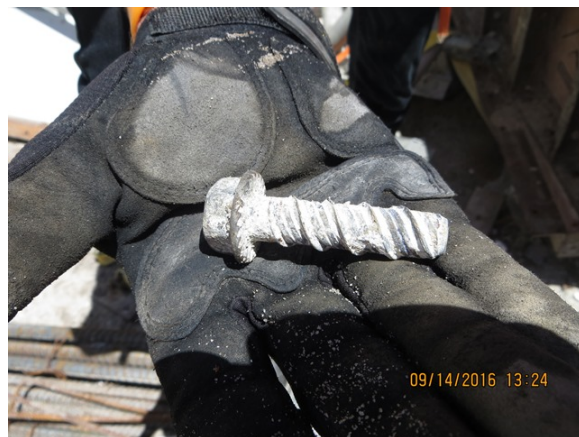
Table T27 essentially consisted of two 7 ½" deep beams – 17' and 15'-6" long. Over the beams, 5 ½" deep purlins were placed perpendicular to the beams. 5/8" plywood was placed over the purlins to form the sheathing over which concrete was to be directly placed during the concrete pour. The table was assembled on the ground with legs or posts, beams and purlins. The assembly was initially done with four legs, although three additional legs (see figure 4) were to be provided later at the time of concrete pouring. The legs were braced in two orthogonal directions by bracings (see figures 9 and 10). The table with the beams, purlins, four legs, bracings and the plywood weighed approximately 2,000 pounds. The table assembly was successfully hoisted to its final location, thereafter it was levelled, and then two hold down straps with ratchet strap screws were installed near the rear legs (see figures 9, 10). The screws pulled out of the concrete (hole in the concrete slab is shown in figure 16). One screw recovered from the debris is shown in figure 17. Other screws recovered are also shown in figures 18 and 19. It is not certain where these other screws belonged.

Fig. 17 – Wedge-Bolt Screw Anchor found in debris.

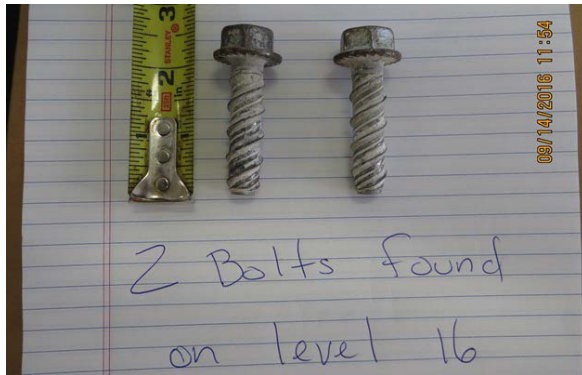
Fig. 18 – Wedge-Bolt Screw Anchor.

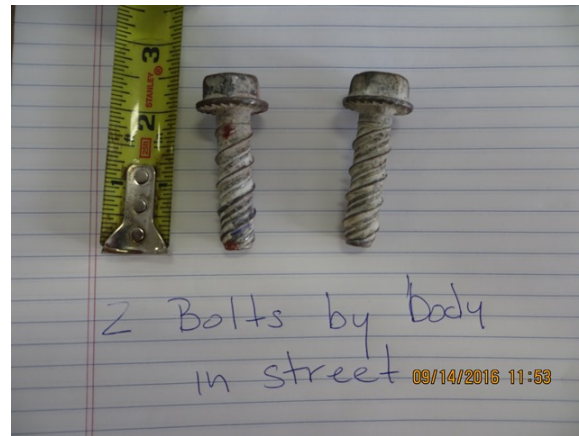
Fig. 19 – Wedge-Bolt Screw Anchor.

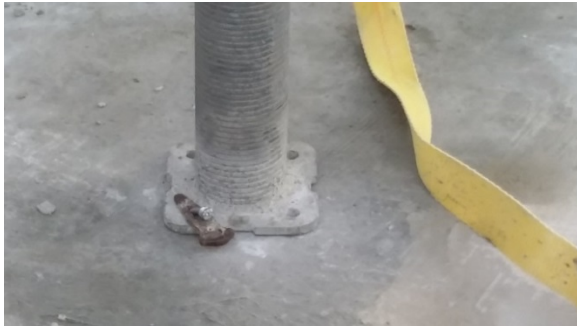
The anchorage of the legs to the concrete floor was done in a haphazard manner. Only the two front legs were anchored; the two rear legs were not anchored. The legs were provided with four holes, but only one anchor was provided in the front legs. Instead of using the required ½" diameter bolts with a minimum embedment of 2", concrete smooth nails were used as the erection crew was reported to have run out of the bolts (see figure 20 to 23). No consideration was given to the low withdrawal capacities of smooth nails. Even the embedment of the nails in the concrete slab was questionable.

Fig. 20 – EZ post anchoring.

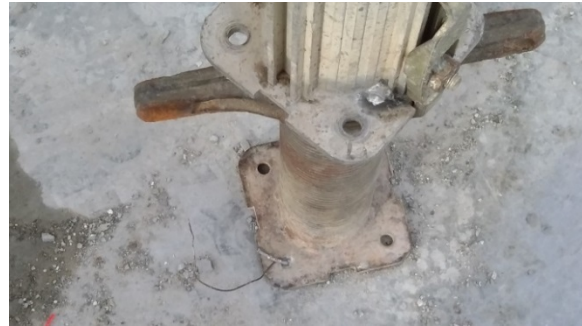
On the day of the incident, the ratchet straps were anchored to the concrete floor using a ½" diameter Powers wedge-bolt screw anchor with a 2" embedment, a deviation from the best practice document, see figures 24 and 25. The crews also ran out of the screws and substituted cement nails for a few tables to anchor the EZ posts (see figures 21 and 23).

Fig. 21 – EZ post anchoring with nails.

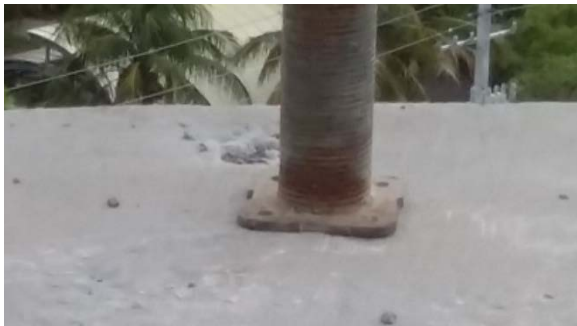
Fig. 22 – EZ post anchoring. (no screws)

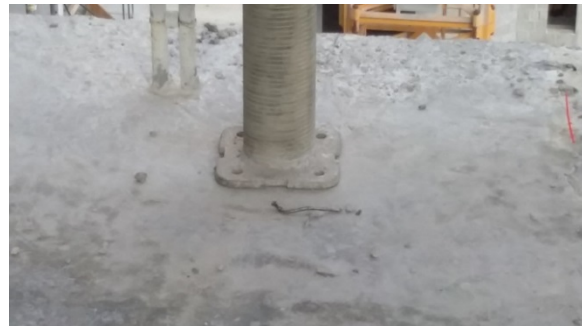
Fig. 23 - EZ post anchoring. (see the nail)

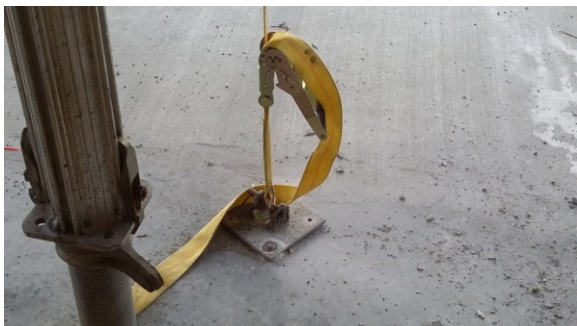
Fig. 24 – Ratchet Strap anchoring.

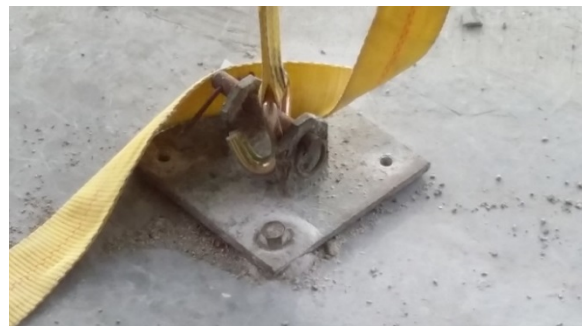
Fig. 25 – Ratchet Strap anchoring.

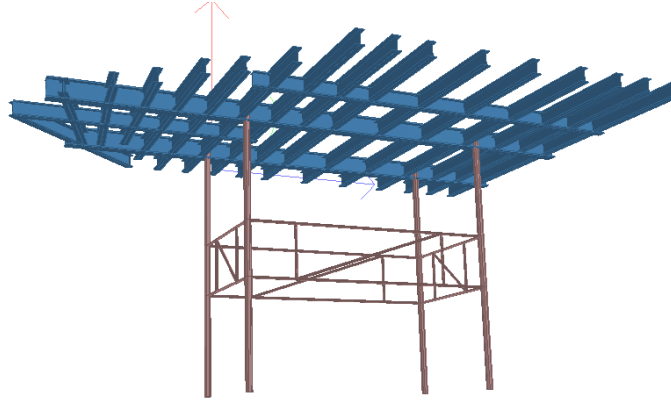
Fig. 26 – 3D model of Table T27. (see the front and side overhangs)

- 2) The 16 ft. x 12 ft. formwork table was unsymmetrical, and had 6 ft. cantilever projections on two sides due to architectural requirements. The gust of wind produced an uplift force on the rear legs, bouncing the formwork off the floor.

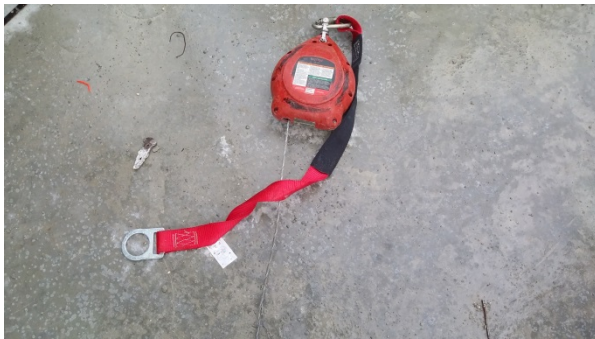
Fig. 27 – Snapped PFAS.

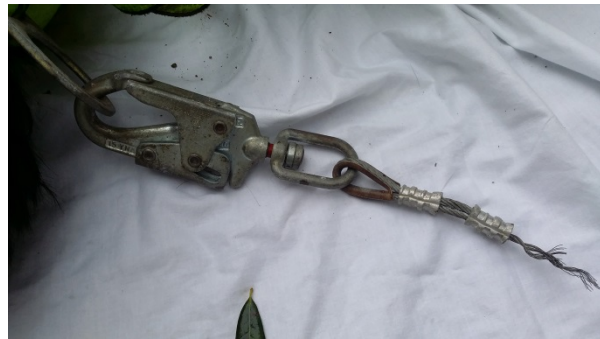
Fig. 28 – Snapped PFAS.

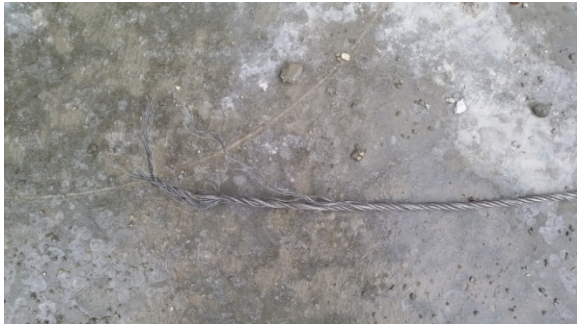
Fig. 29 – Snapped PFAS.

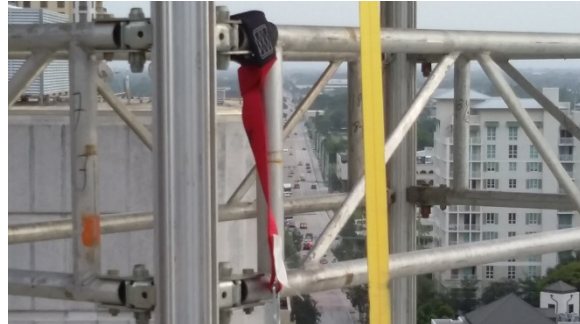
Two employees anchored their fall protection arrest system to the bracings of the nearby formwork tables (see figures 30 and 31) without ascertaining the capacity of the bracings to withstand a force of 5,000 pounds. The formwork tables were not properly designed to resist lateral loading and the legs were not anchored properly.

Fig. 30 – PFAS tied to the bracing of a table.

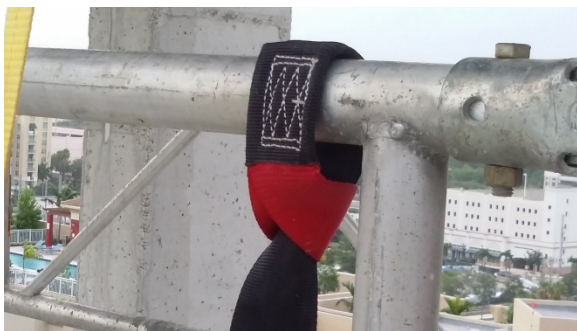
Fig. 31 – PFAS tied to the bracing of a table.
