Investigation of the October 19, 2016, Collapse of Two Scaffold Platforms during Climbing in Miami, Florida

U.S. Department of Labor
Occupational Safety and Health Administration
Directorate of Construction

April 2017

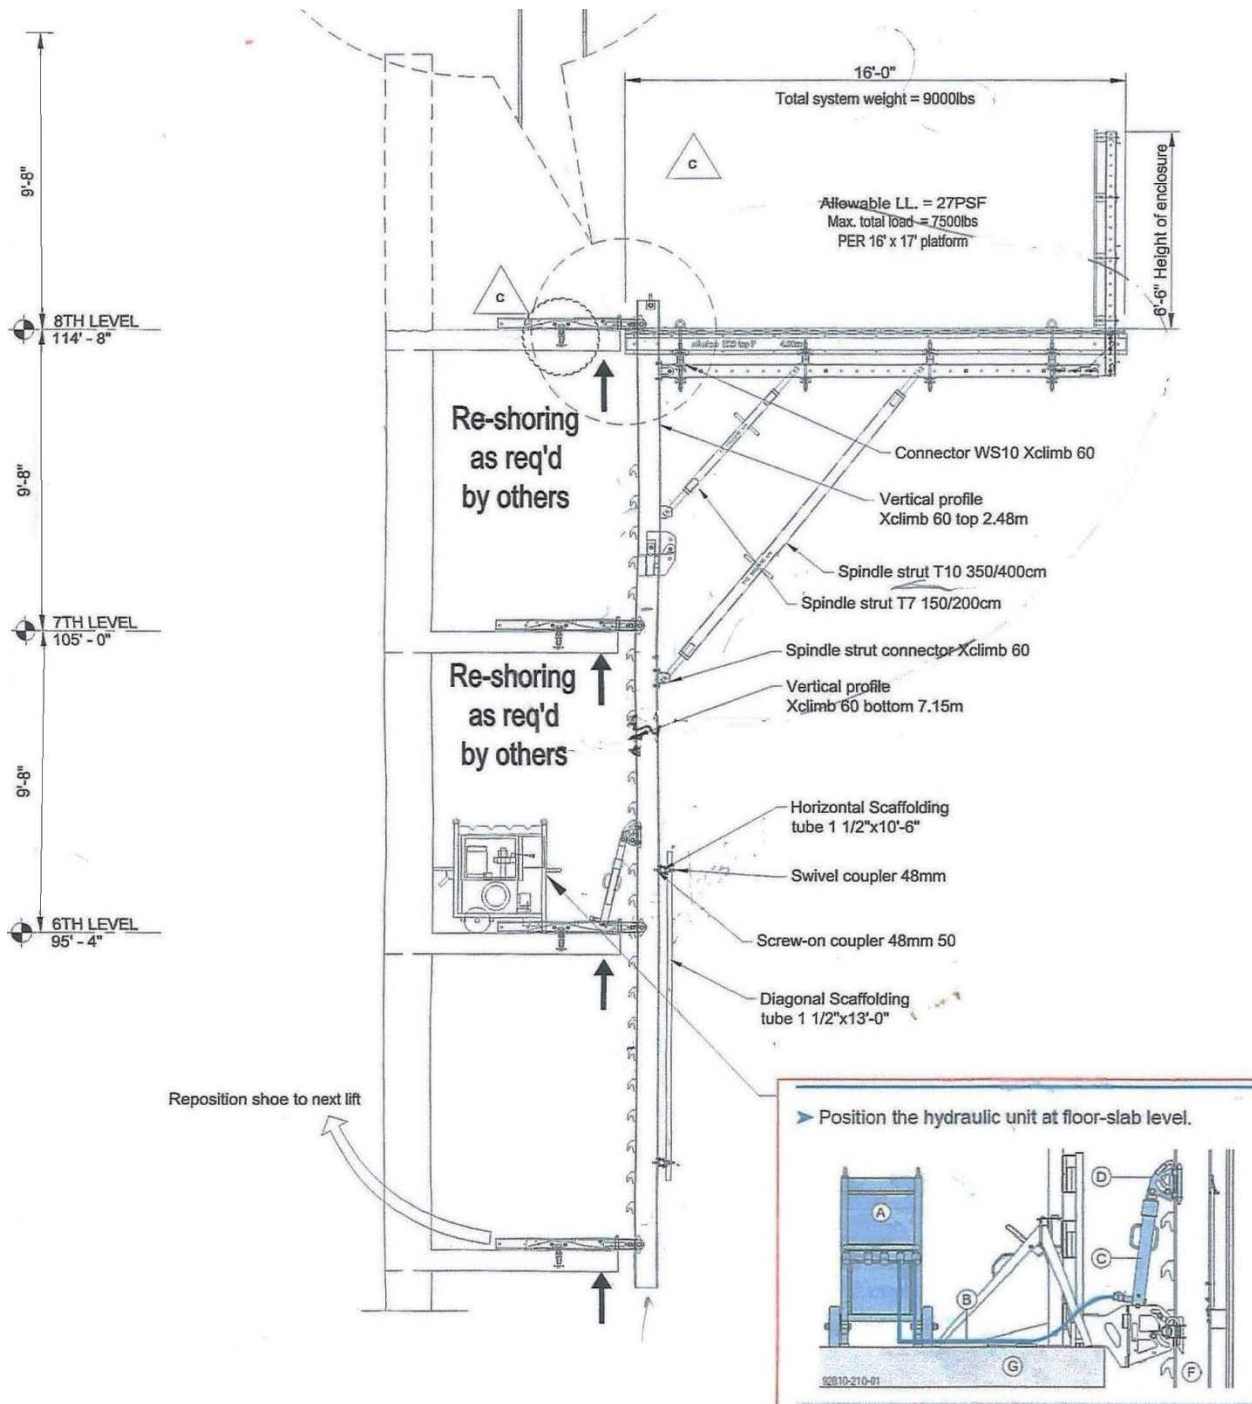
Fig. 4 – Typical section of the scaffold and hydraulic unit (from sheet 1530)

The drawing sheet 1530 of 4/21/2015 with latest revisions on 1/8/16 prepared by Doka (see figure 4 and appendix), indicated that the allowable live load on the platform was 27 psf. The height between the floors was shown by Doka as 9'-8". The drawing also indicated that “*X-climb 60 Loading Platform must be in MINIMUM 2 Slab shoes while climbing/repositioning*” and “*X-climb 60 Loading Platform must be in MINIMUM 3 Slab shoes in working condition.*”

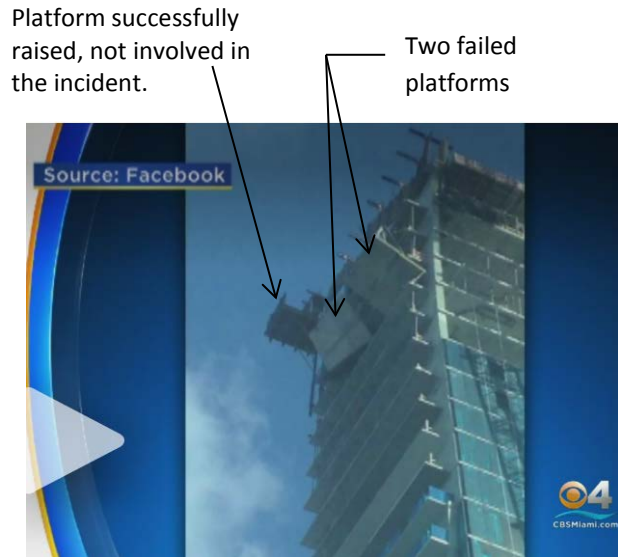
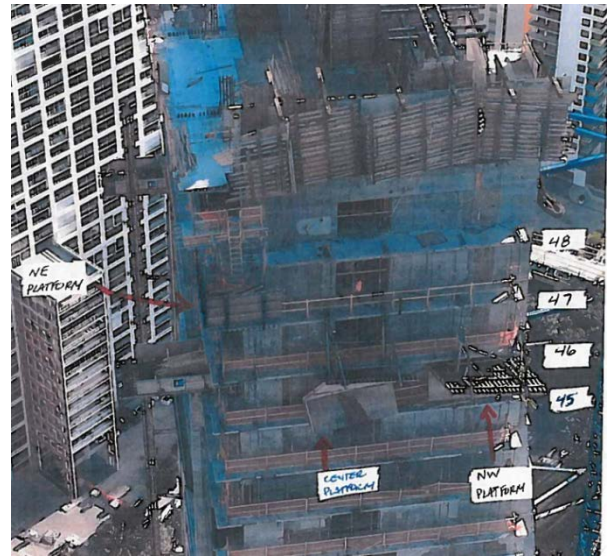
Before the incident, the crew had successfully raised the smaller platform by hydraulic climbing to the 48th floor and the platform was in a stationary position. As required, it was anchored with the slab shoes at three locations at the 46th, 47th and 48th floors. CECO then decided to hydraulically climb the larger two scaffolds together, with materials spanning between them, in a synchronized manner. The hydraulic jacks were positioned on the 46th floor. During hydraulic climbing, both scaffolds failed and the scaffolds rotated almost 135 degrees (see figures 9 to 12).

Taken from CBS Miami
Fig. 9 – Failed platforms

Fig. 10 – Failed platforms

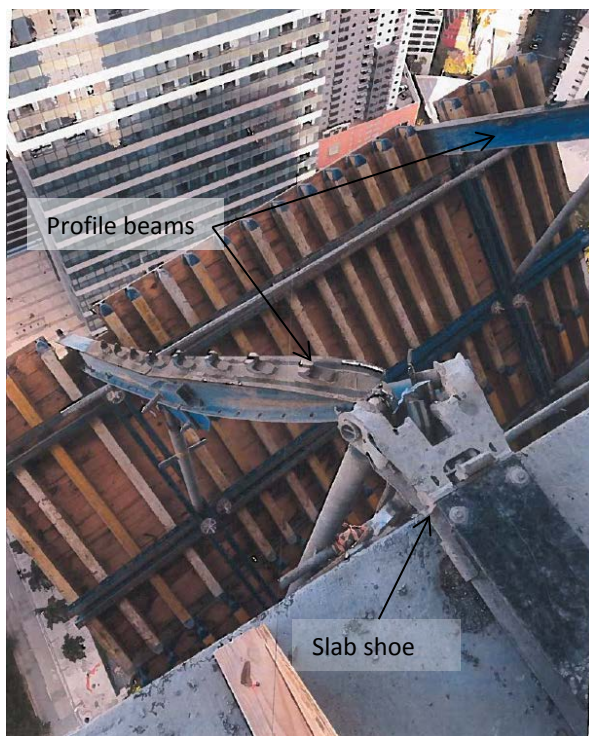
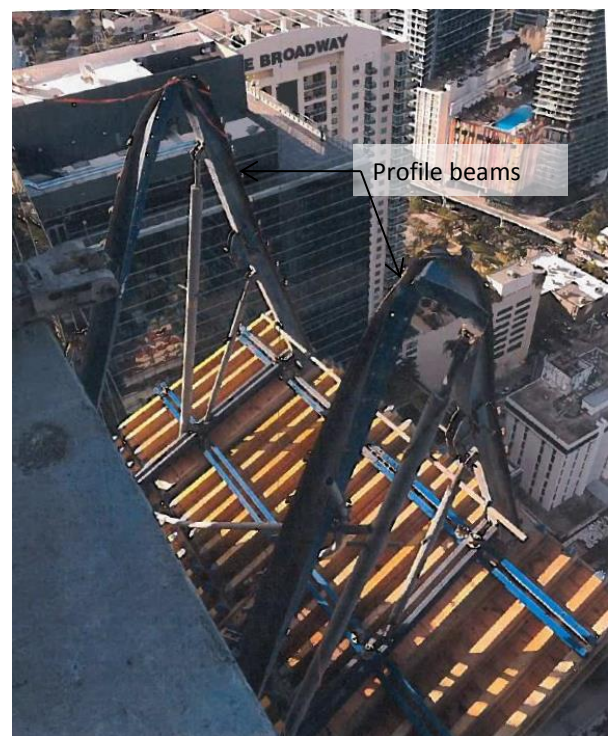
Fig. 11 – Failed platform

Fig. 12 – Failed platform

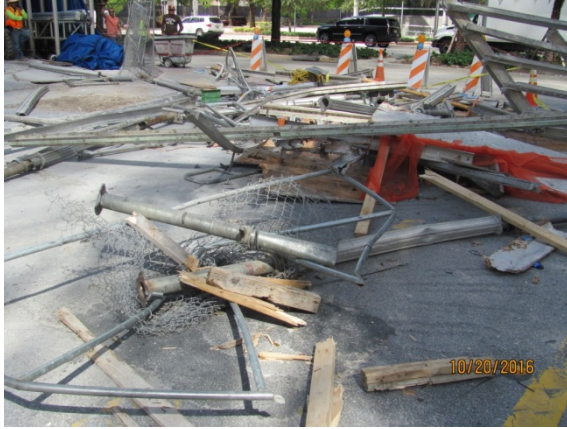
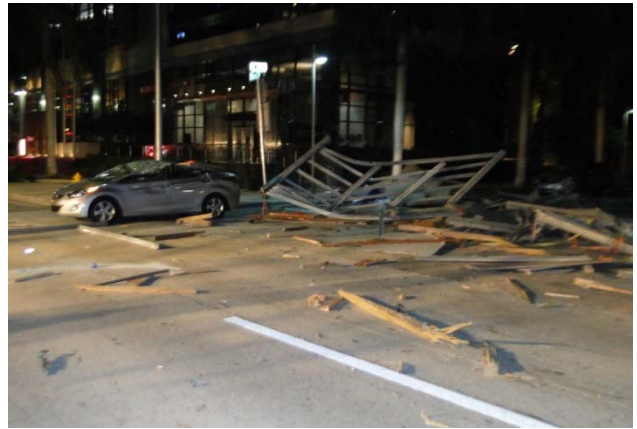
Both scaffolds had already climbed more than 13 feet and the scaffolds were almost at the 48th floor, but did not quite reach to the 48th floor. The materials on the two scaffolds, weighing approximately 13,000 pounds, fell to the ground, see figures 13 and 14. The failed scaffolds (see figures 15 and 16) were brought down later with a crane.

Fig. 13 – Materials on the ground

Fig. 14 – Materials on the ground

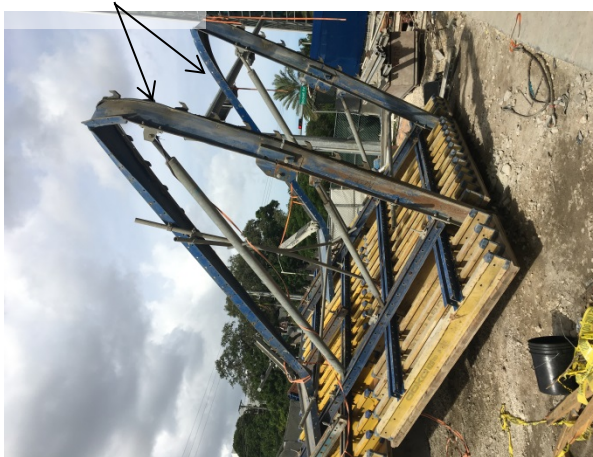
Fig. 15 – One of the failed platforms

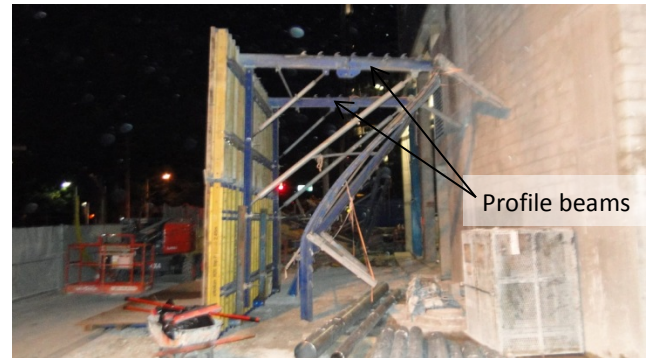
Fig. 16 – Other failed platform

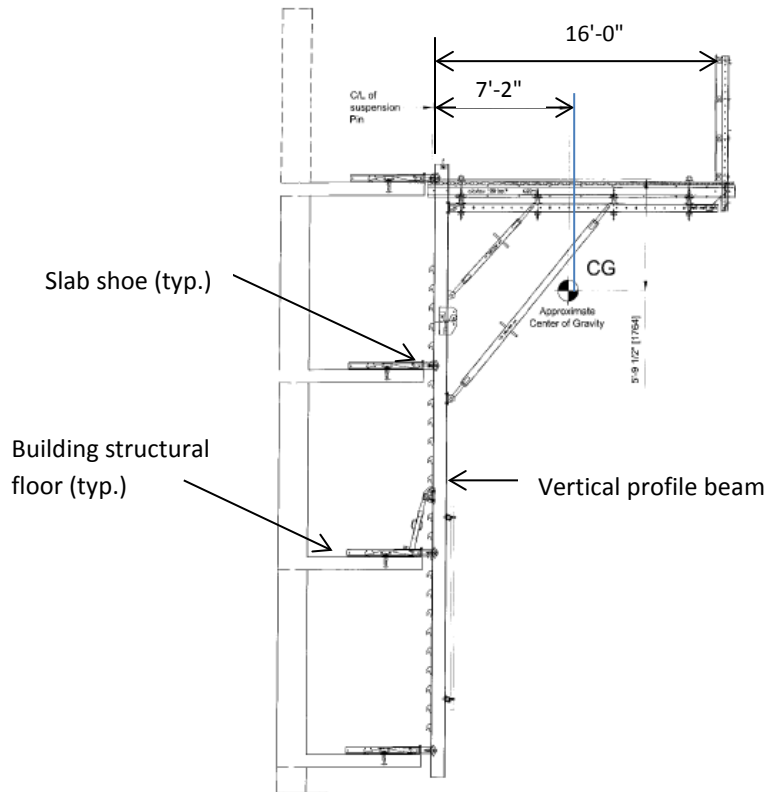
Fig. 17 – Self-weight of platform and CG obtained from manufacturer

After the incident, Doka provided the material list for the scaffold assembly, and it indicated that the weight of a type B scaffold was 8,183 pounds and the approximate center of gravity of the assembled scaffold was about 7'-2" from the edge of the vertical profile beam (see figure 17).
