**STRUCTURAL COLLAPSE AT THE
OLYMPIC SWIMMING VENUE
ATLANTA, GEORGIA
MARCH 18, 1996**

U.S. Department of Labor
Occupational Safety and Health Administration

June, 1996

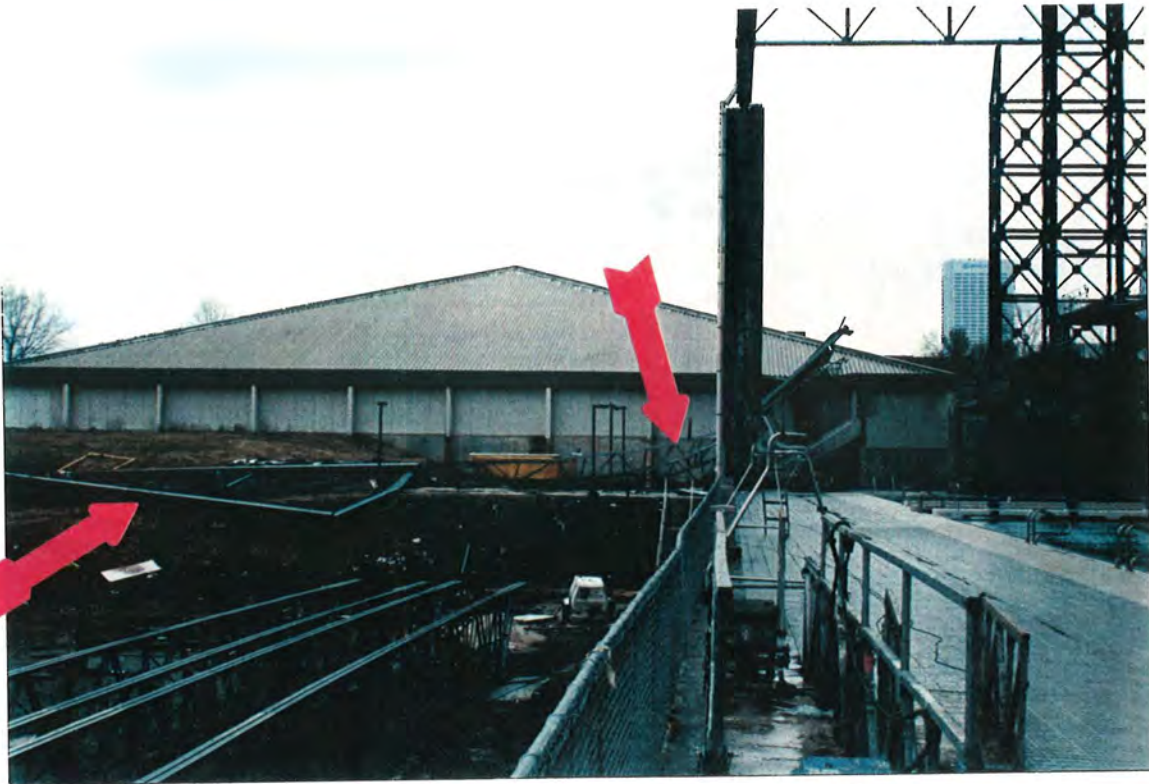
Failed Steel Joists and Frame (Arrows)
(Looking east; Existing pool on right, Student Gymnasium in background)
Figure 1.1

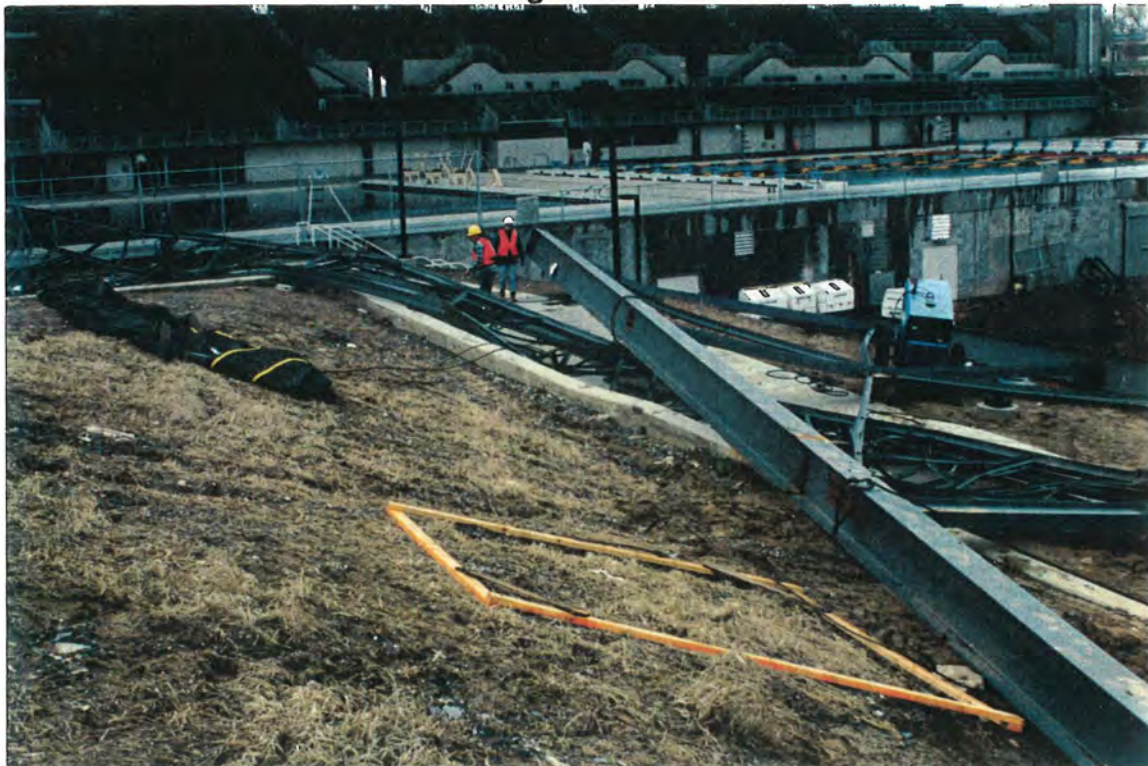
Frame and Paired Joists on Ground
(Looking south-southwest; Existing pool in background)
Figure 1.2

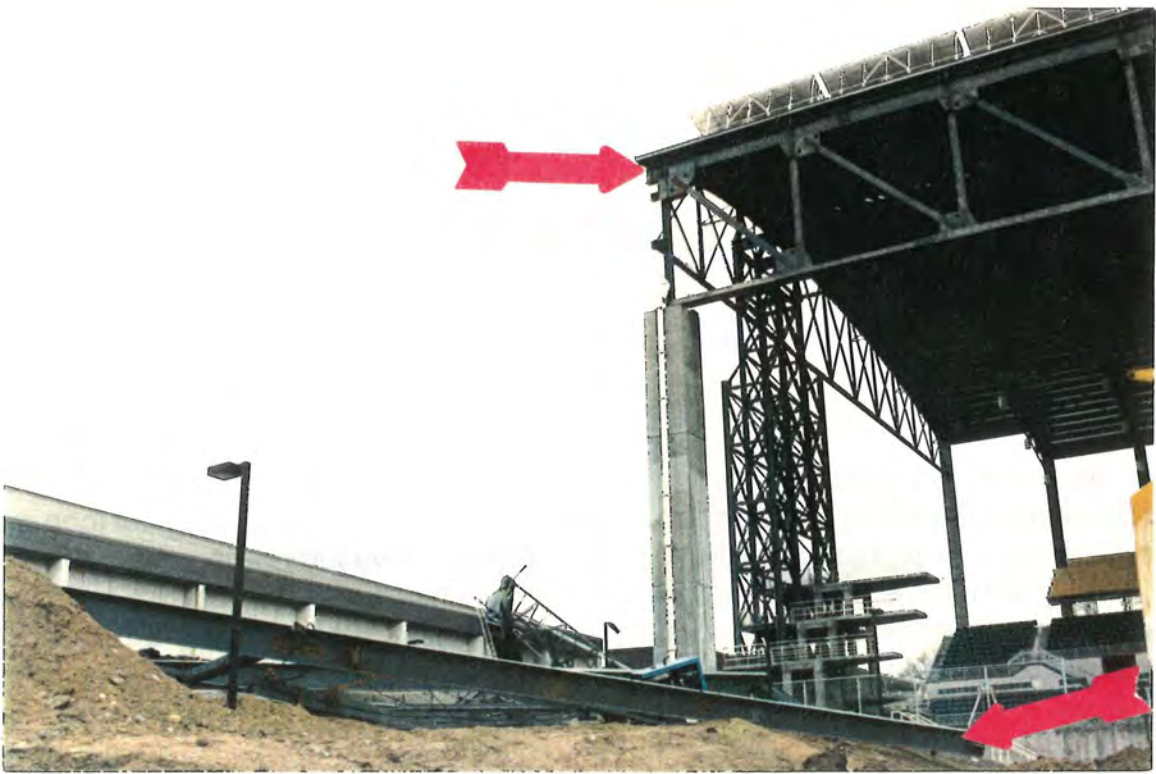
Failed Joists Supports - Frame on Ground & Existing Roof Beam (Arrow)
(Looking south-southeast)
Figure 1.3

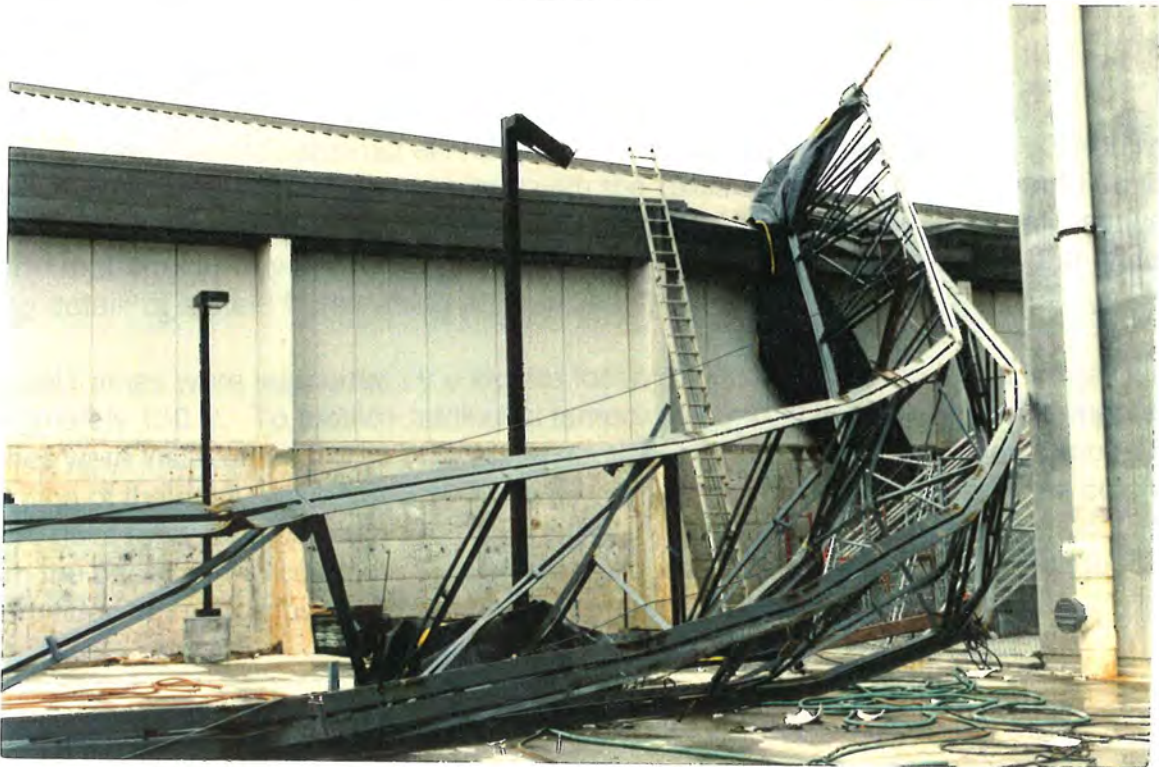
South End of Collapsed Joists Resting On Roof of Student Gymnasium
(Looking southeast)
Figure 1.4

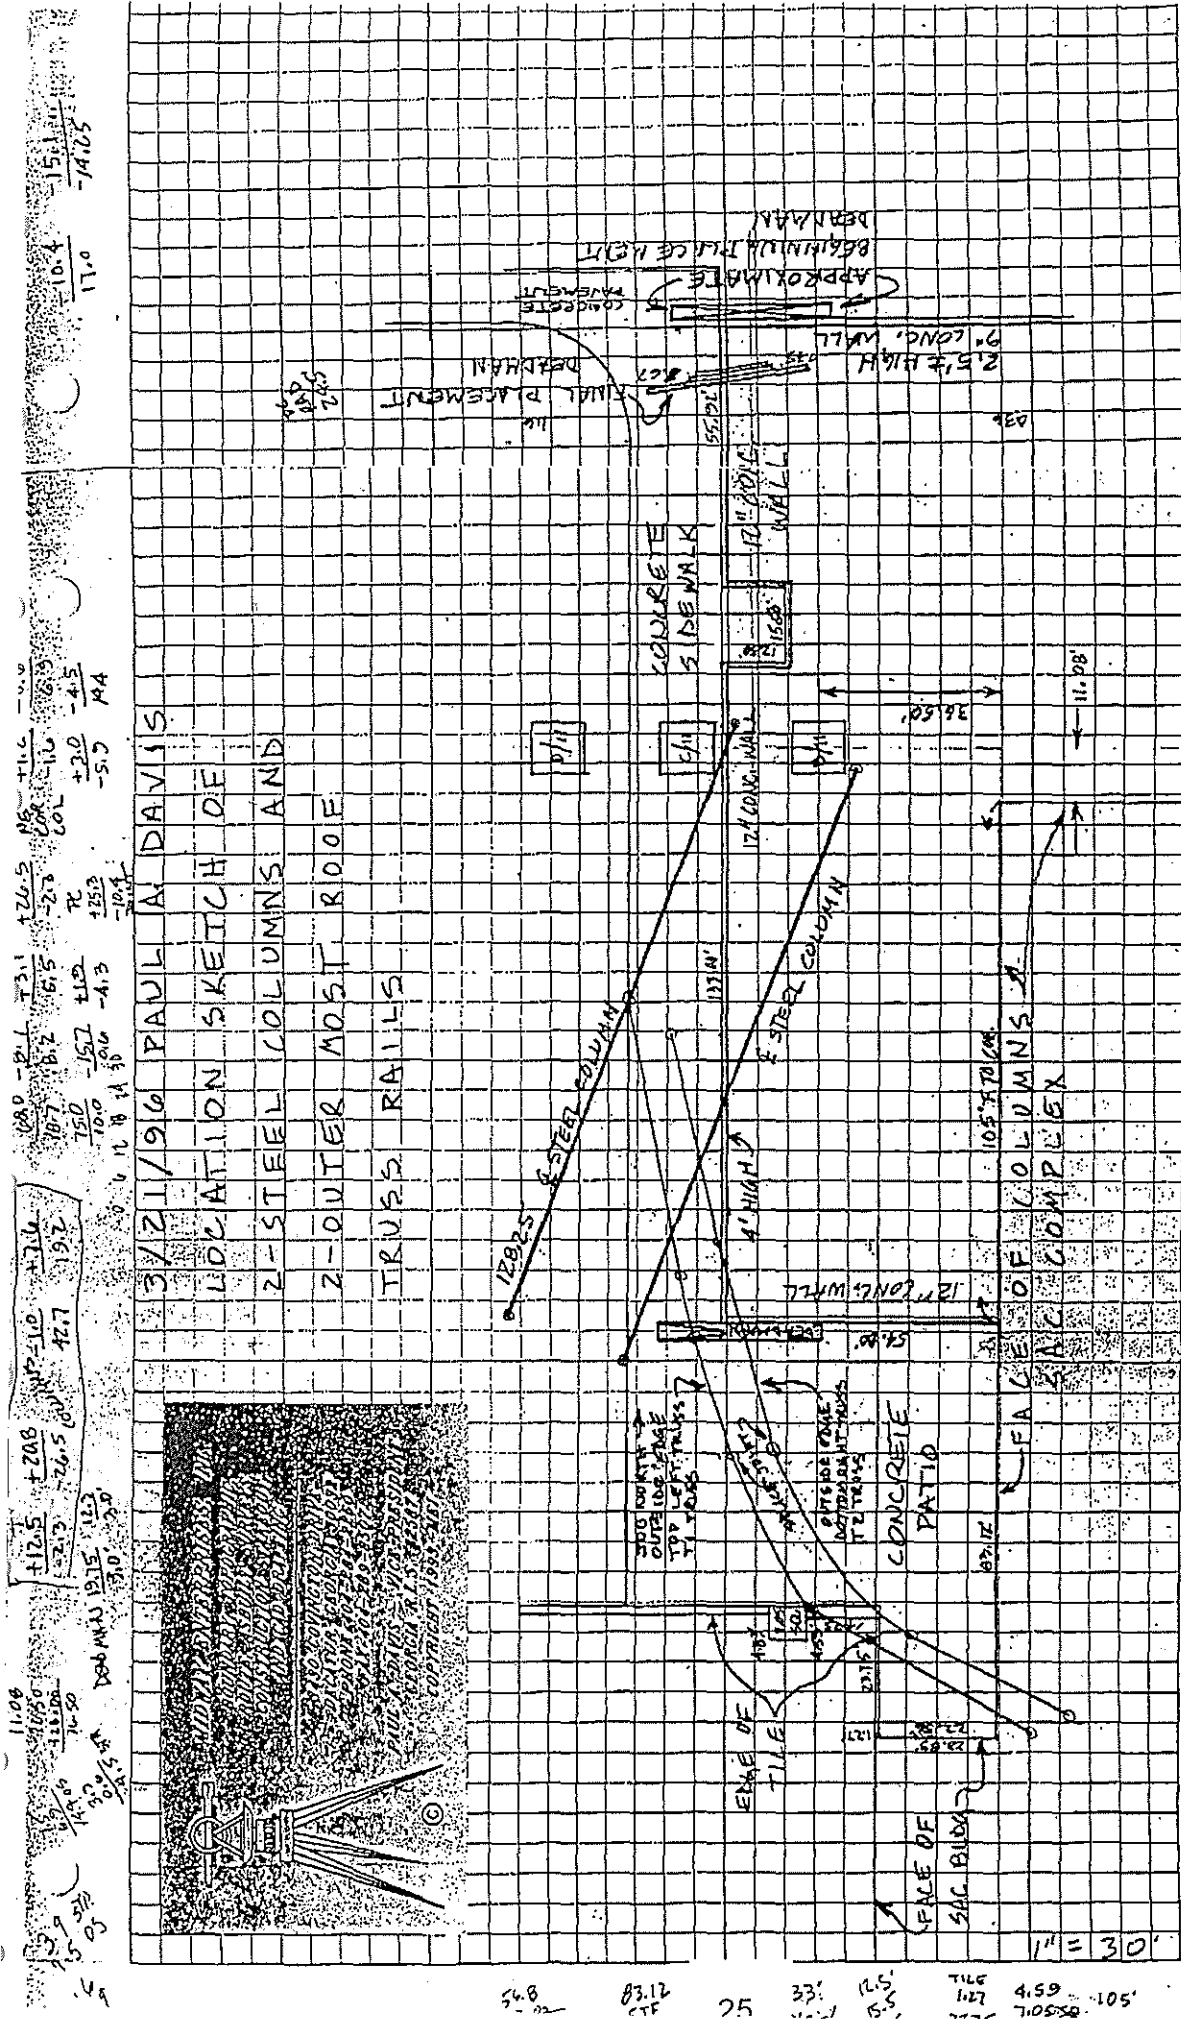
Figure 5.1 - Post Event Survey of Collapsed Structure

The post event site evidence showed that the failed structure had collapsed in such a manner that the paired joists appeared to have bowed near midspan and the ends of the joists translated after their connection to the supports failed. Figure 5.1 is a post event survey⁶ of the collapsed structure. The south end of the paired joists was located on top of the Student Athletic Gymnasium about 30 ft. south and 20 ft. east of its original location. The north end of the paired joists ended in a position on the ground, approximately 50 ft. south and 30 ft. west of its original location. The center of the paired joists moved about 25 ft. south and 5 ft. west. A photo montage of the failed structure is shown in Figure 5.2. Figure 5.3 shows two photographs of the failed structure with the south end resting on the Student Athletic Gymnasium. Figure 5.4 shows two photographs which include the midspan and north end of the paired joists and the position of the south deadman.

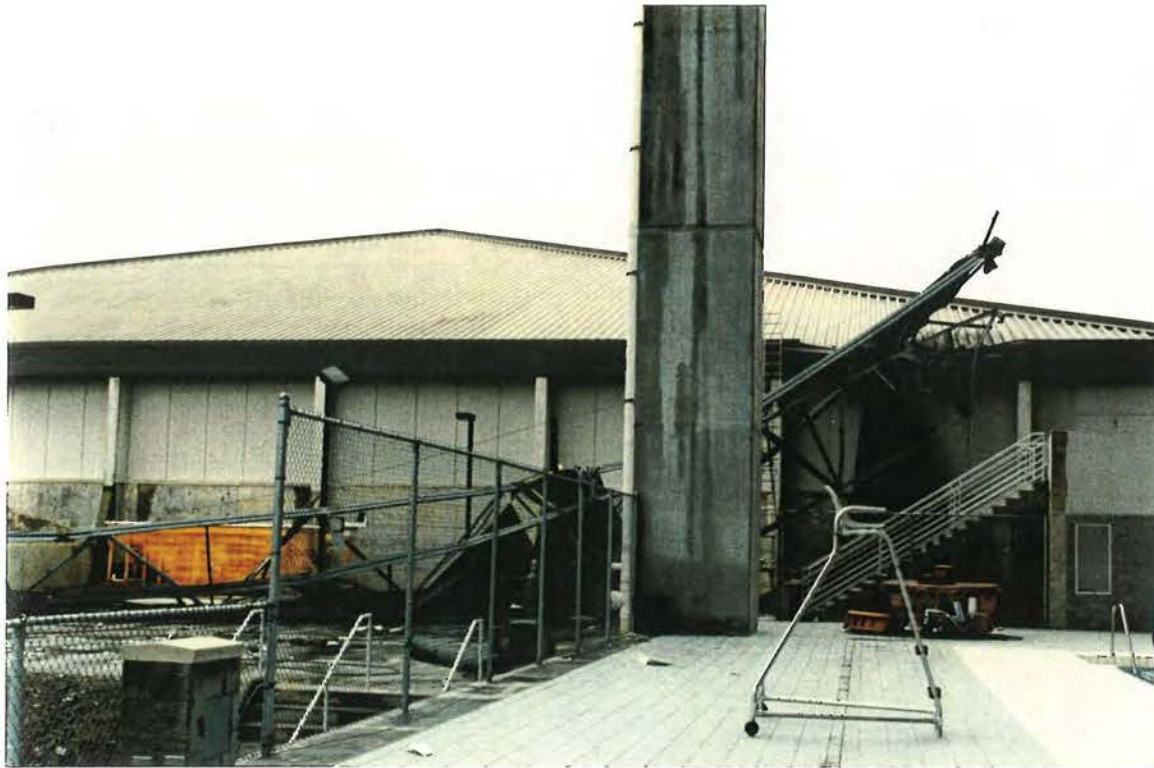
Figure 5.3

**Failed Paired Joists Resting On
Top of Gymnasium**

Top Photo (Looking East)
The Original Location of T2 Joist South
End was Directly on Top of the
Concrete Column.

Bottom Photo (Looking Southeast)
Paired Joists From South End to About
Midspan. Arrow Shows T2 Top Chord

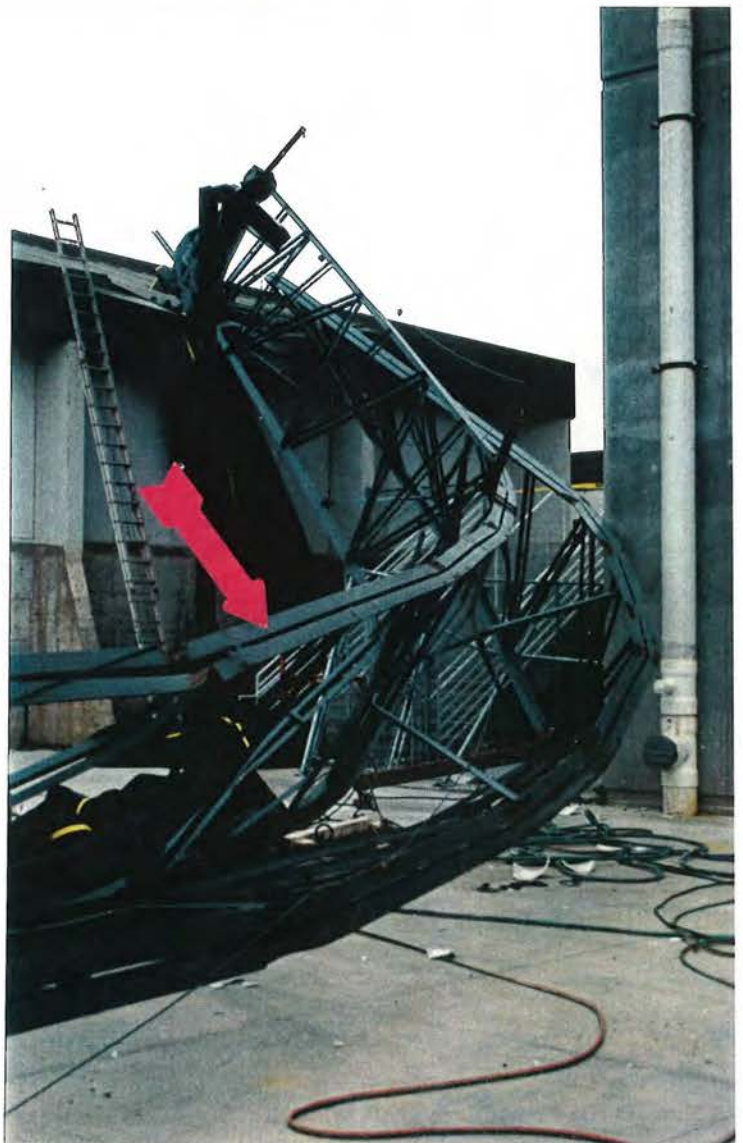
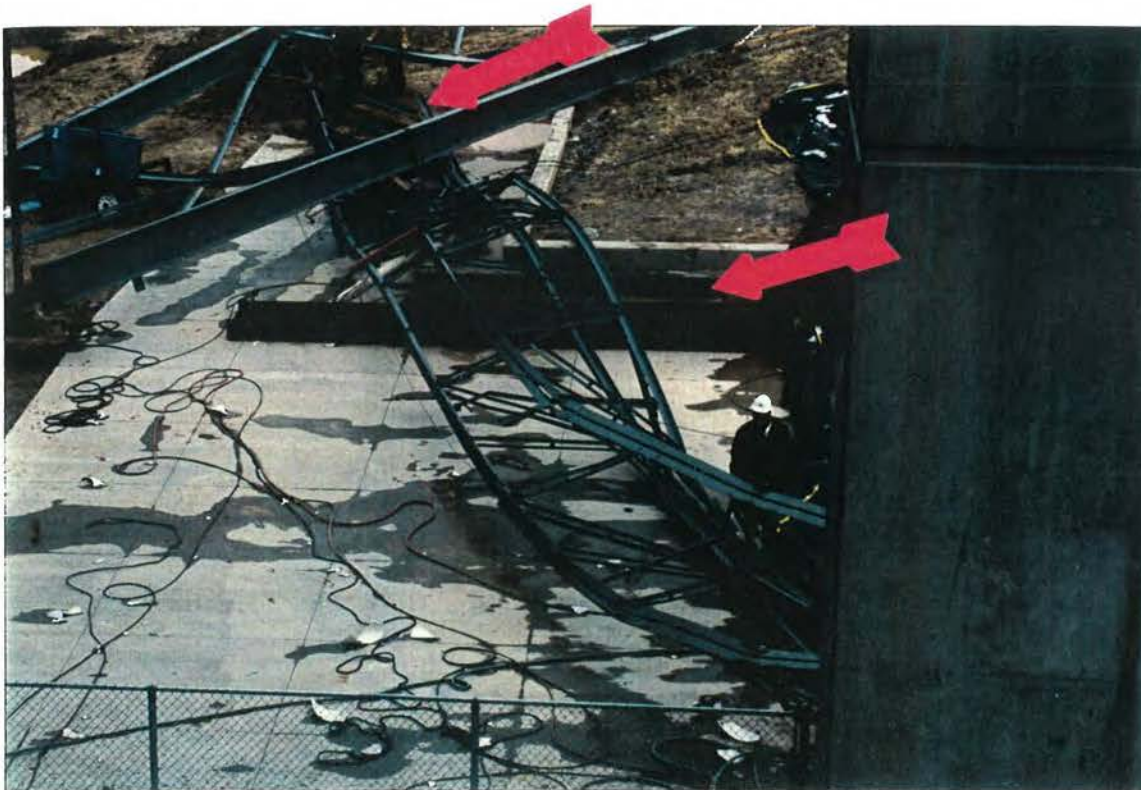
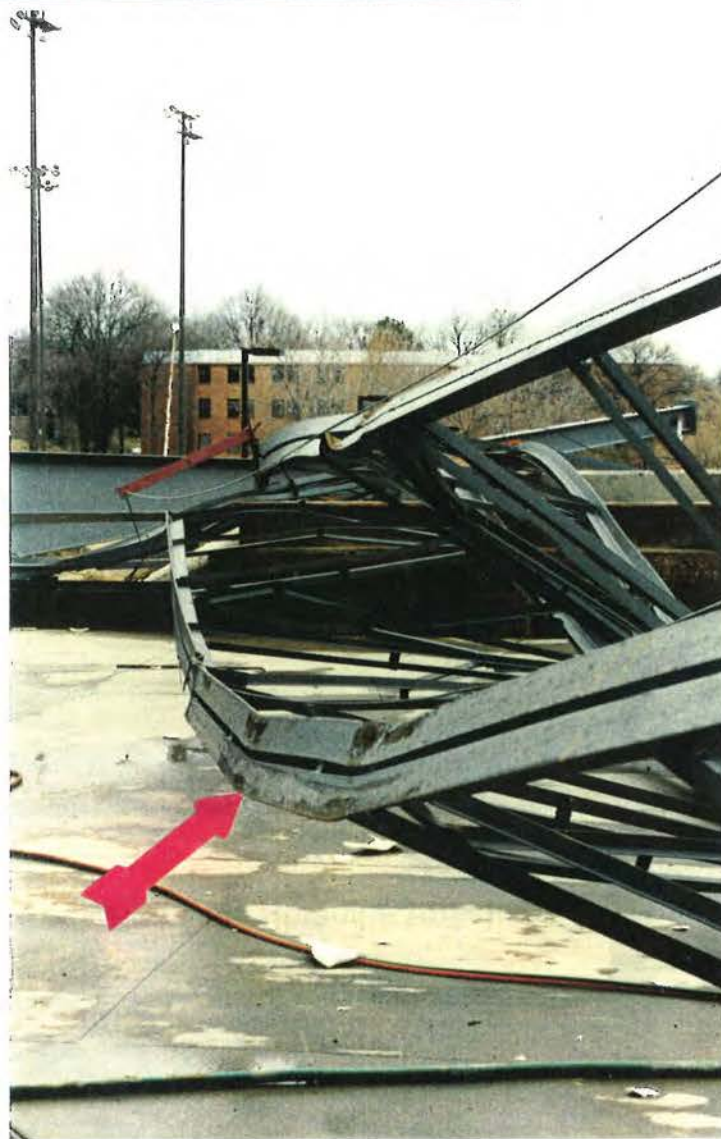
Figure 5.4

Collapsed Structure

Top Photo (Looking North-Northwest)
 North Section of the Failed Joists.
 Arrows Show North End of Paired Joists
 and South Deadman.

Note: The Steel Frame Laying Across
 the Joists Was Pulled Over After the
 Event.

Bottom Photo (Looking North)
 Midspan Section of Failed Joists
 Arrow shows T1 Top Chord.

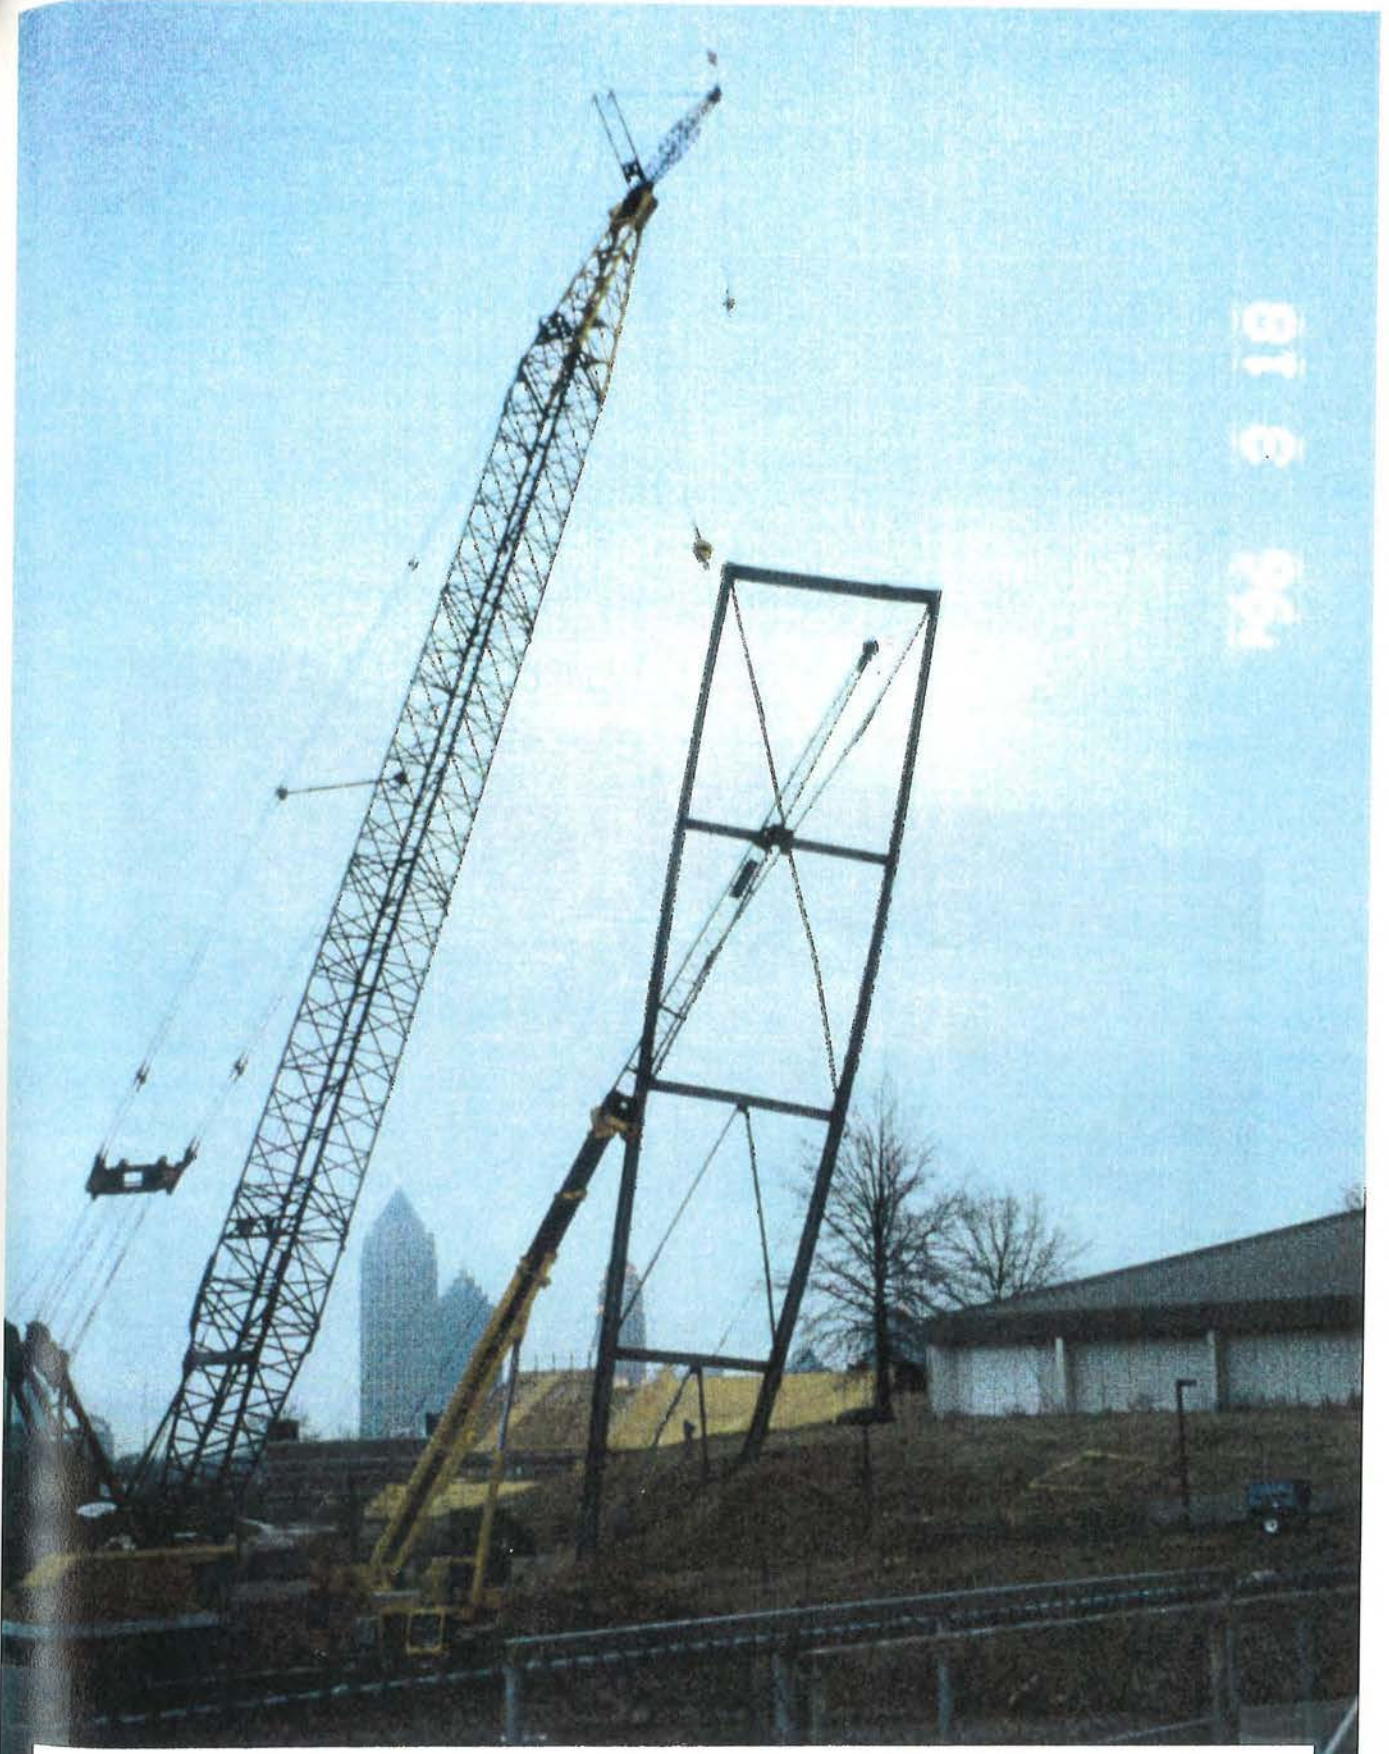
The steel frame did not completely collapse as a result of the joists failure. Column 11B deflected from its base with respect to its longitudinal axis, in a southeast direction about 20 degrees. Column 11C deflected in the same manner about one-half the deflection of 11B. Figure 5.5 shows the position of the steel frame after the collapse. The crane which was moved and rigged to the steel frame apparently to provide additional support for the structure at column 11C. This may have prevented the total collapse of the frame during the event.

Figure 5.5 - Post Event Disposition of Frame With Crane Hoistline Attached

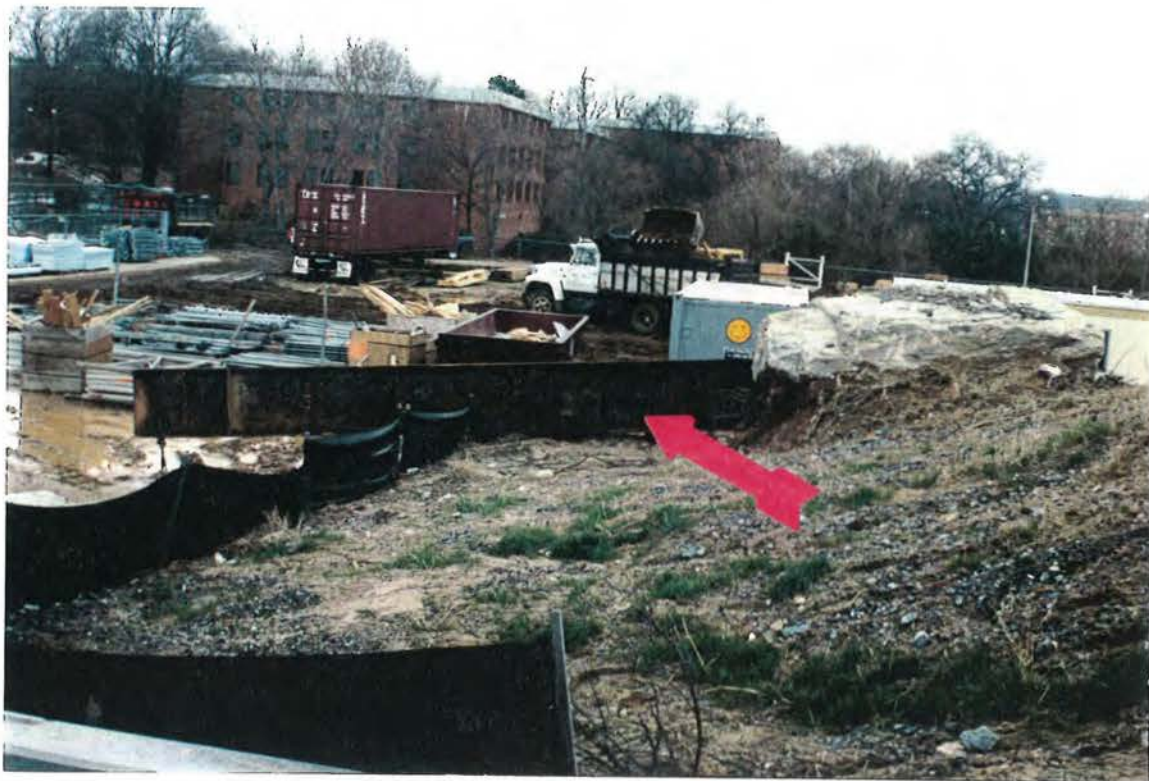
North Deadman's Post Event Location
(Looking North - Arrow shows deadman)
Figure 5.6

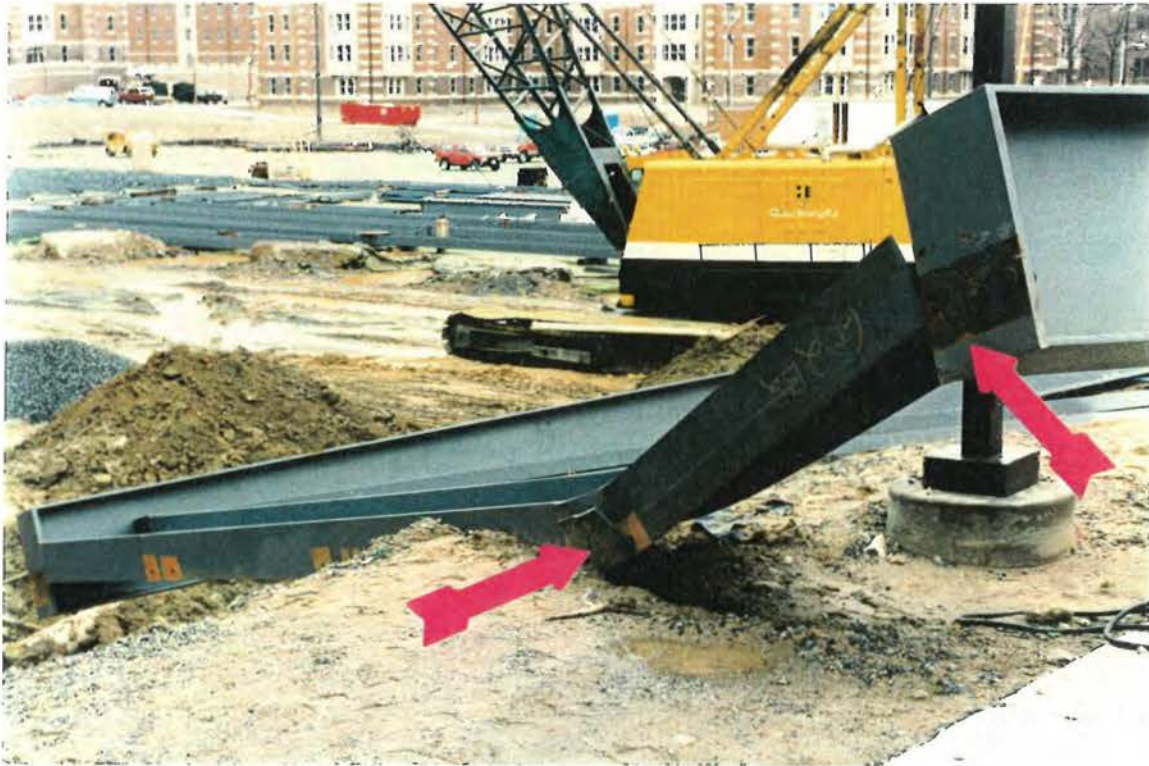
Figure 5.7a

Looking Northwest, Showing the
2 Failed Joist Bearing Connection,
T1 Joist Bearing on Left. T2 on Right.

**Failed Joists Bearing Connections
On Top of Steel Frame**

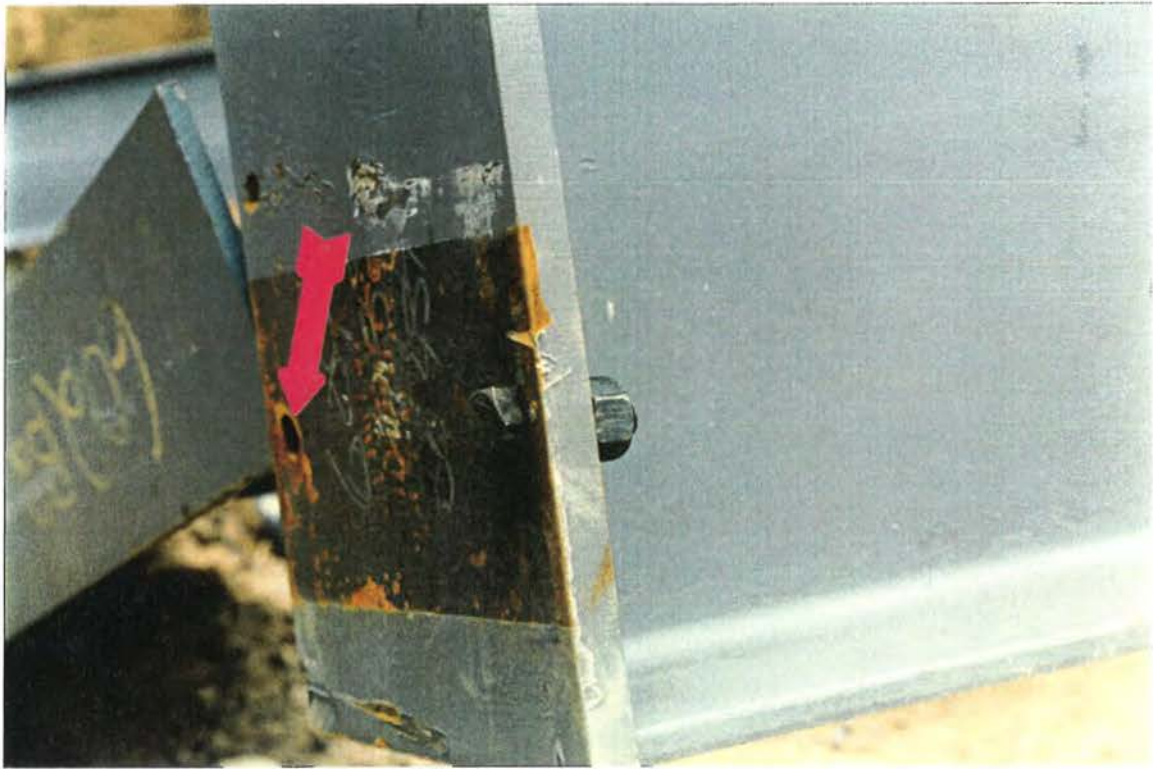
T2 Joist Bearing. Arrow indicates location of the failed bolt.

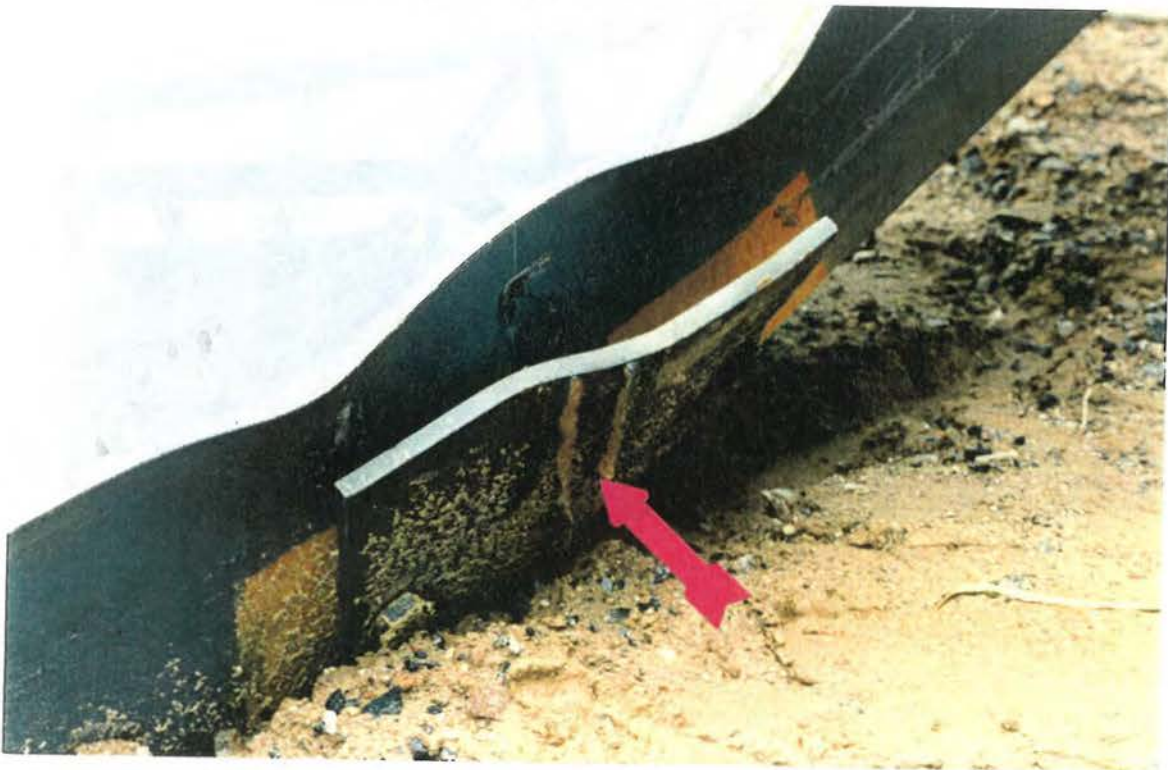
T1 Joist Bearing. Arrow shows location of failed weld on bearing plate.

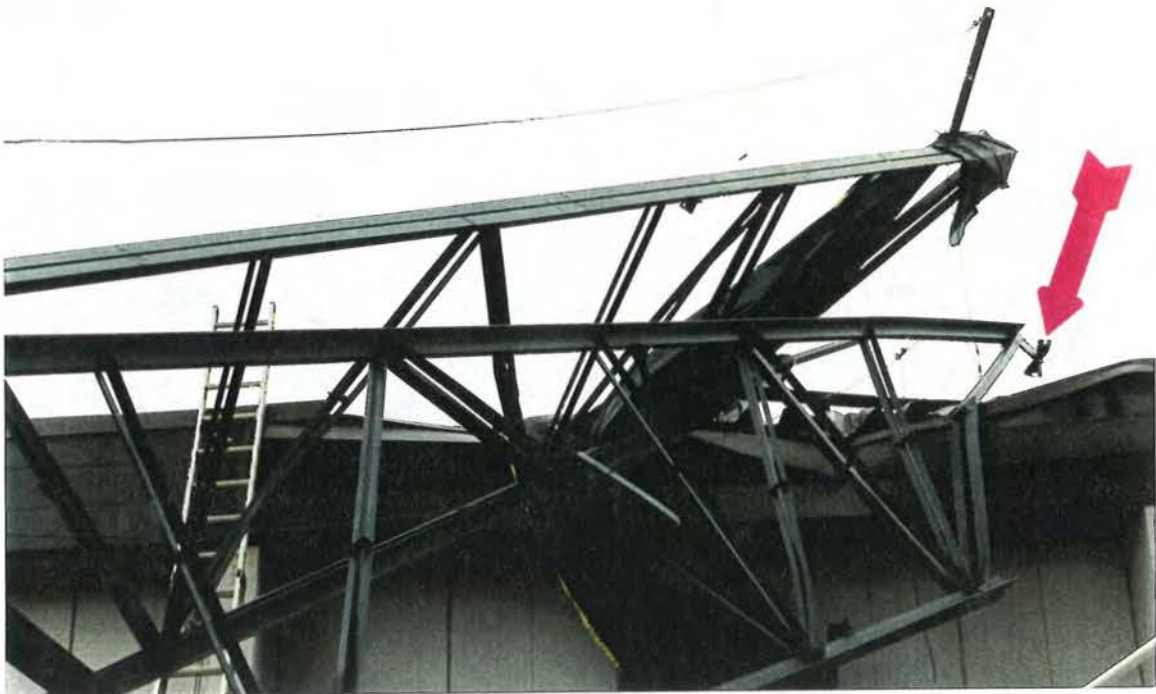
Bearing Plate Support at South End of Failed Joists (Arrow)
(Looking - Southwest)
Figure 5.8

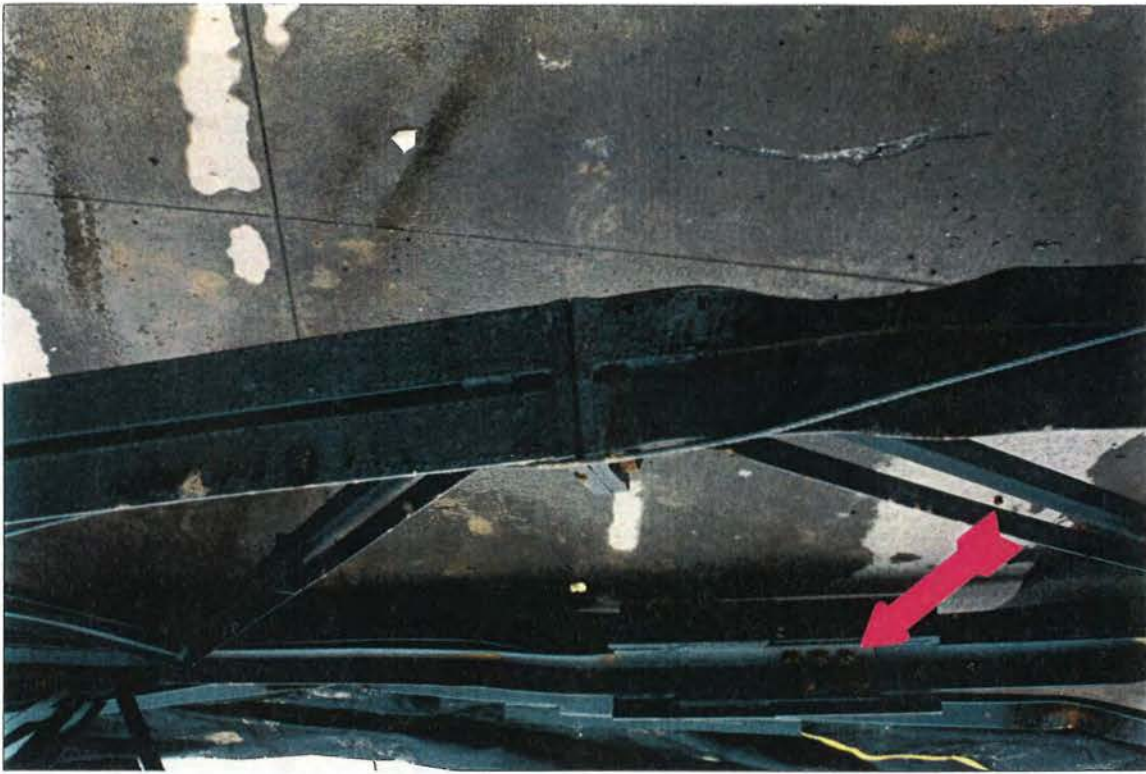
Each joist is fabricated and shipped to the site in one-half sections. The joists are bolted together at center splices in the top and bottom chords after they arrive on-site. Both the top and bottom chord splices exhibited no apparent damage as a result of the failure. However, top chord members were buckled at near the center spliced location. Figure 5.9 shows the center splices and buckling in the top chord.

Top & Bottom Chord Center Splices
(Looking West - Arrow Shows Bottom Chord Splice)

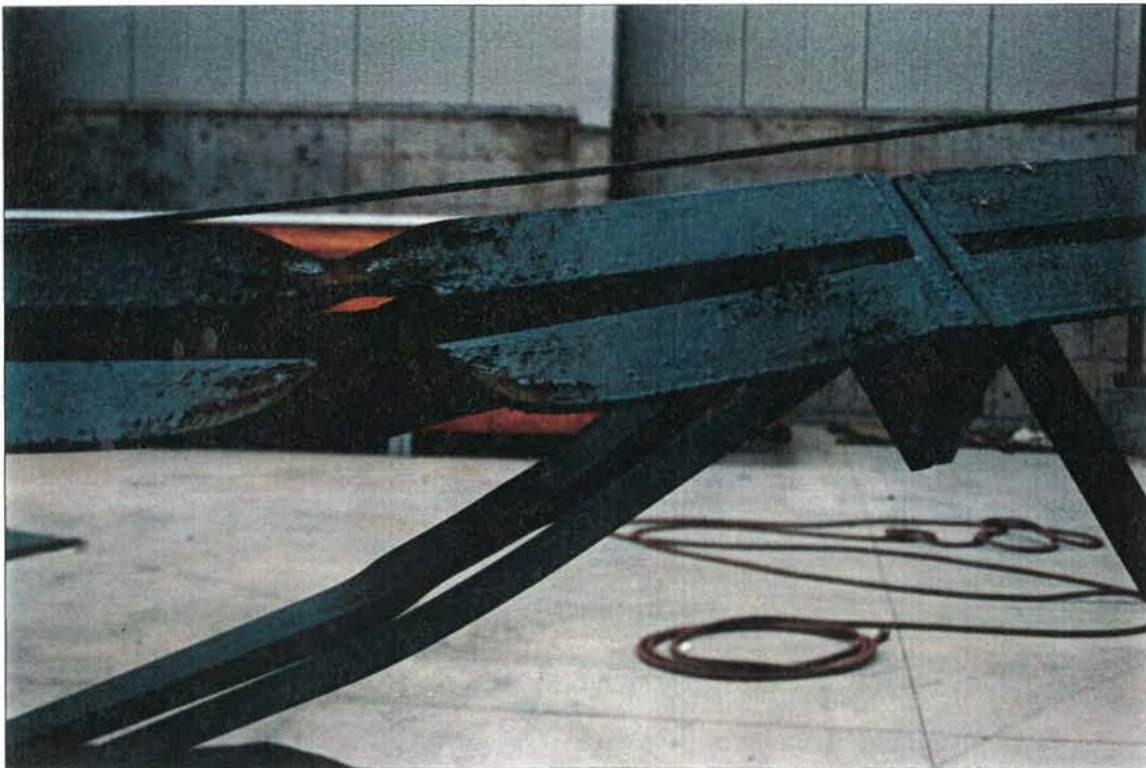
Buckling in Top Chord
(Looking West)
Figure 5.9

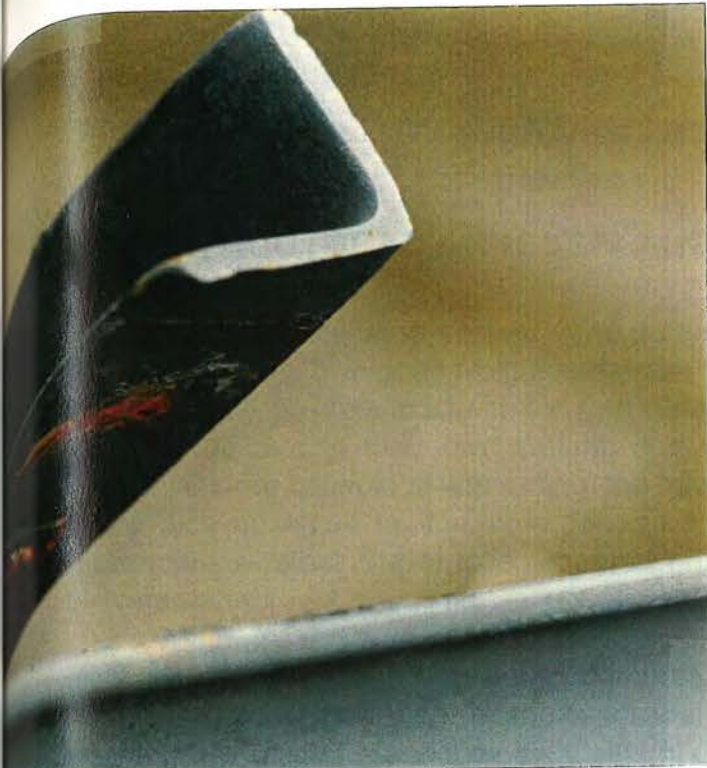
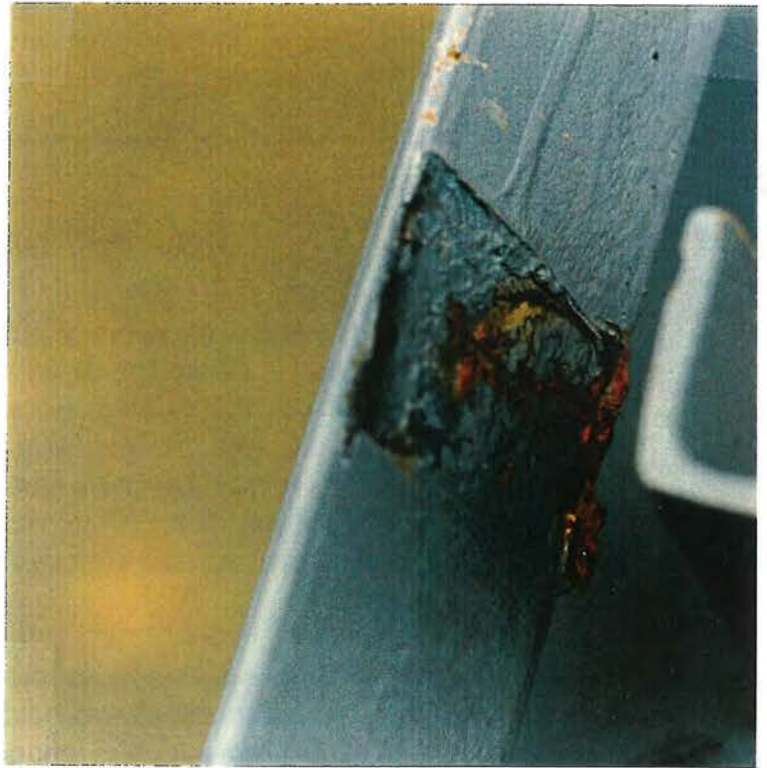
Visual examination revealed that many welds had failed during the event. Figure 5.10 shows fractured welds in spacers located on diagonal members between the top and bottom chords, and a spacer located between main chords of the joist. The exact locations of the fractured and/or broken welds were identified by a Testing Lab, and their impact to the integrity of the paired joists will be discussed in Structural Analysis and Discussion Chapter.

Fractured Welds in Diagonal Member Spacers Between Top and Bottom Chords

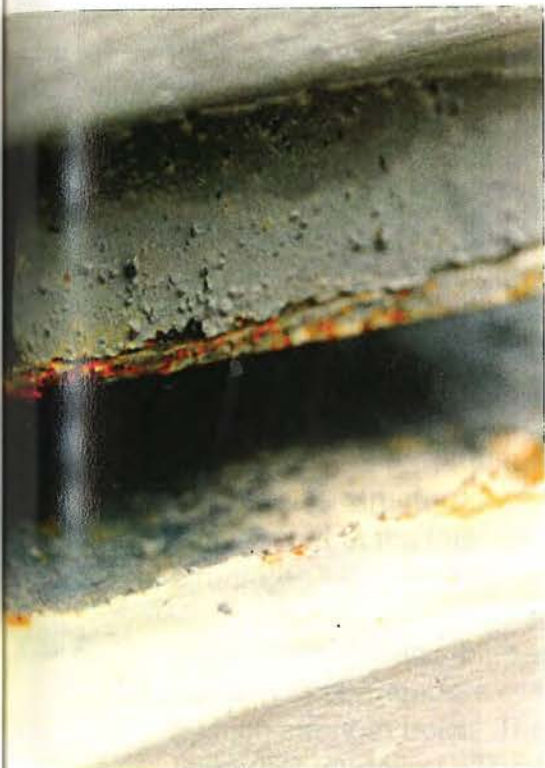
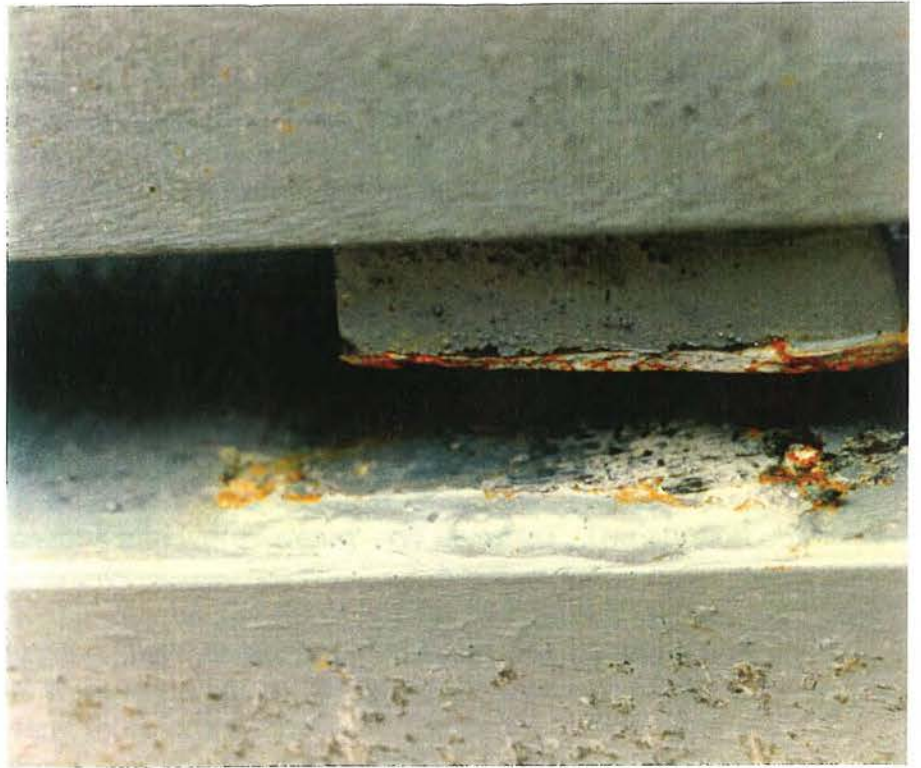
Figure 5.10

Fractured Weld in a Spacer Between a Joist Chord

- (2). It was reported that several of the spacer bars placed between the top chord angles were improperly welded. Due to the flaws in the welds, an attempt was made to determine whether the flaws contributed to the collapse. The exact locations of such spacer bars on the failed joists were identified by a testing Lab, see Fig. 6.6.- Excerpt from Report of Materials Testing and Evaluation⁸. The same Testing Lab also identified the fractured and/or broken welds of the spacer bars on the failed paired joists, see Addendum to the Report. It is stated in the Report's Addendum that "At the time of our inspection, we did not attempt to distinguish between welds that failed due to the collapse and welds that may have failed causing the collapse". (Appendix C-Lab Report and the Addendum). By eliminating all spacer bars of the above identified broken/fracture welds locations, our analyses indicated that the paired joists were capable of supporting their own dead weights if the bridging lines have been properly anchored. And It further indicated that with three consecutive spacer bars improperly welded (assumed missing in our computation), the joists would be able to support their own dead weights if the bridging lines were properly anchored.
