Investigation of the October 23, 1997 Collapse of the 1889' High TV Antenna Tower in Raymond, Mississippi

**Office of Engineering
Directorate of Construction
Occupational Safety and Health administration
U.S. Department of Labor**

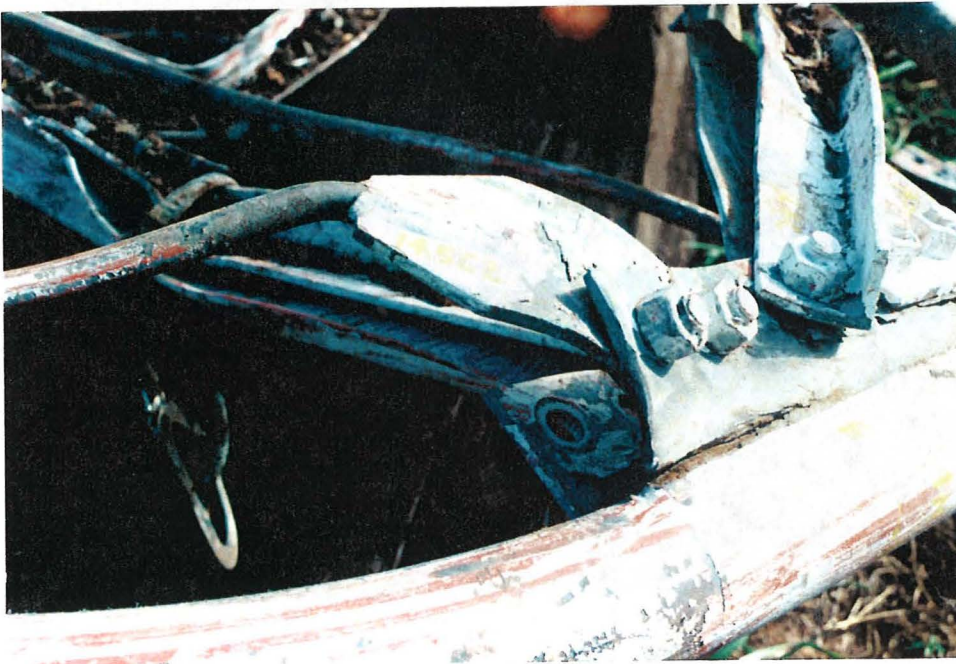
Gusset plate
of 14.5a1 at
north leg,
bolt missing,
hole intact

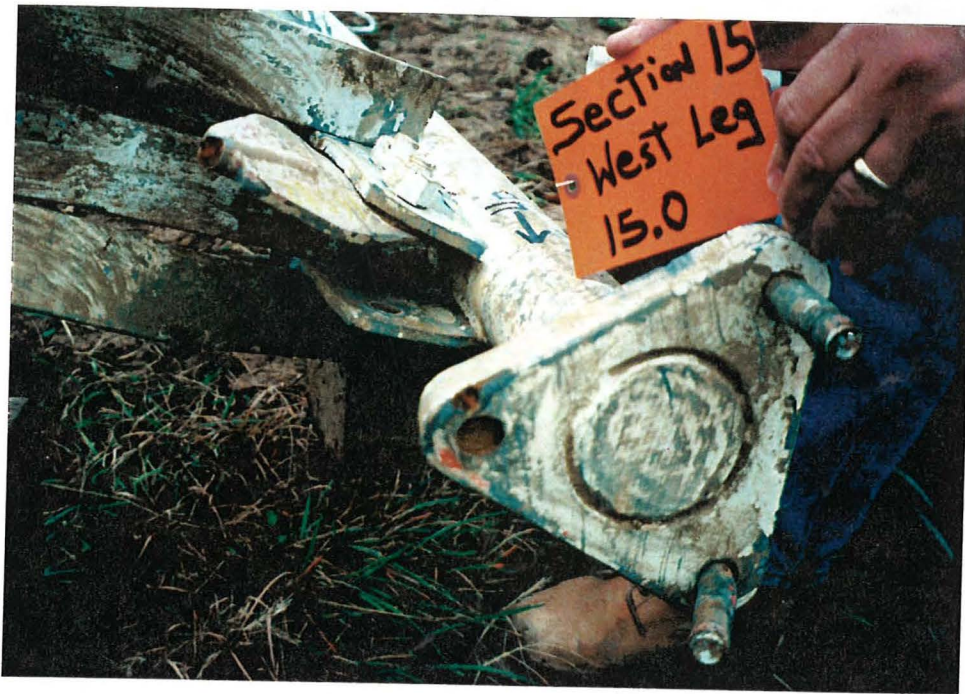
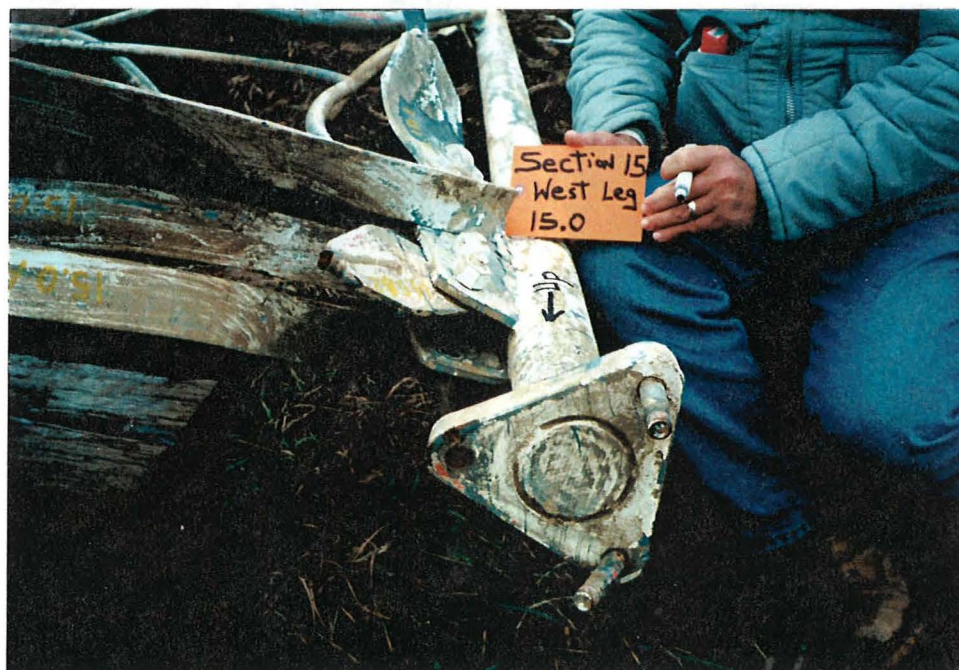
Gusset plate of diagonal 14.5a1 at the West leg.
Connecting bolt missing, member intact.

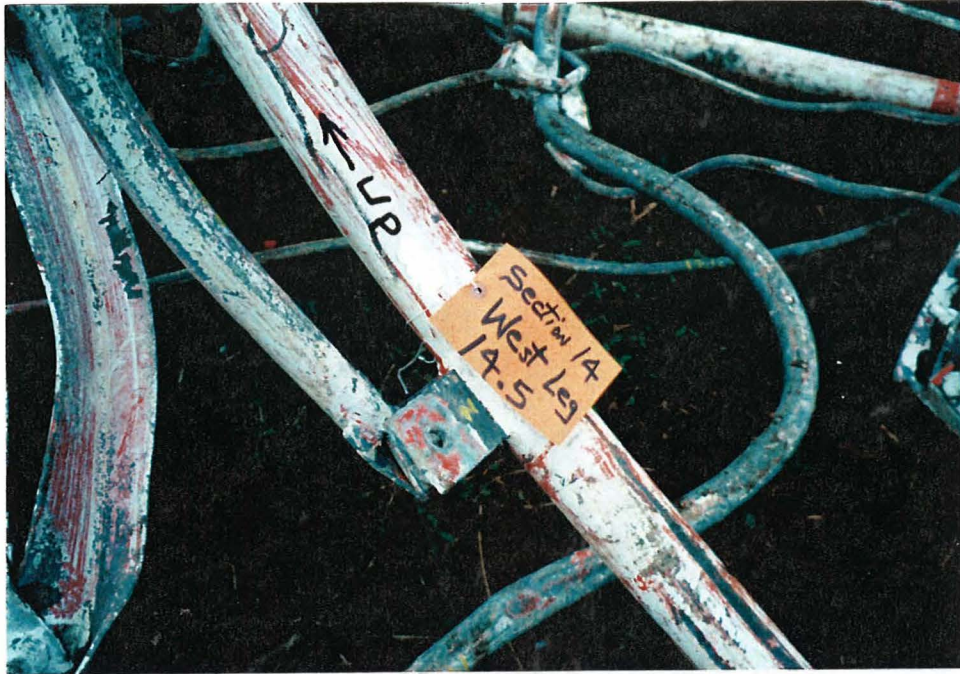
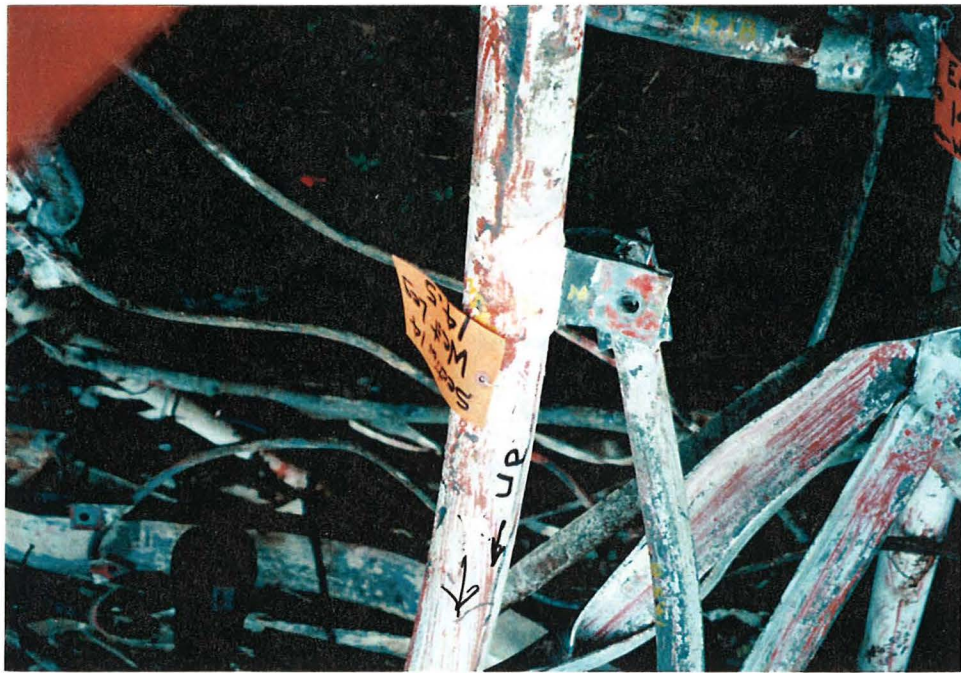
Gusset plate of redundant member 14.5a at the west leg.

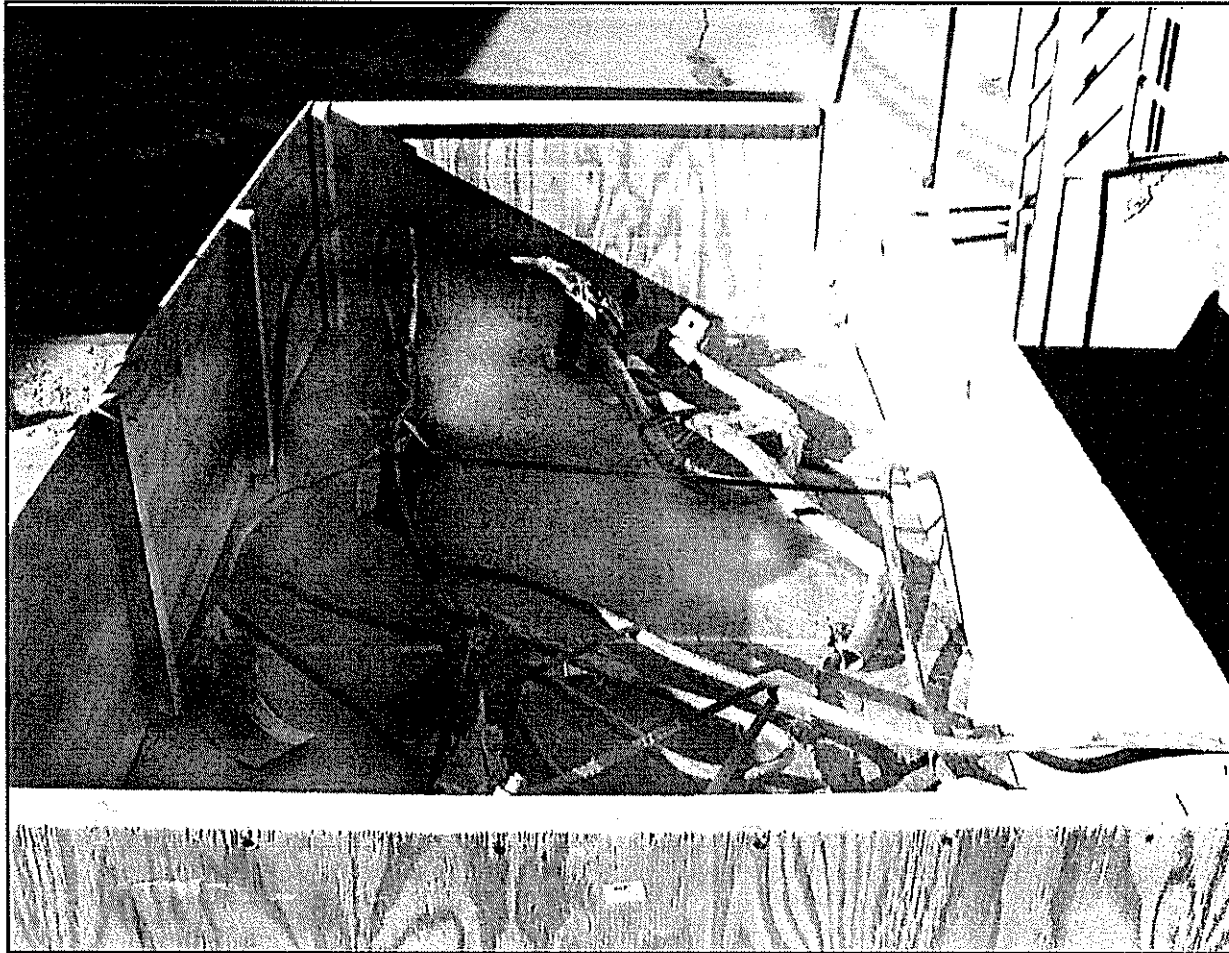
Figure 1: Tower pieces as received in box at Salt Lake Technical Center

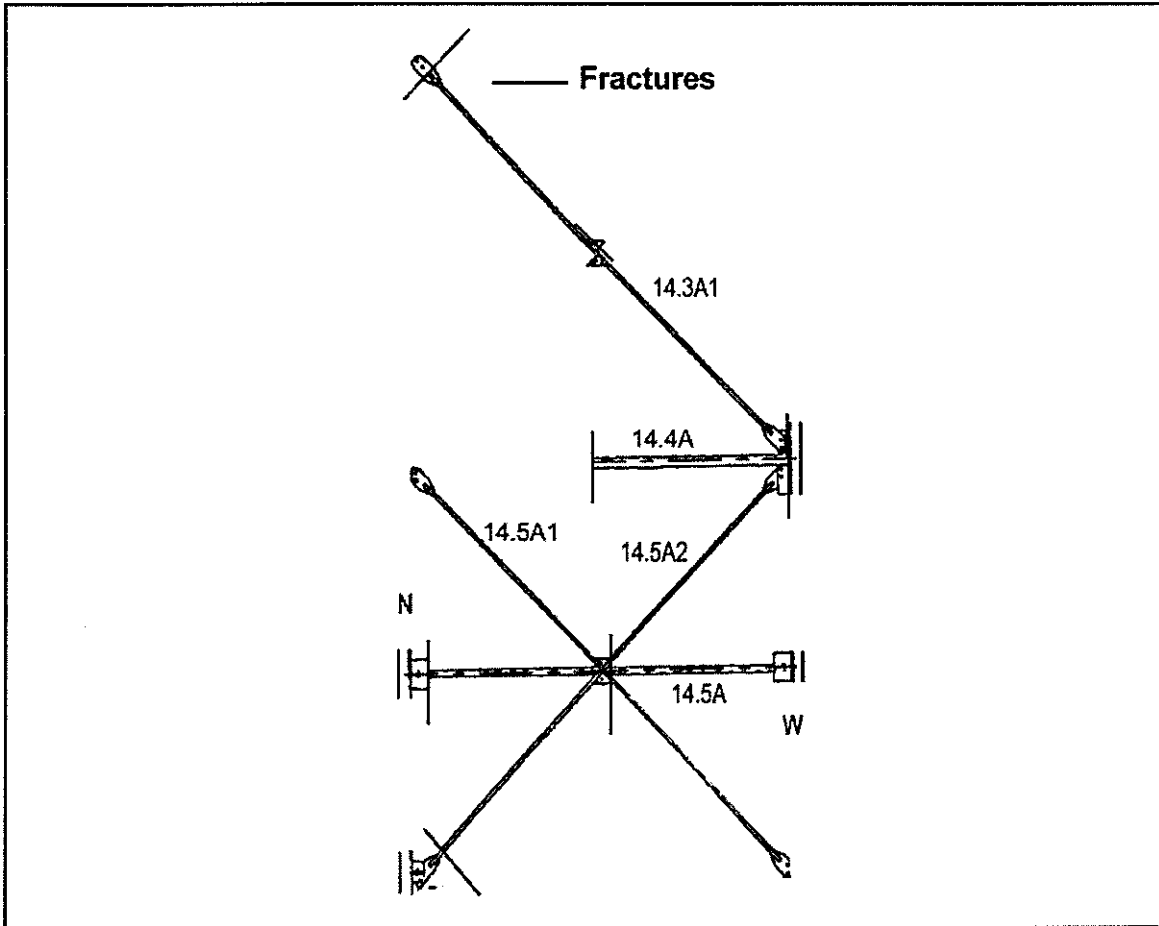
Figure 2: Relative position of submitted members in the tower before collapse. The points of fracture are noted by solid lines (Red in the original).

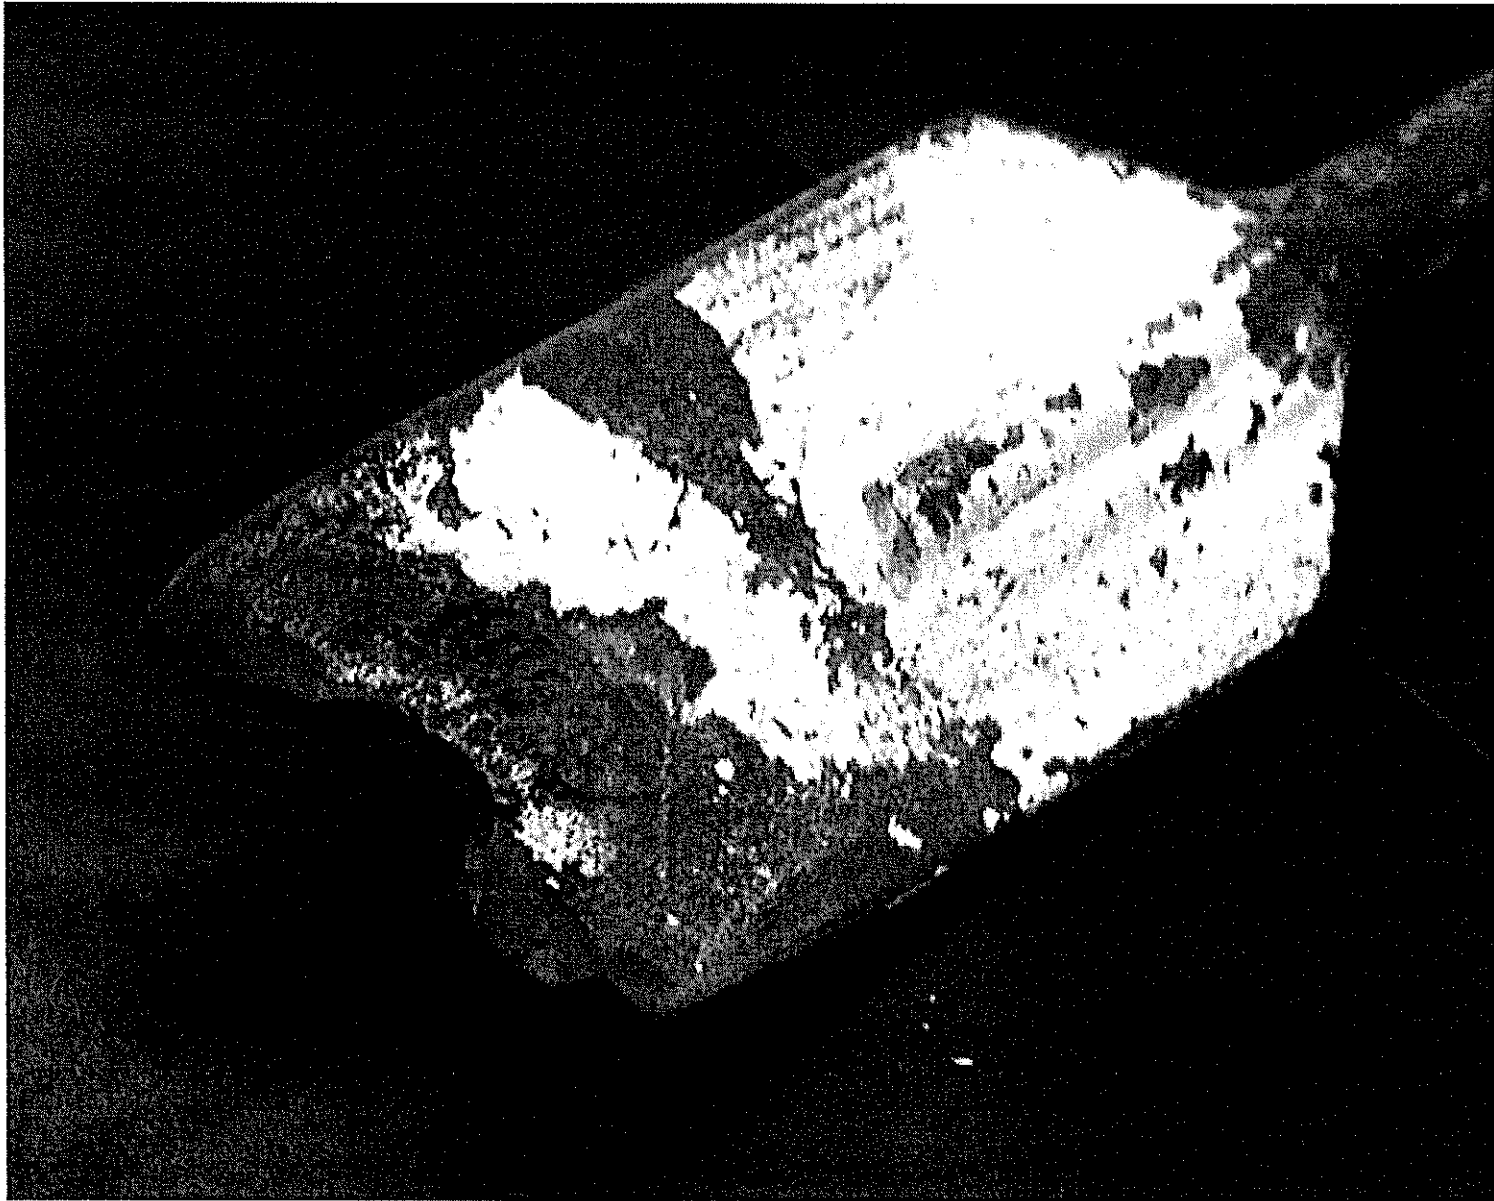
Figure 3: North connection at 14.3 of 14.3A1. This piece was attached at the time of failure as indicated by the fracture of the “fish head.”

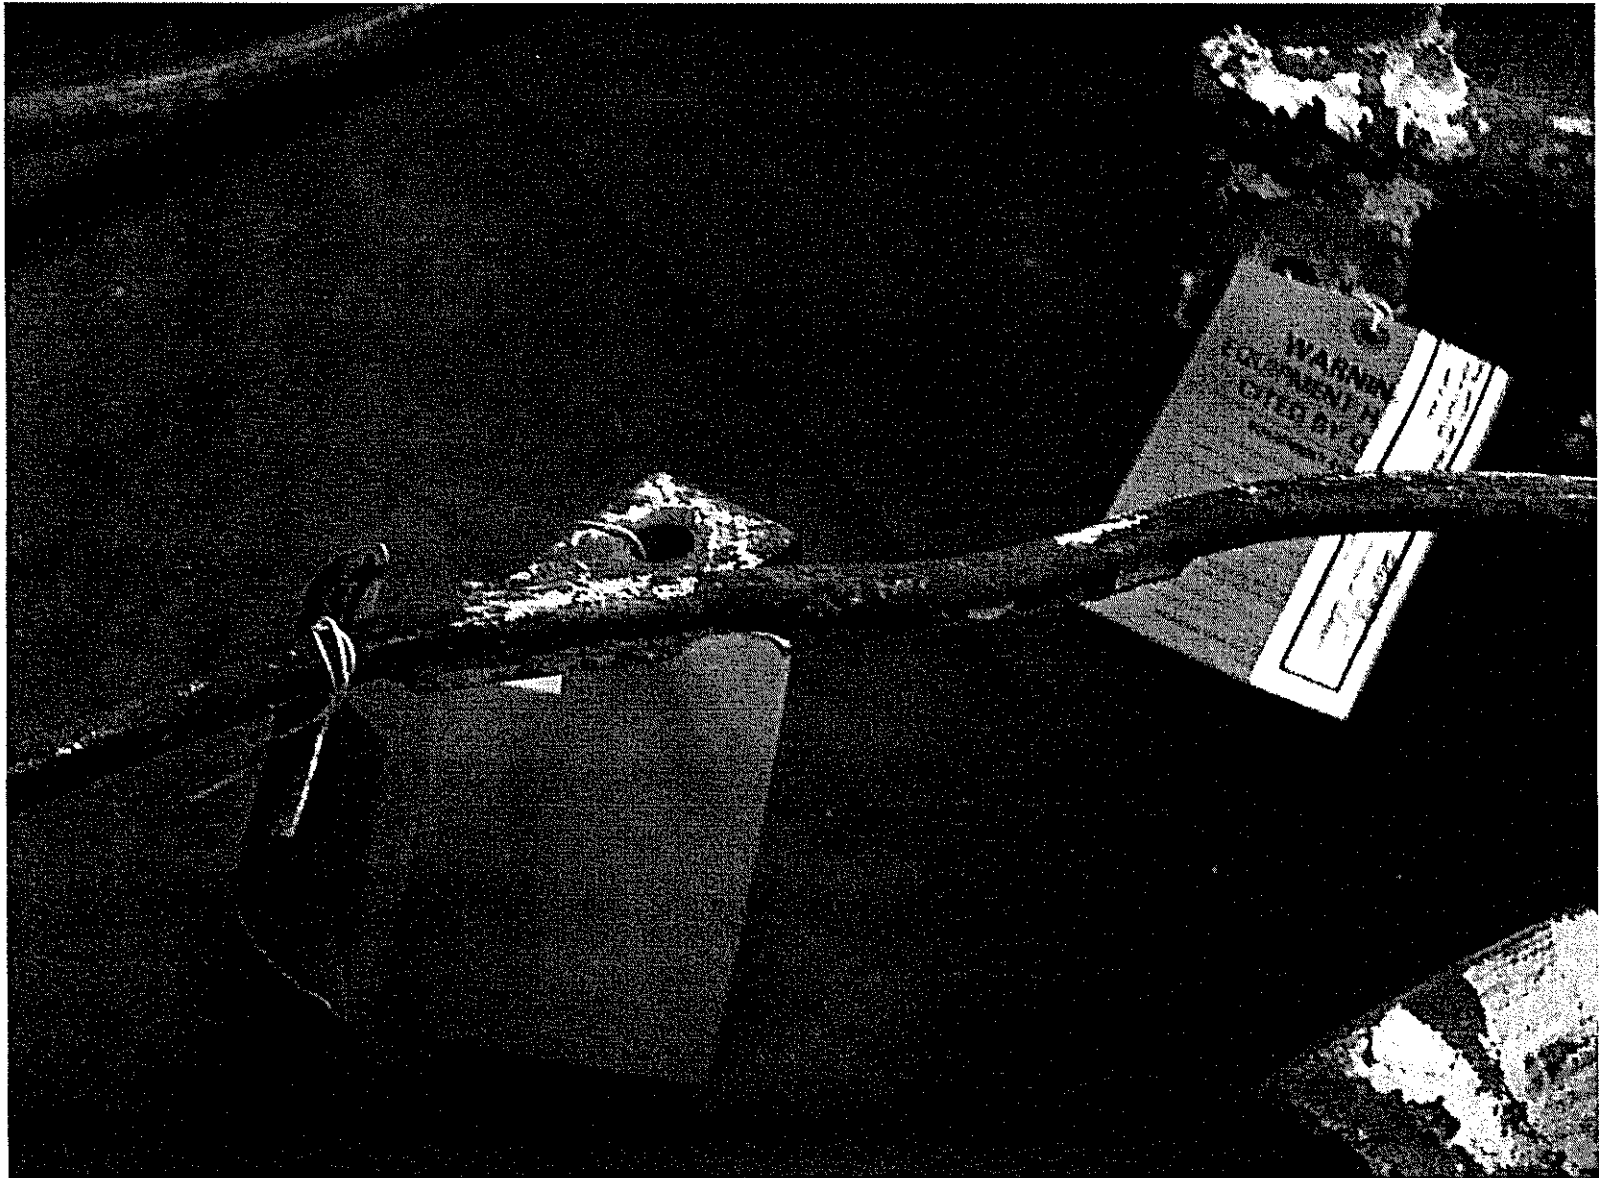
Figure 4: Center connection points of 14.3A1. The upper tab is missing having failed at the weld, while the lower tab remains. The hole is unremarkable.

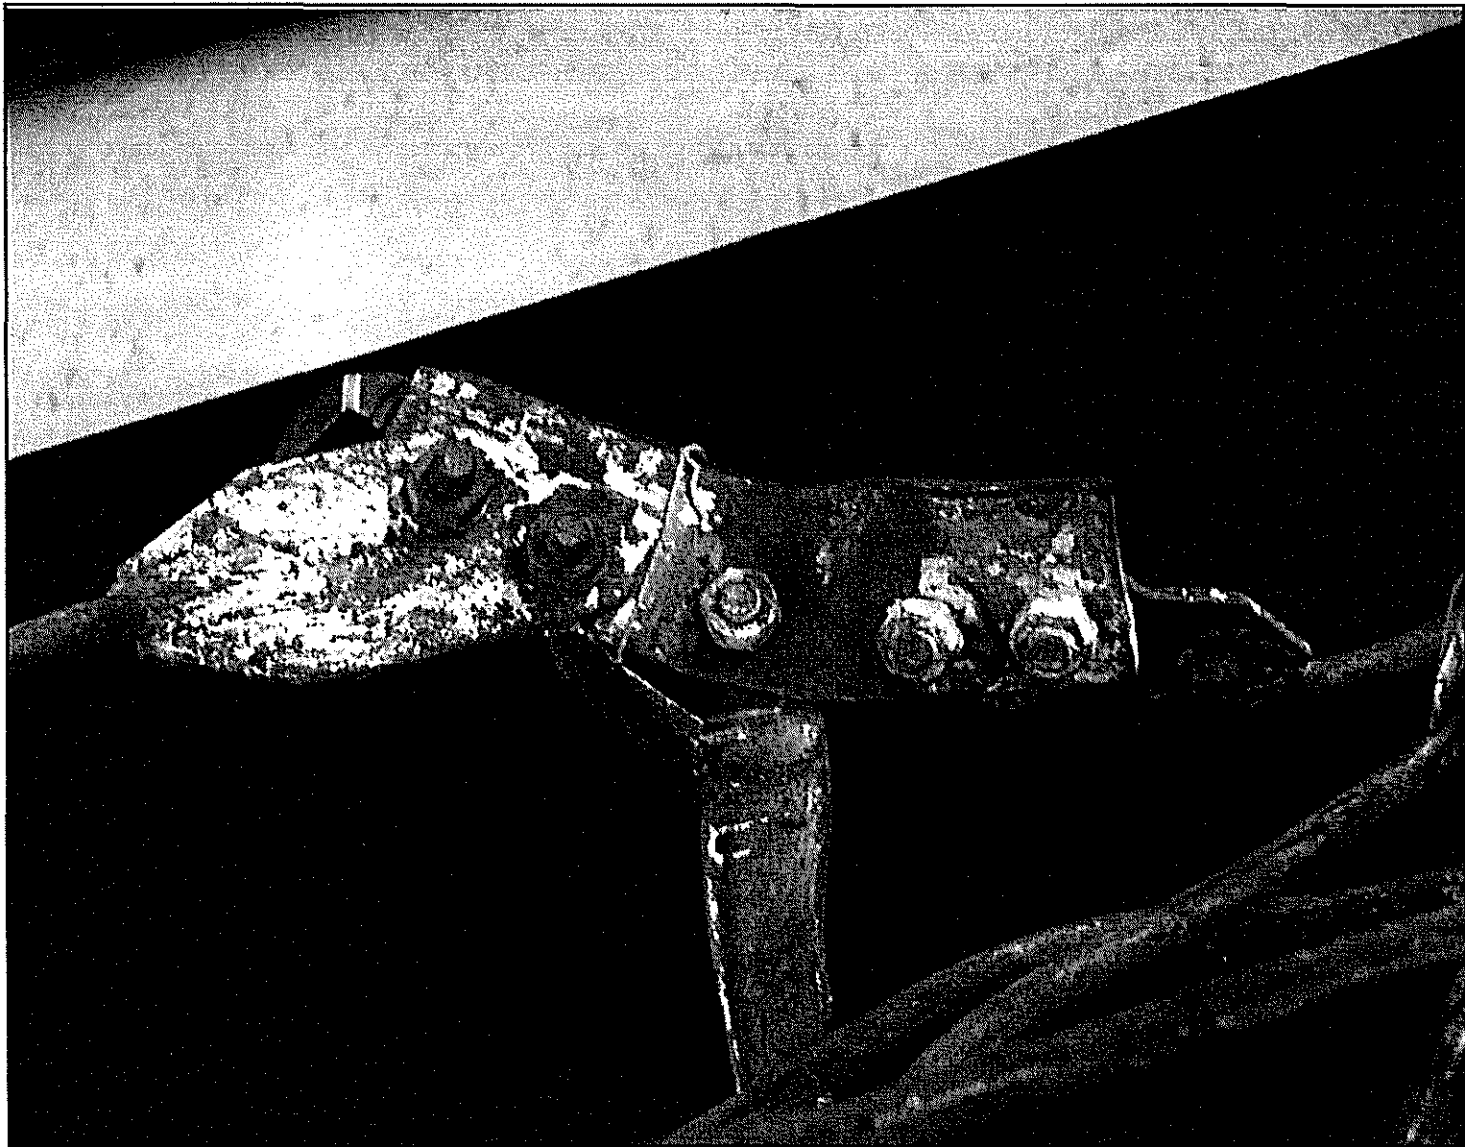
Figure 5: This is the separated main leg gusset from the West leg at 14.4. Shown are the connections for 14.3A1 diagonal, 14.4 horizontal brace and 14.5A2 diagonal. The fish head for 14.3A1 is attached with new bolts, while the remaining members are attached with original spring-loaded bolts.

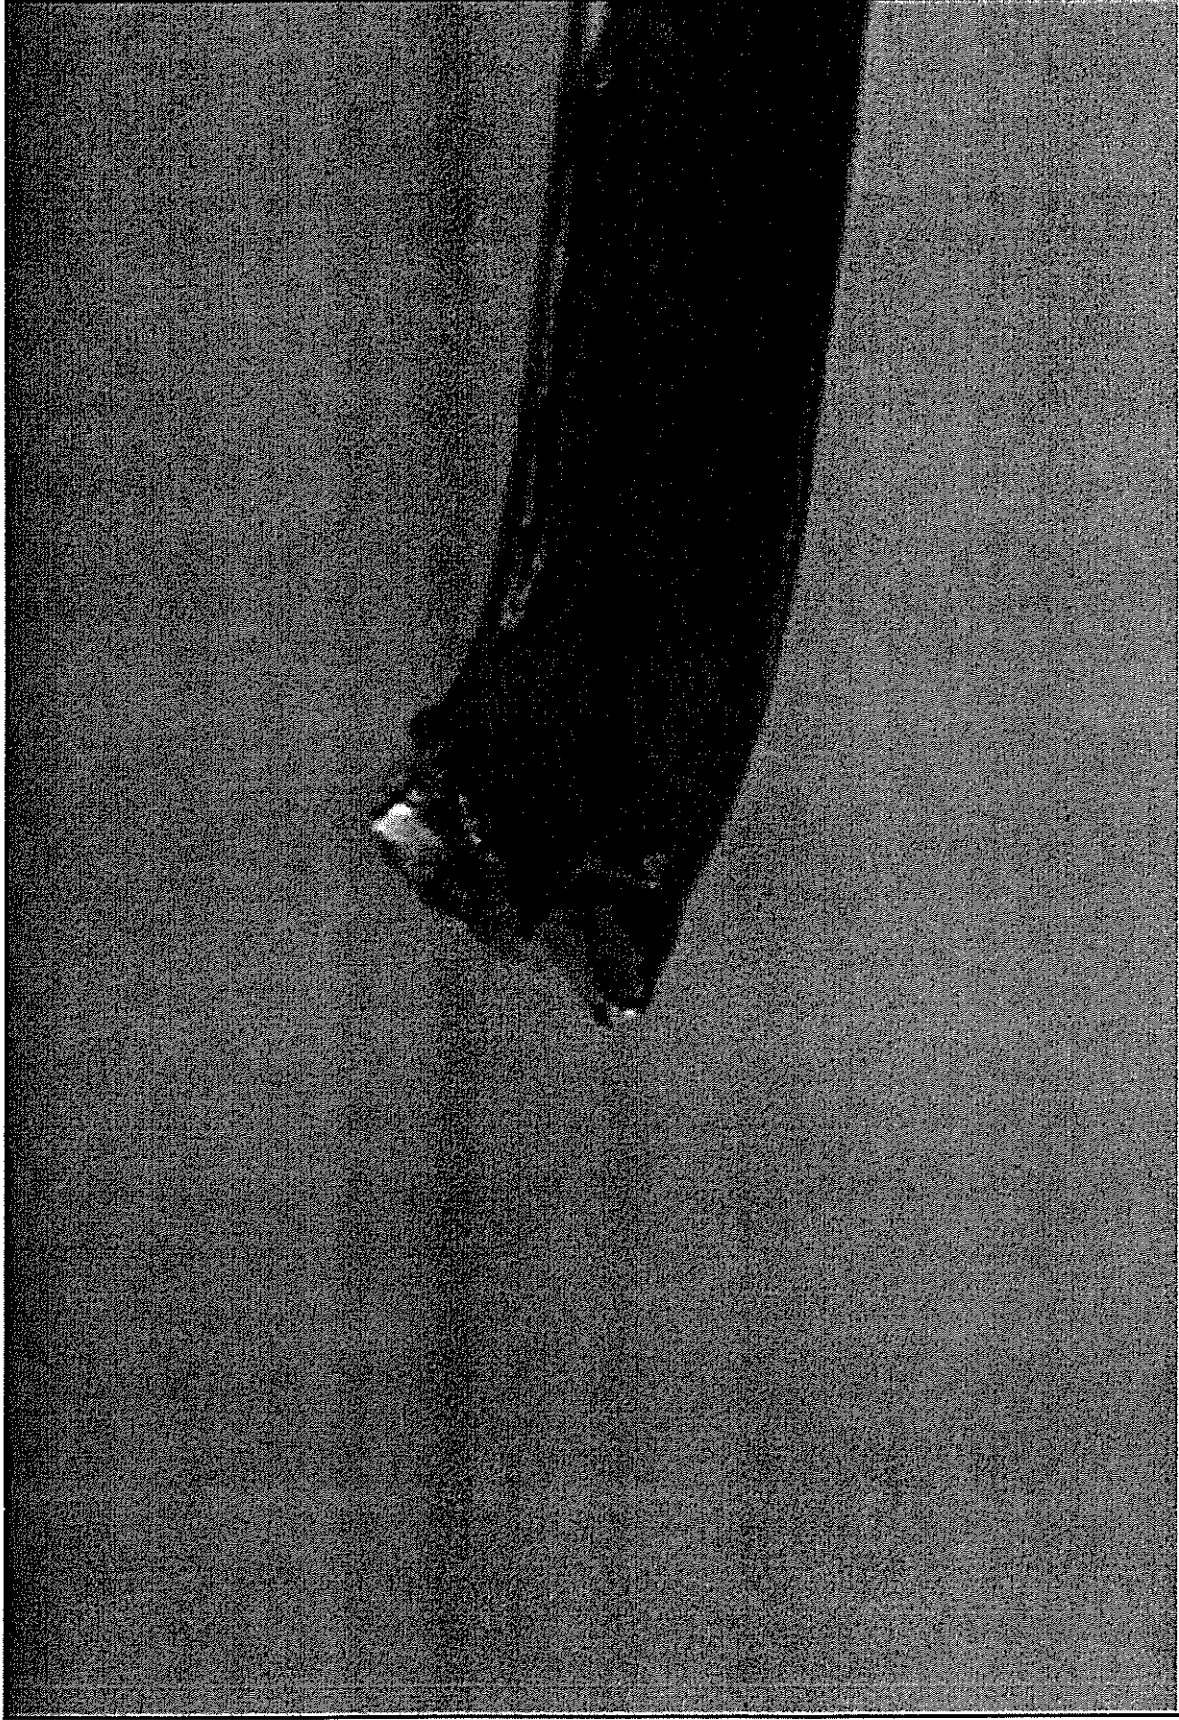
Figure 8: Broken end of 14.5A2 at 15.0 North

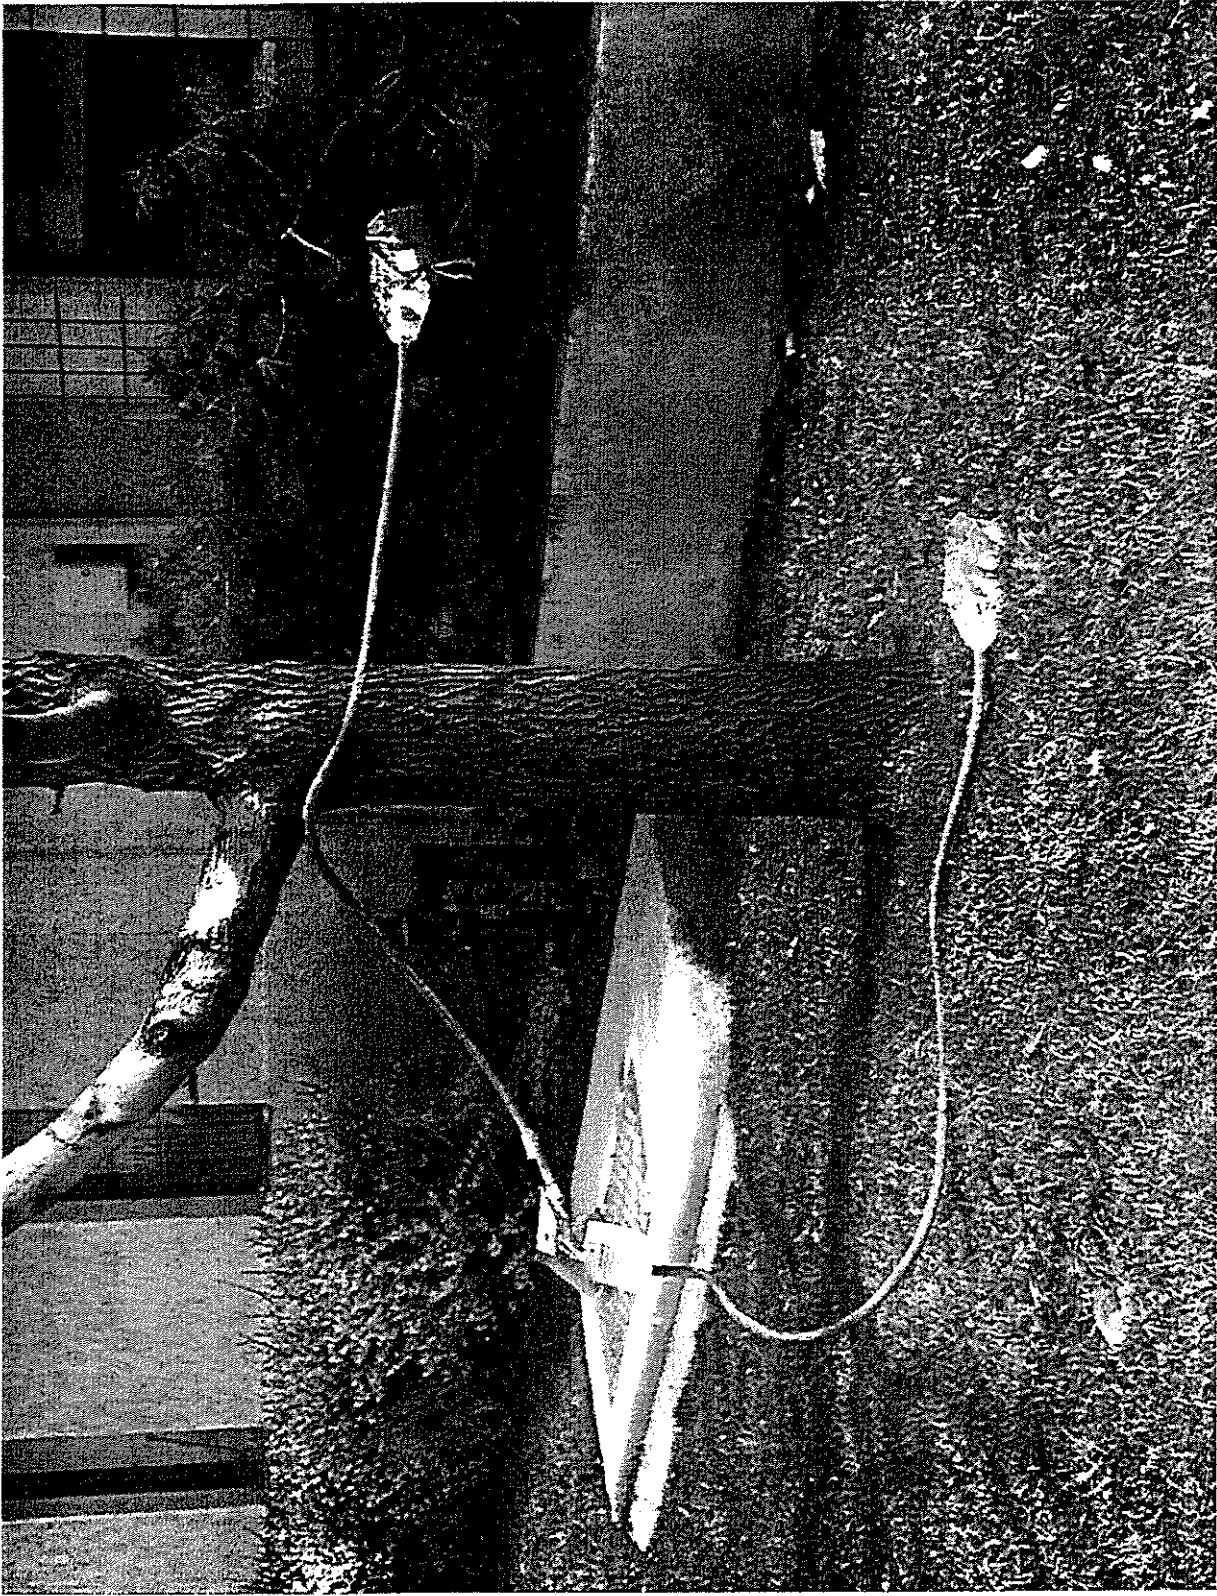
Figure 9: View of diagonal 14.5A1 at Salt Lake Technical Center

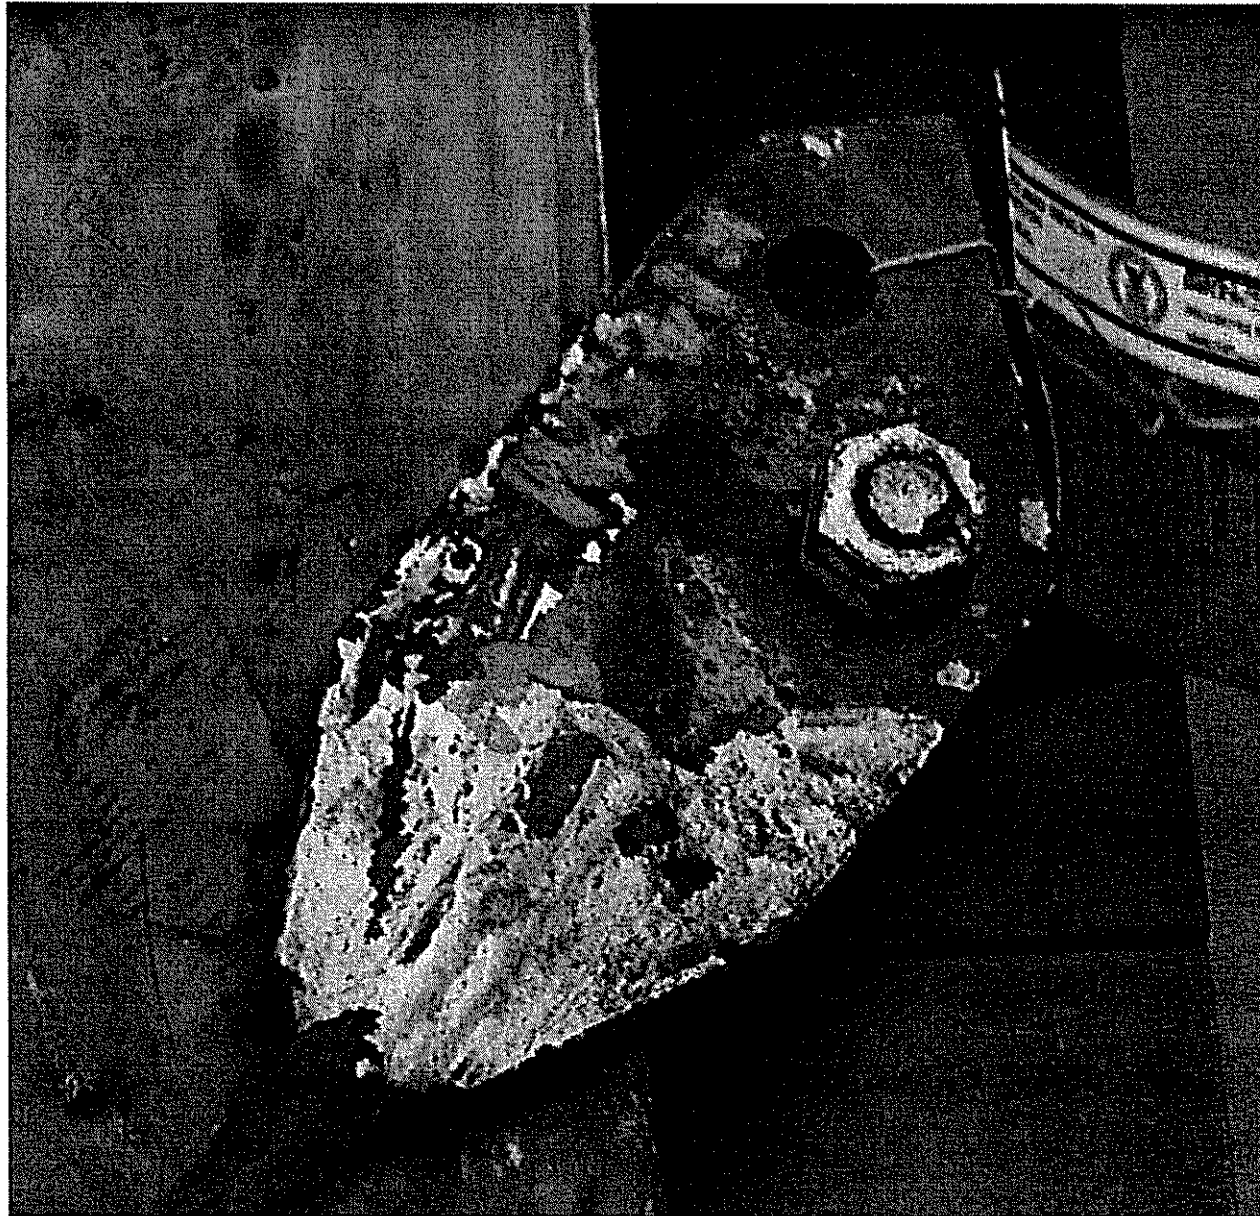
Figure10: Diagonal 14.5A1 W. Note the bolt with the spring-loaded nut was replaced into the hole

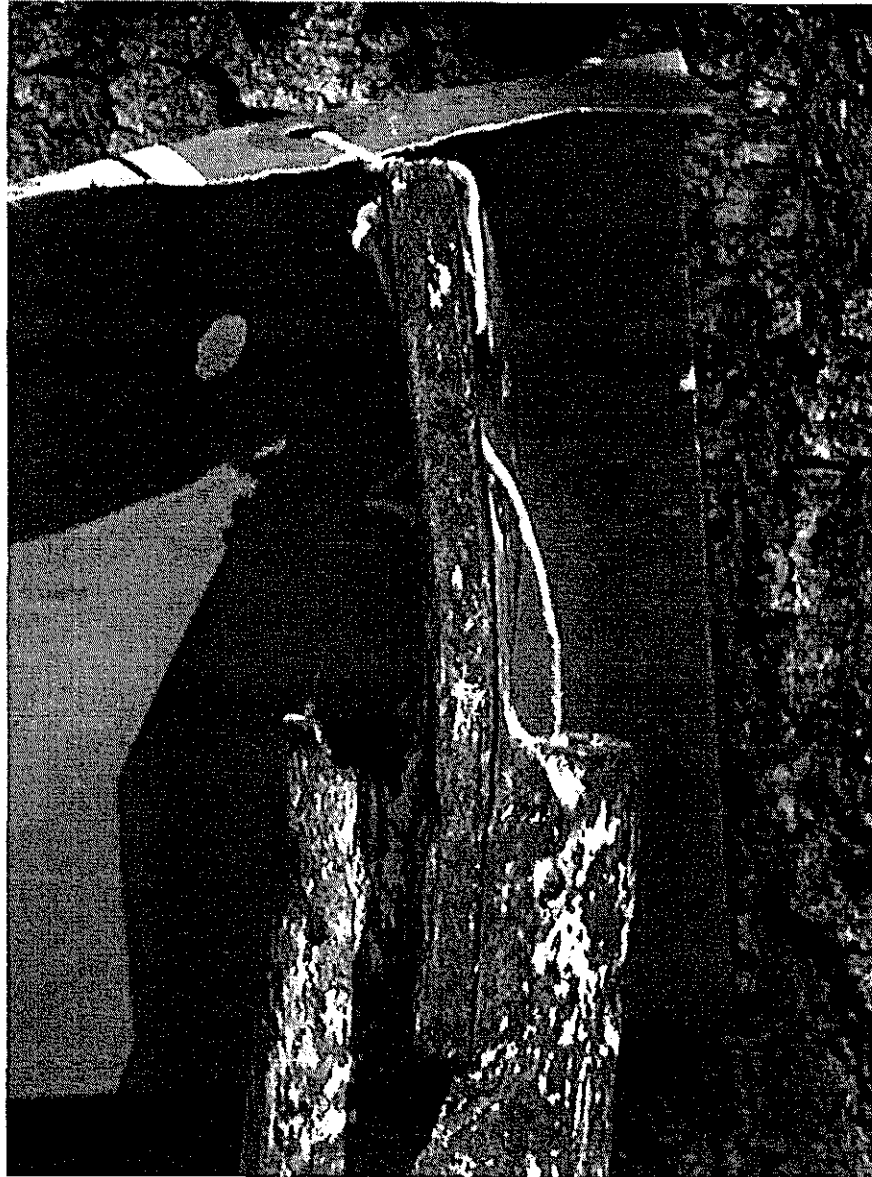
Figure 11: West end of 14.5A redundant showing bend in the direction of the attachment lug on West leg 14.

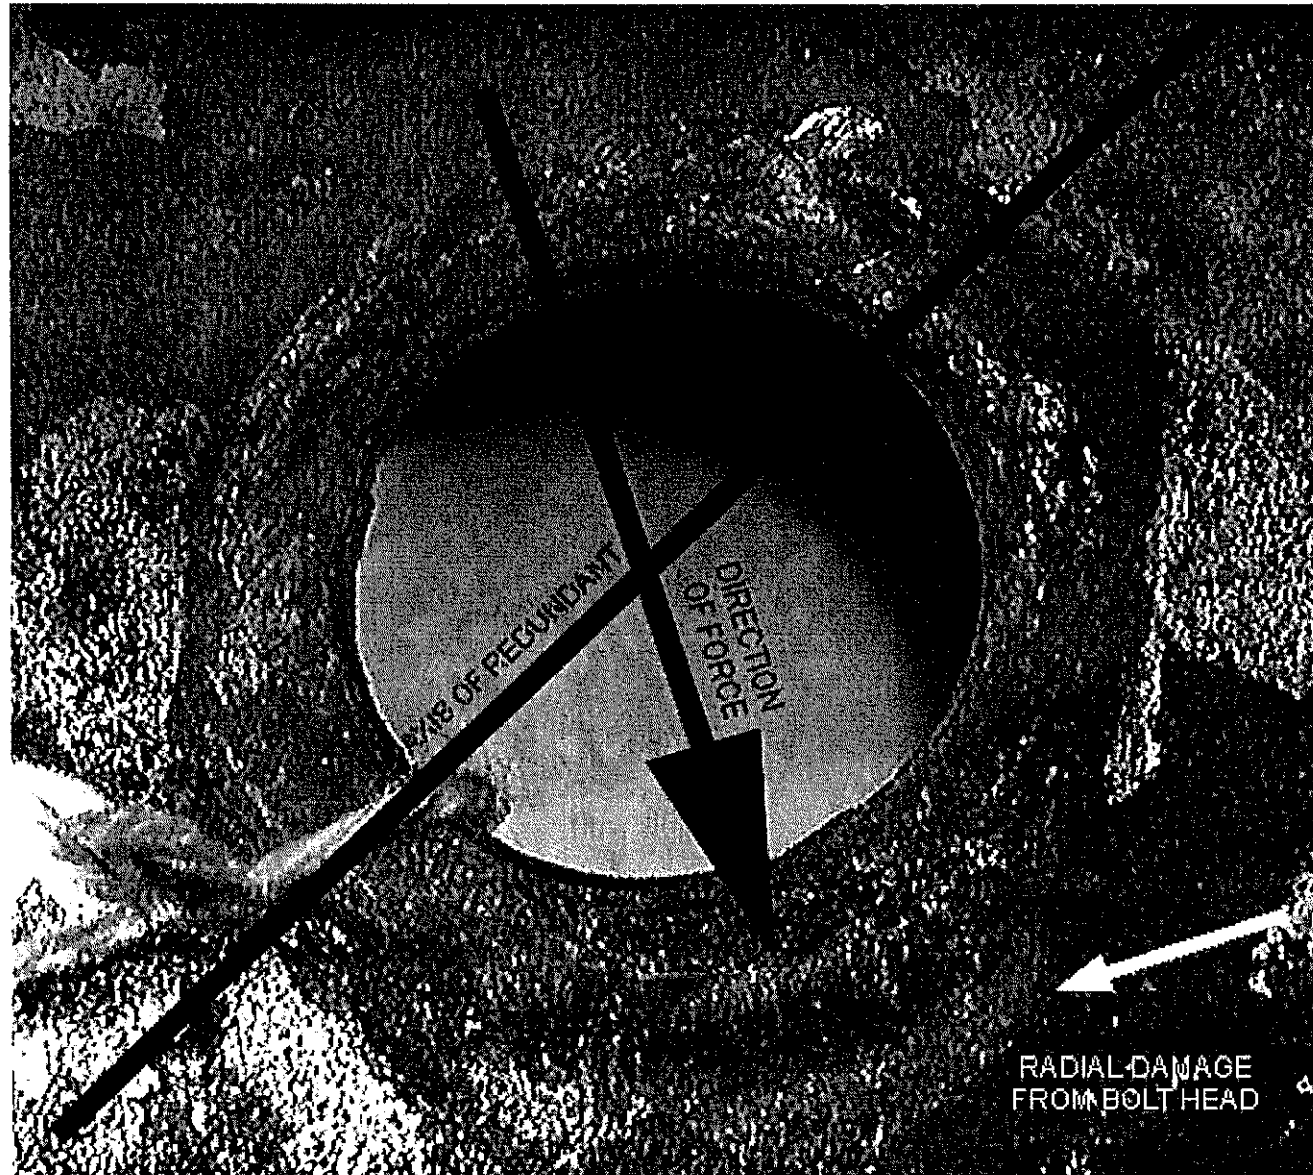
Figure 13: Direction of force relative to the axis of the redundant 14.5A also showing radial damage due to bolt head gouging during bolt failure.

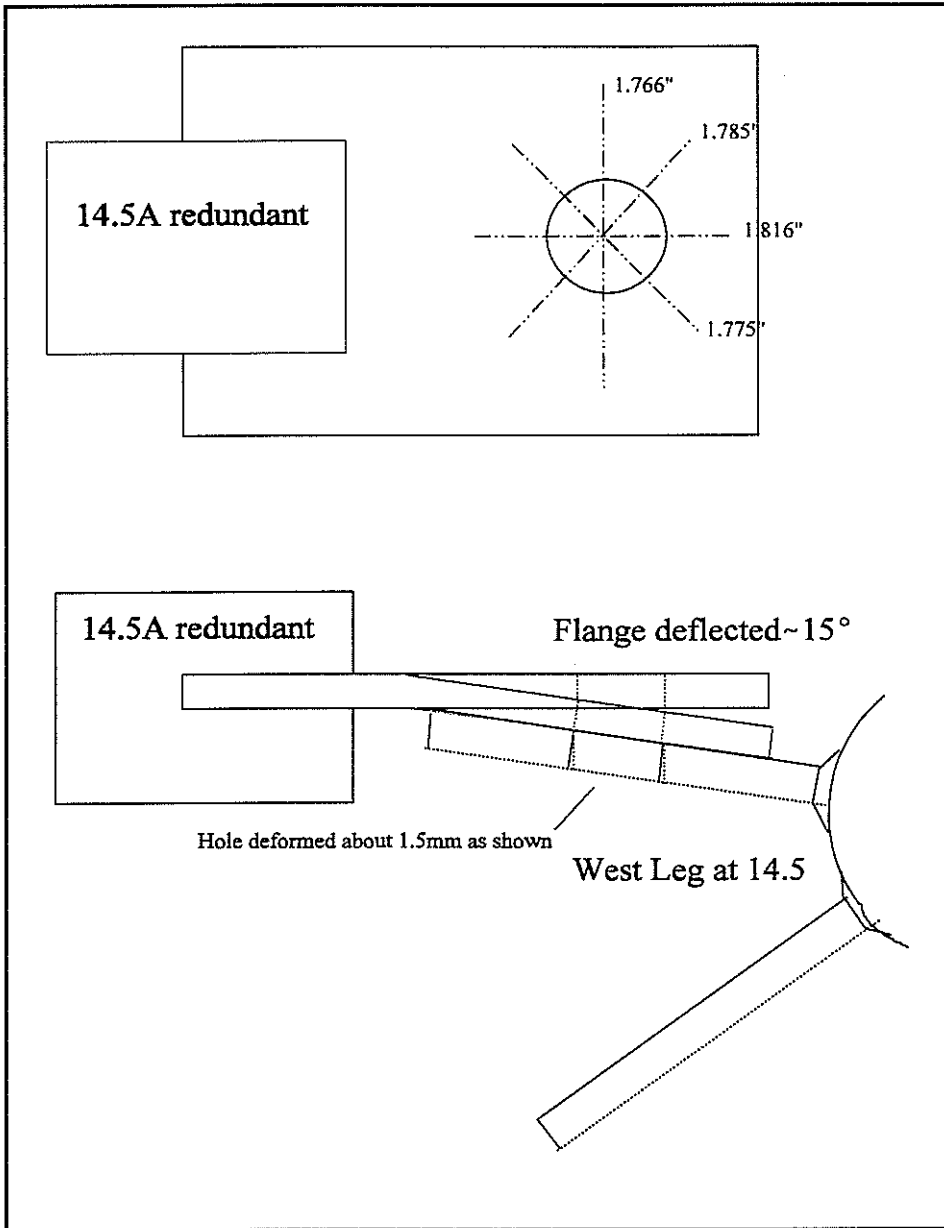
Figure 14: Attachment of 14.5A redundant to West leg at 14.5. The top diagram shows the hole distortion and the bottom shows the flange bend and the hole distortion in the attachment gusset to 14 W. The redundant member is not shown in the position in which it finally failed.

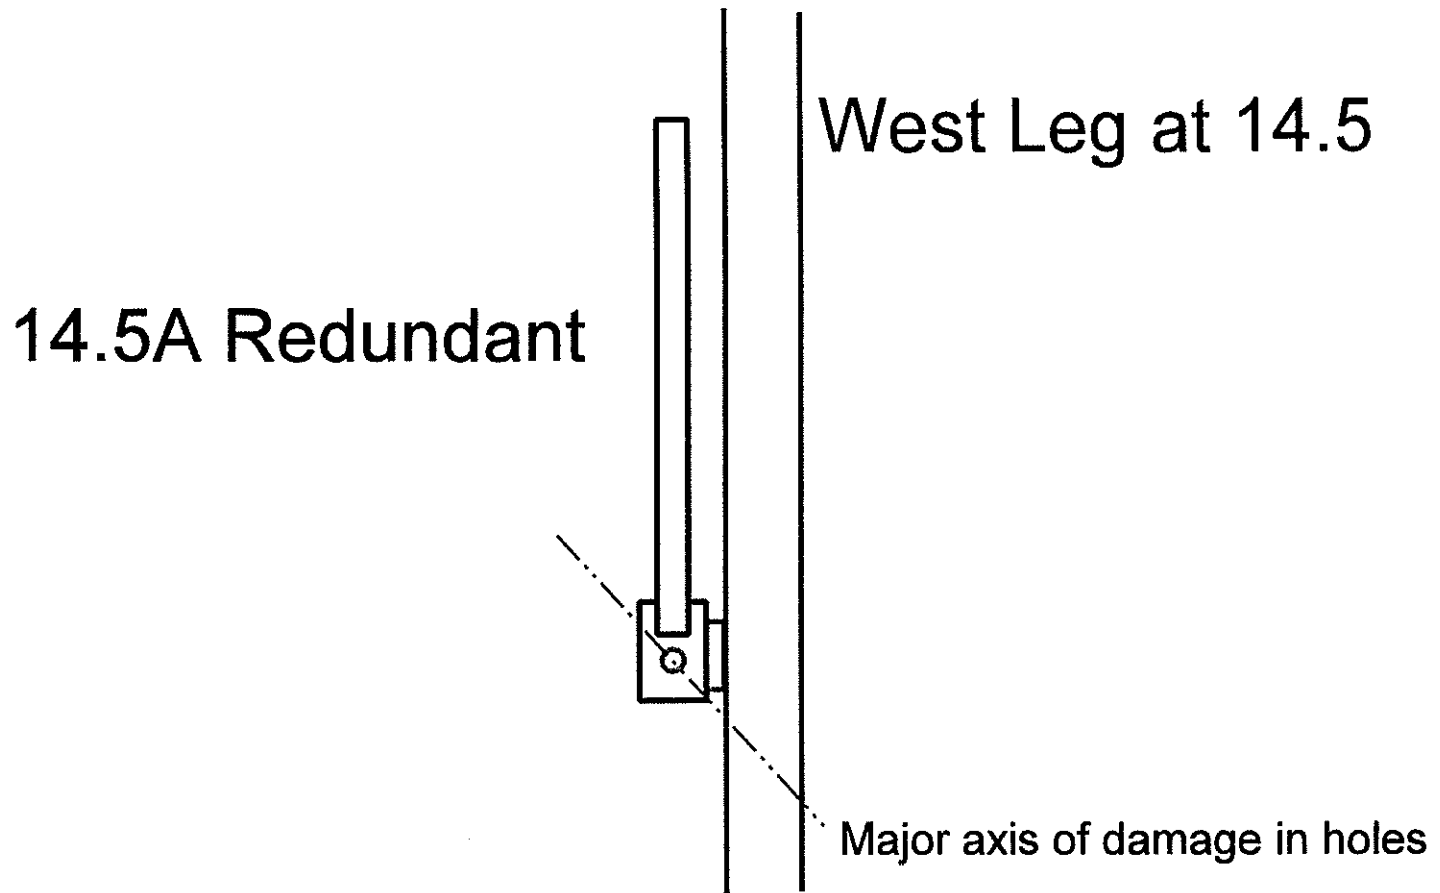
Figure 15: Diagram of 14.5 redundant at failure.

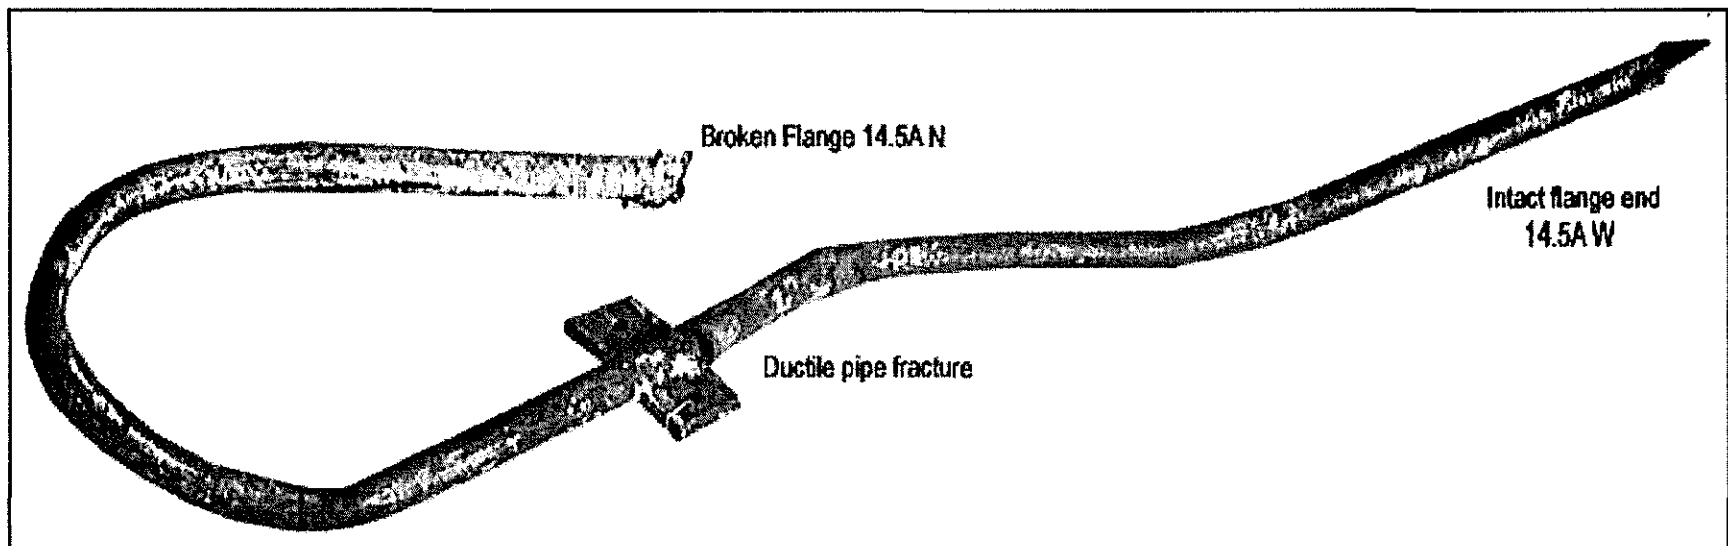
Figure 16: Layout of the pieces of redundant member 14.5A identifying the fracture points.
