Investigation of the October 23, 1997 Collapse of the 1889' High TV Antenna Tower in Raymond, Mississippi

**Office of Engineering
Directorate of Construction
Occupational Safety and Health administration
U.S. Department of Labor**

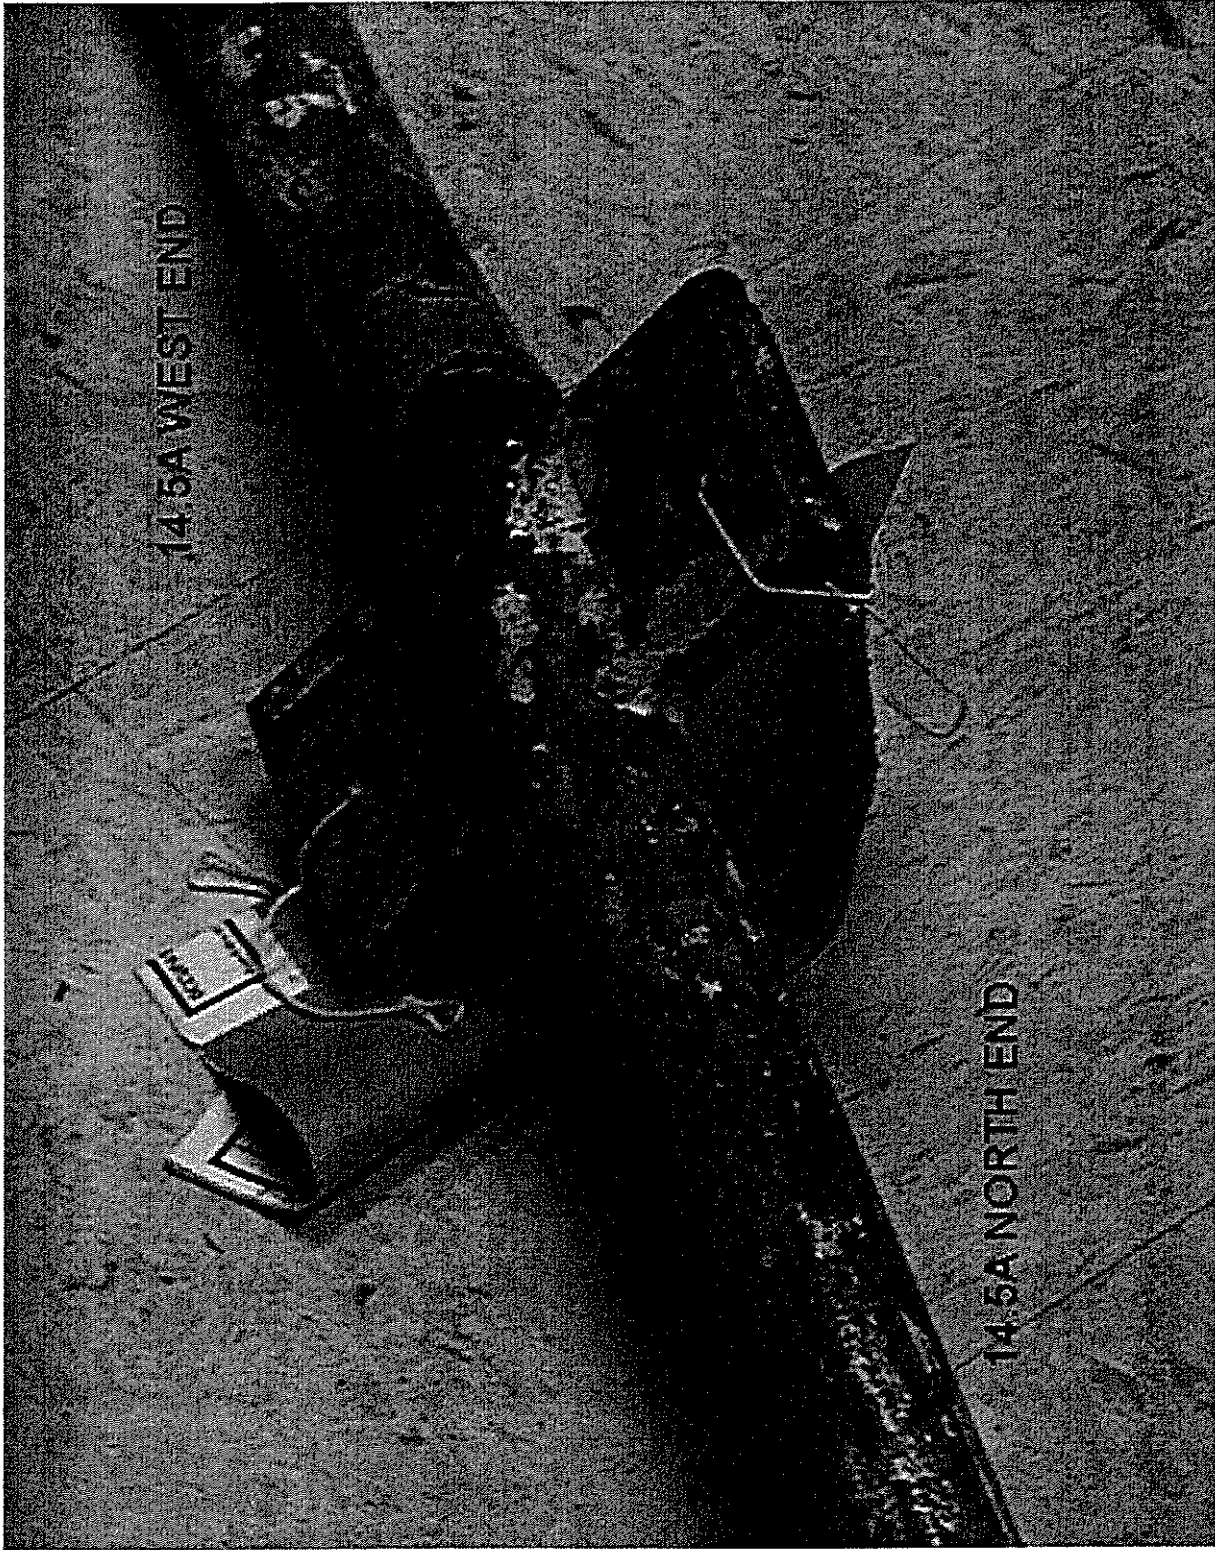
Figure 17: Close-up of the fracture at the center of redundant 14.5A.

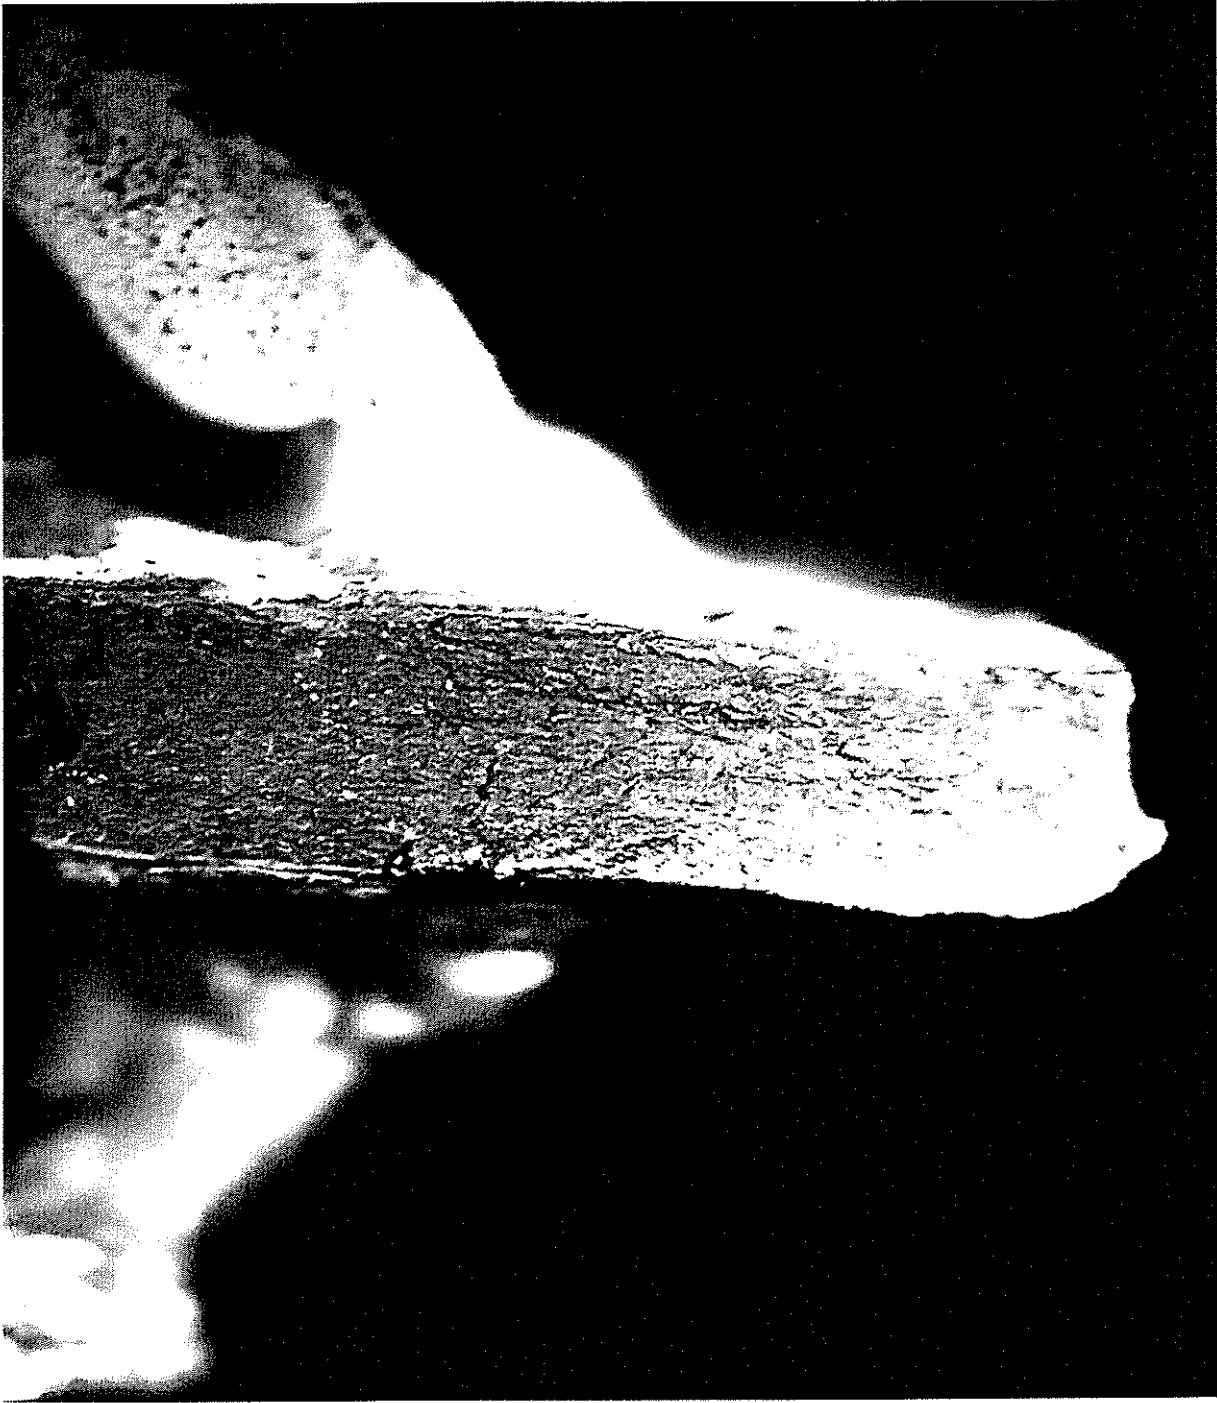
Figure 18: The north end of 14.5A redundant showing ductile fracture.

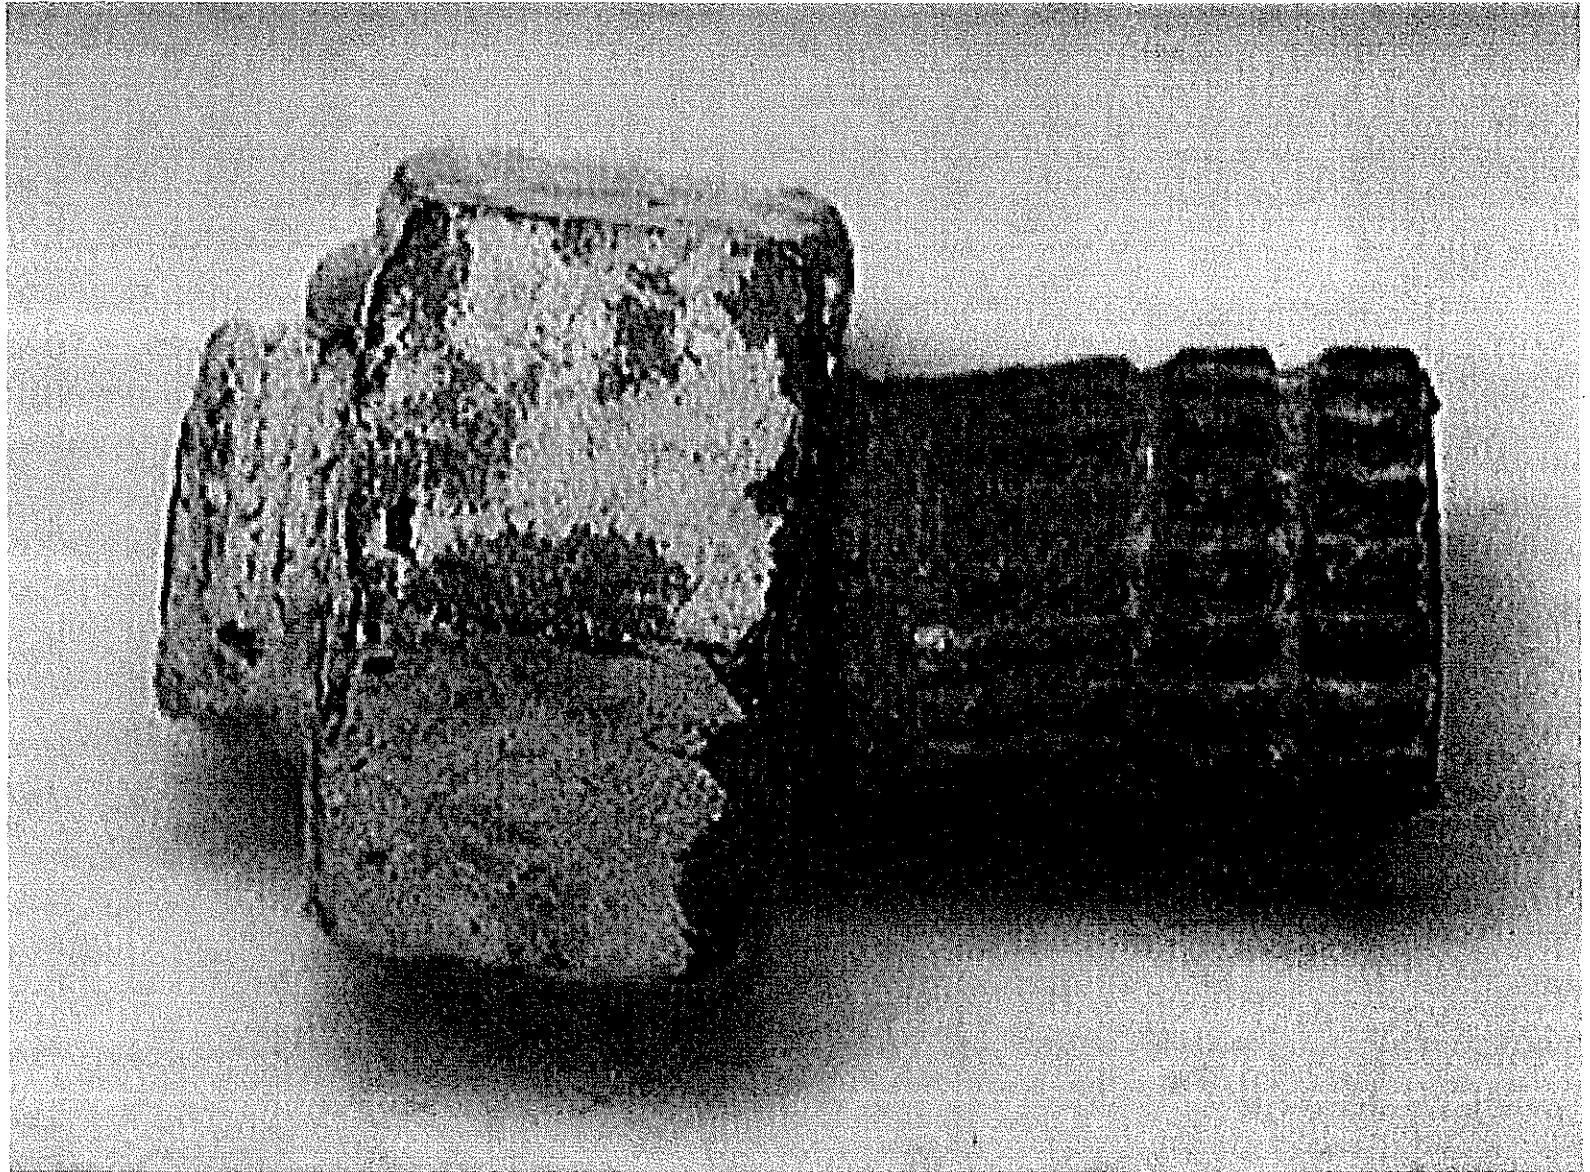
Figure 19: Bolt collected from Tower collapse site. It shows a little bending, little stretching and has apparently failed when the head sheared off.

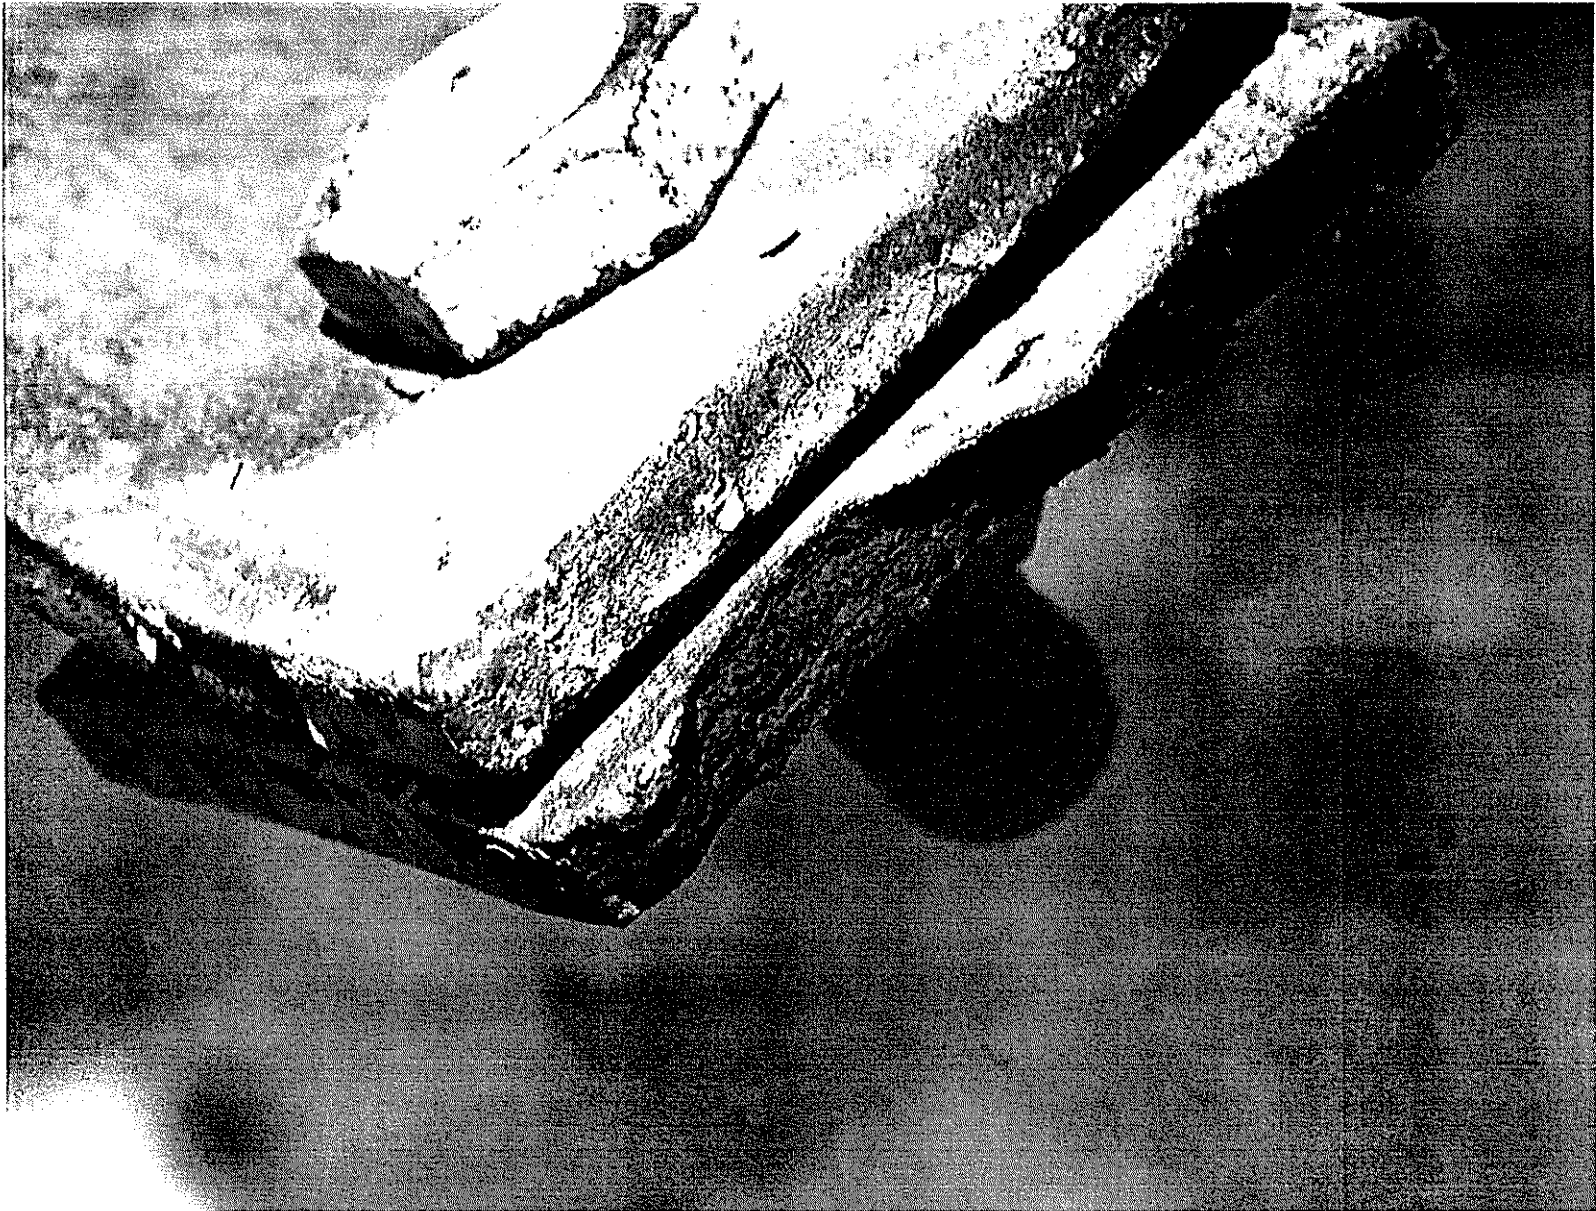
Figure 20: Gusset on North 14 leg at 14.5 with remnant of redundant flange showing ductile fracture.

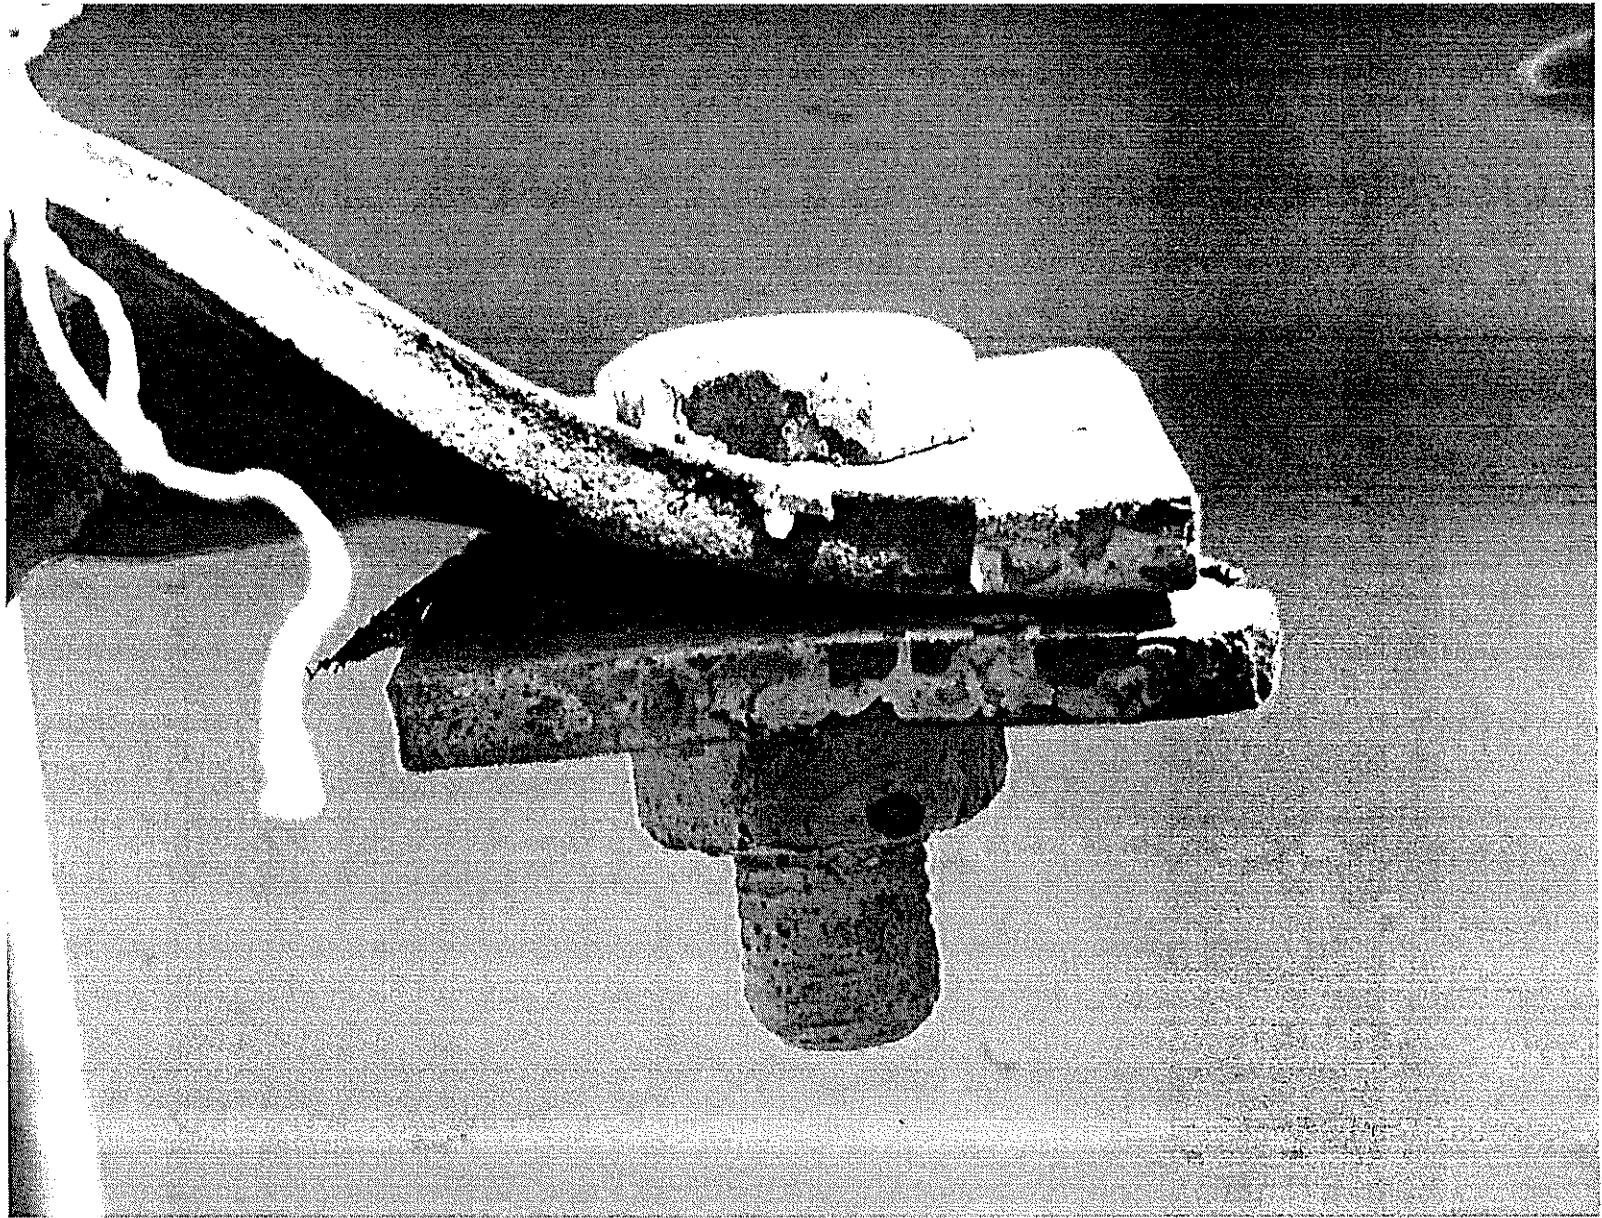
Figure 21: View of remnant of redundant flange attached to North leg at 14.5.

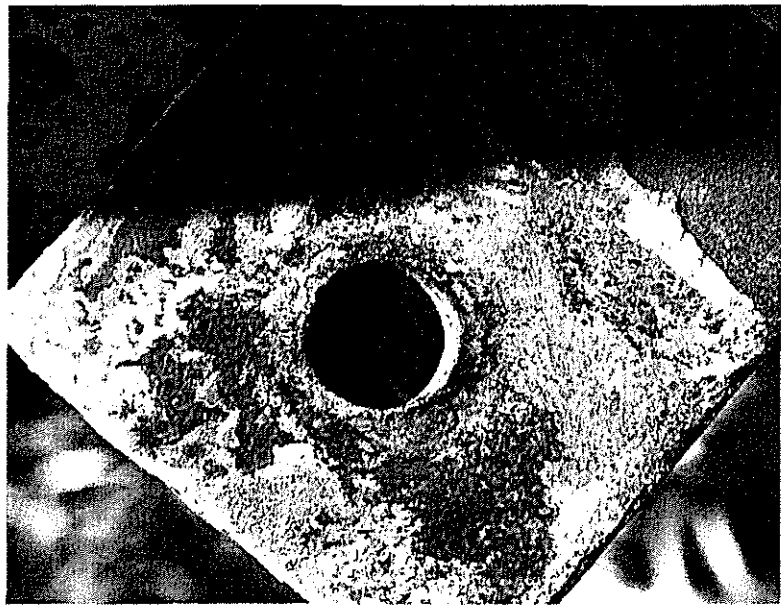
Figure 23: Close-up of attachment lug at 14.5 West showing hole distortion left to right from bolt failure

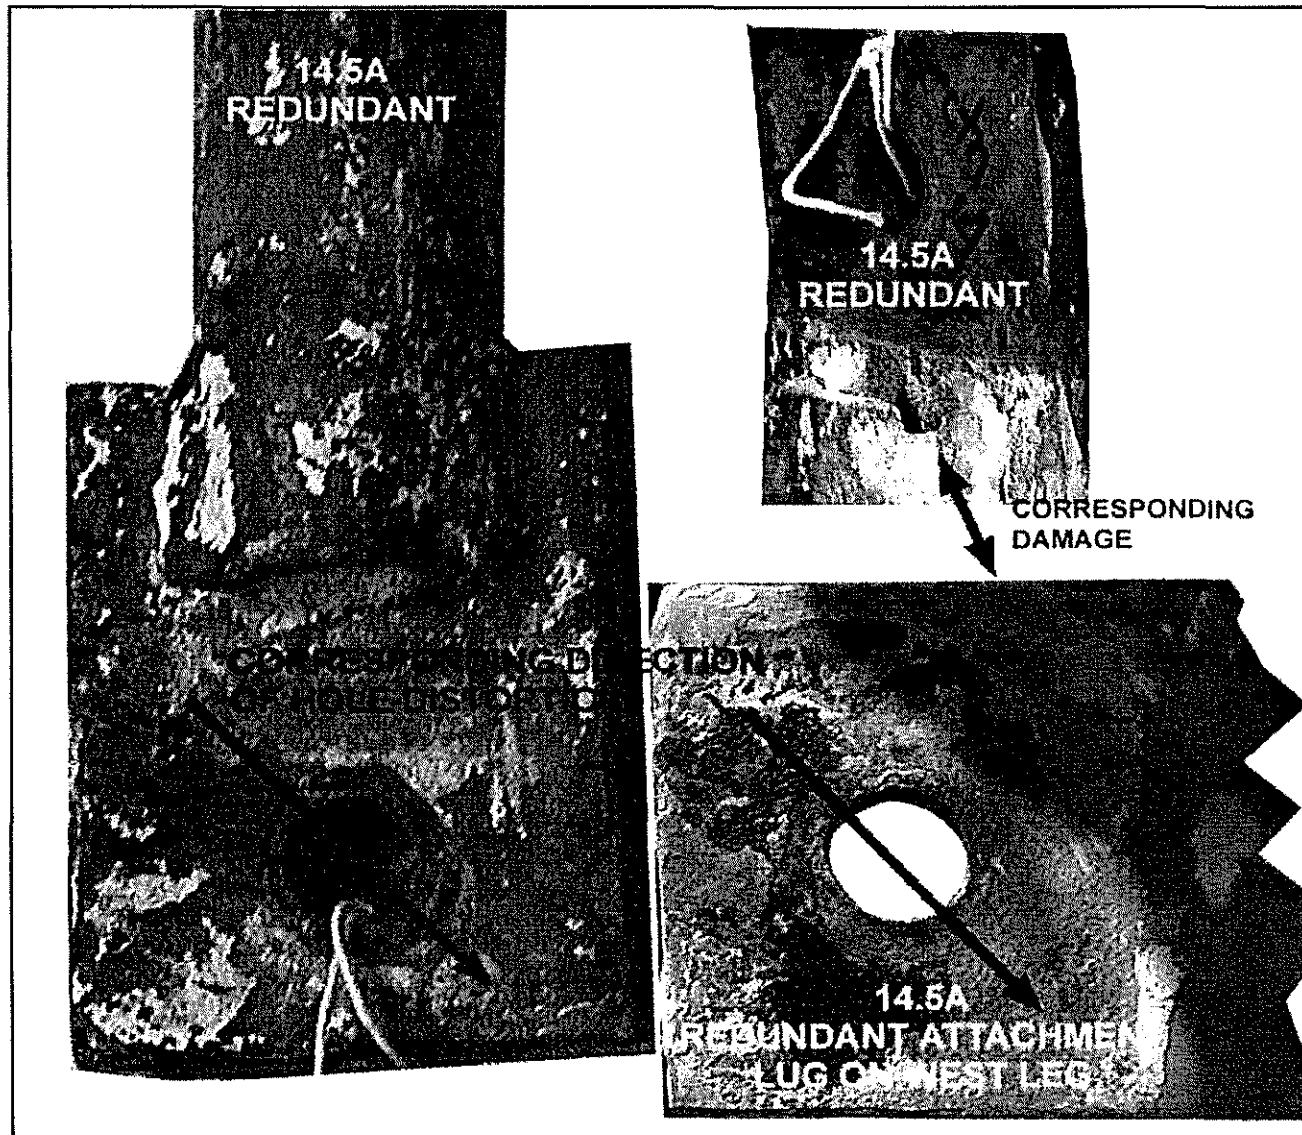
Figure 24: This is a composite showing the relative position of the redundant 14.5A at the time of failure along with damage caused by contact of the redundant with the gusset on the west leg at 14.5. Also noted is the relative direction of the hole distortion.
