Investigation of the January 10, 2020, Scaffold Collapse in Saipan, Commonwealth of the Northern Mariana Islands

U.S. Department of Labor
Occupational Safety and Health Administration
Directorate of Construction

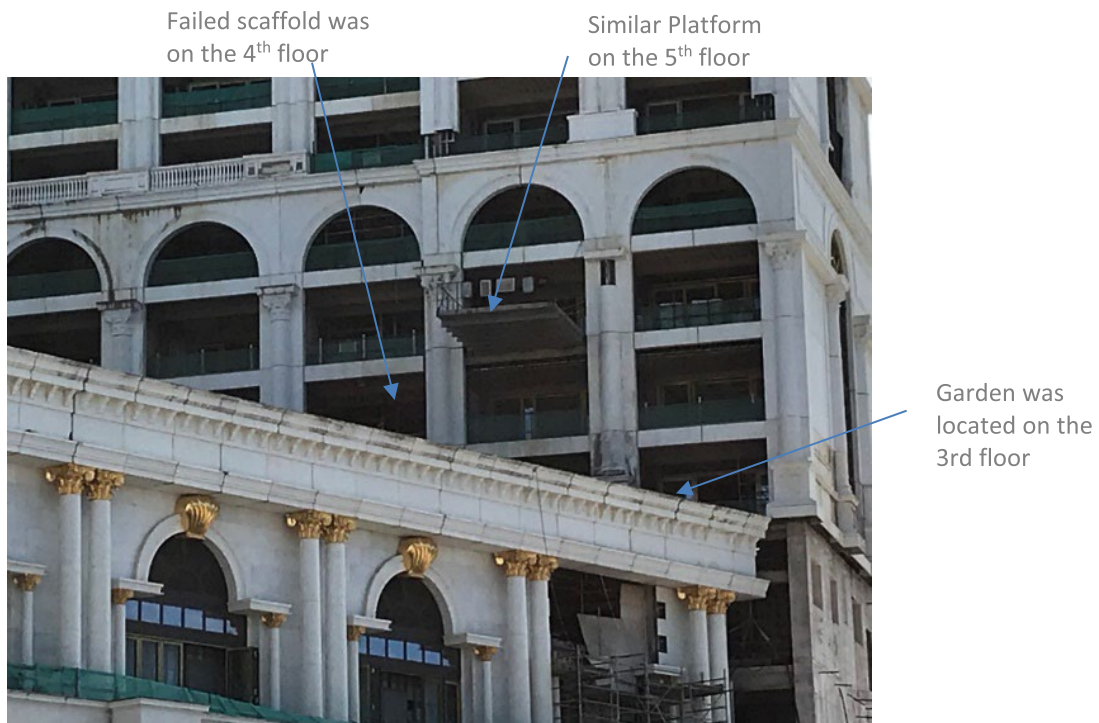
Figure 1 – Hotel and location of failed platform

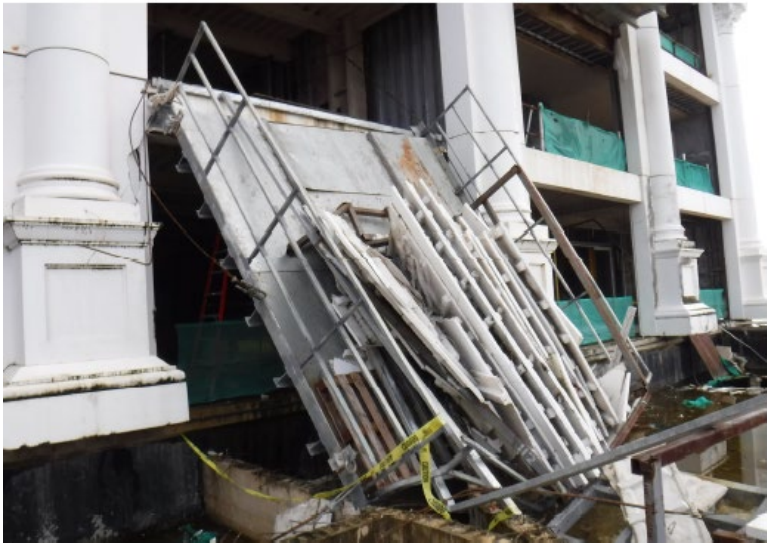
Figure 2 – Failed scaffold with material

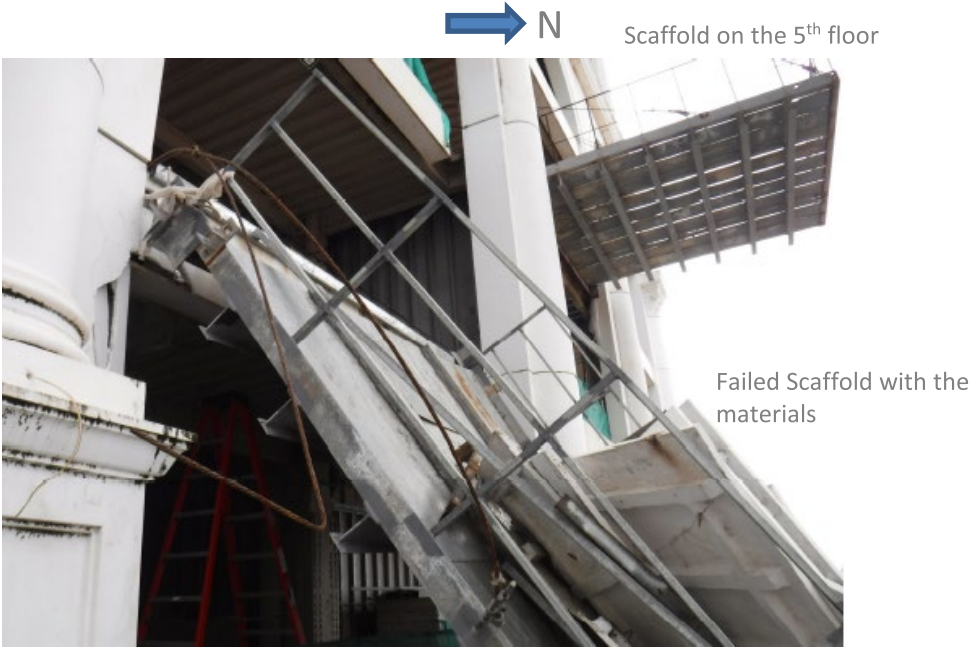
Figure 3 – Failed scaffold

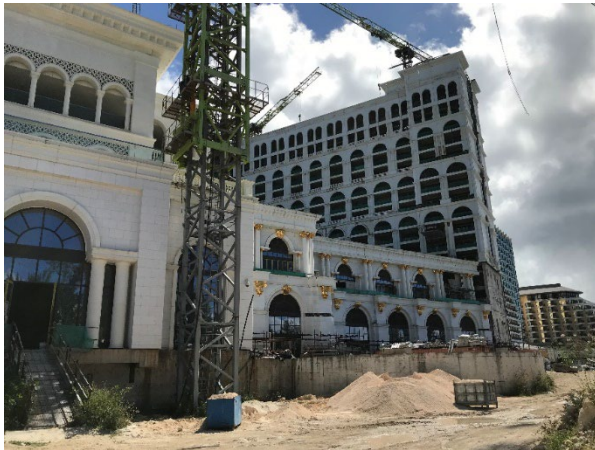
Figure 4 – Another view of the hotel

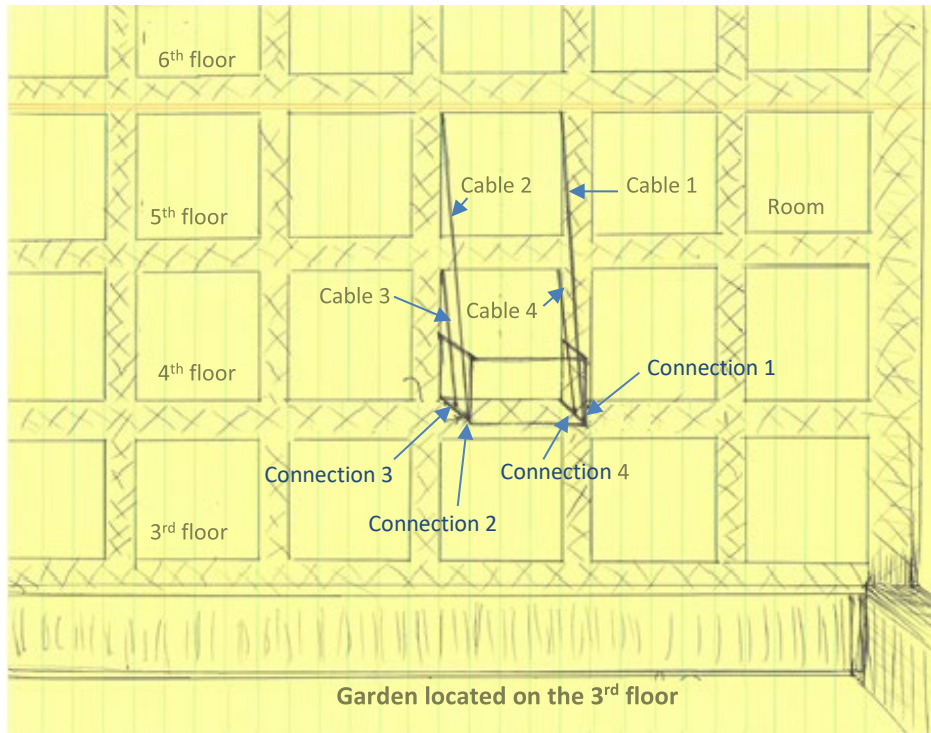
Figure 12 – Scaffold attachment schematic

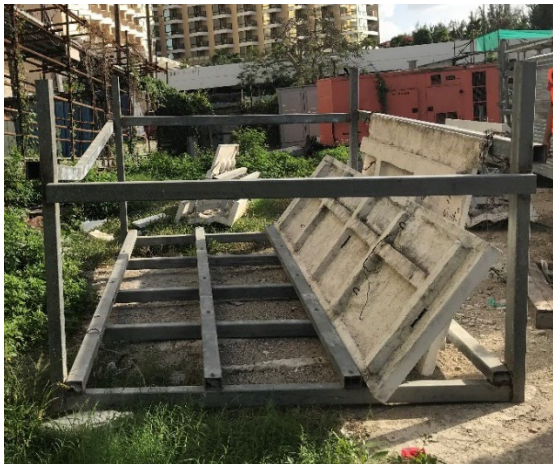
Figure 13 – Crate and GRC panels

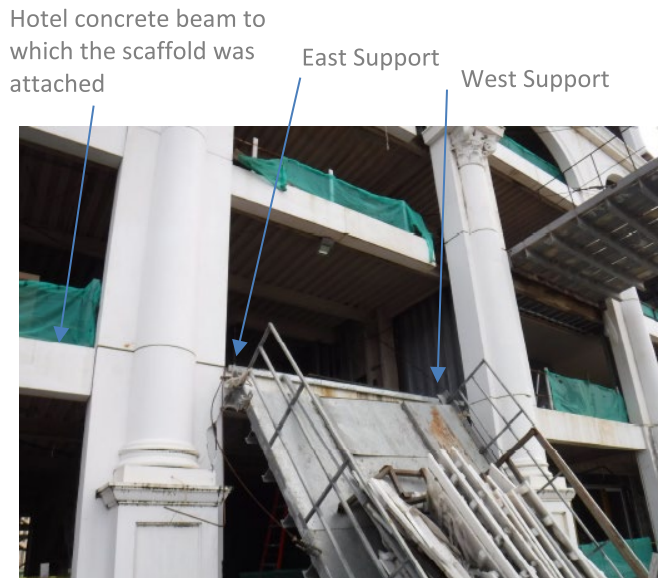
Figure 17 – Failed scaffold

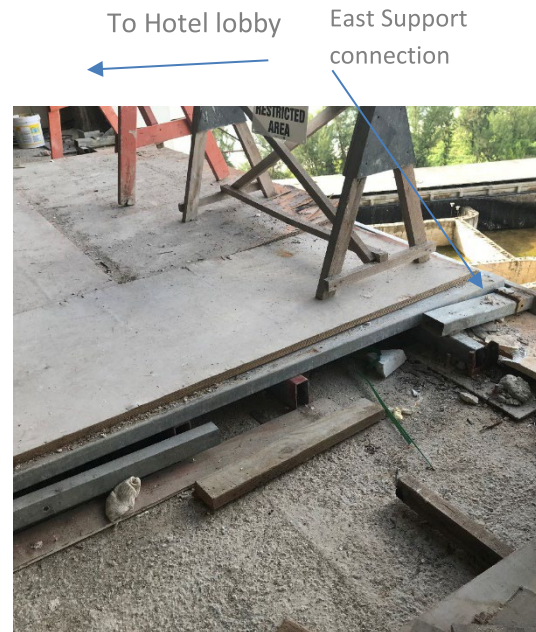
Figure 18 – Connection to the hotel beam (east support)

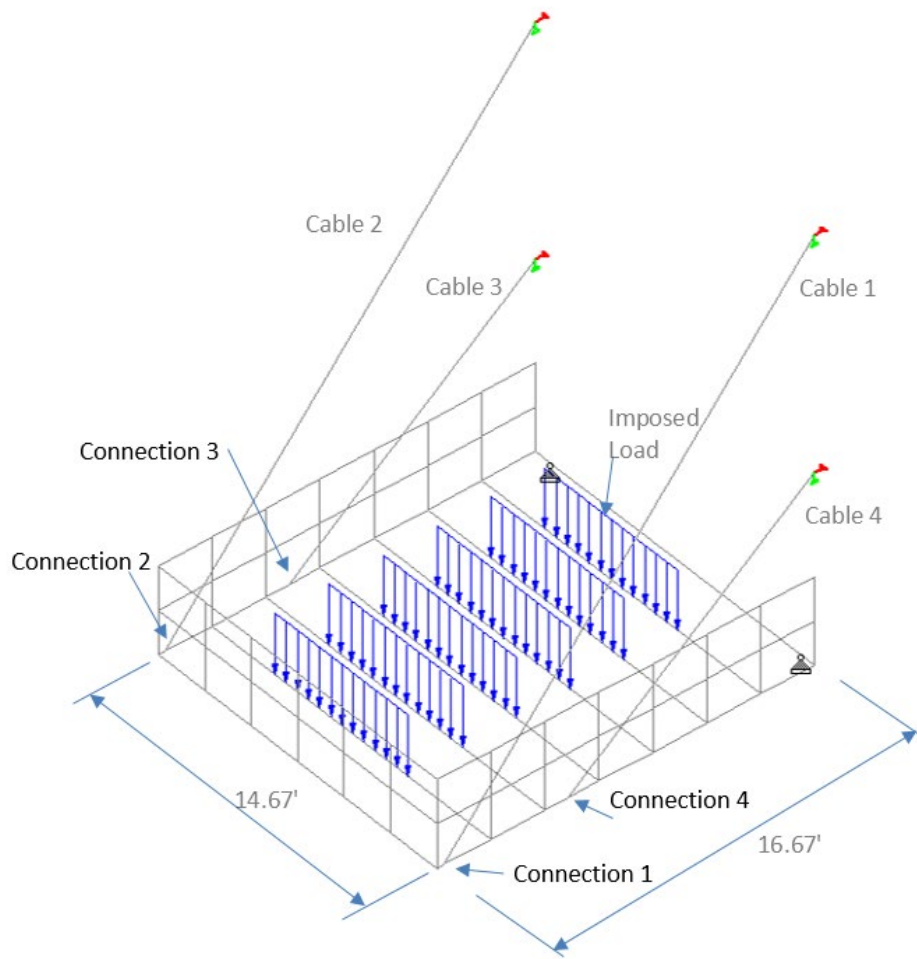
Figure 27 – Computer model for analysis

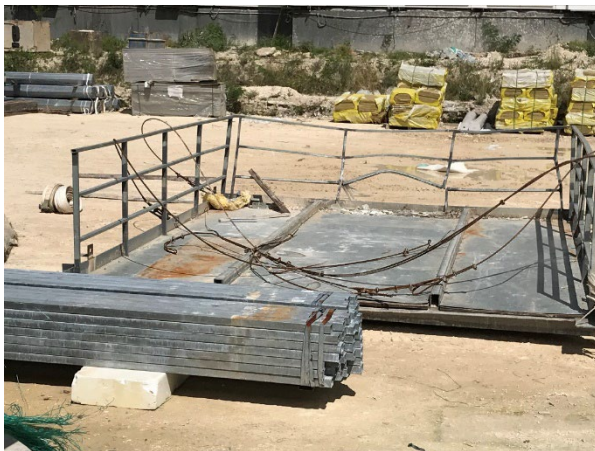
Figure 28 – Failed scaffold

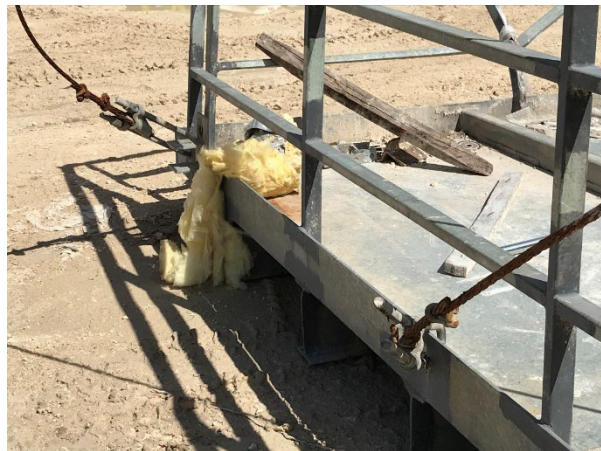
Figure 29 – Failed scaffold

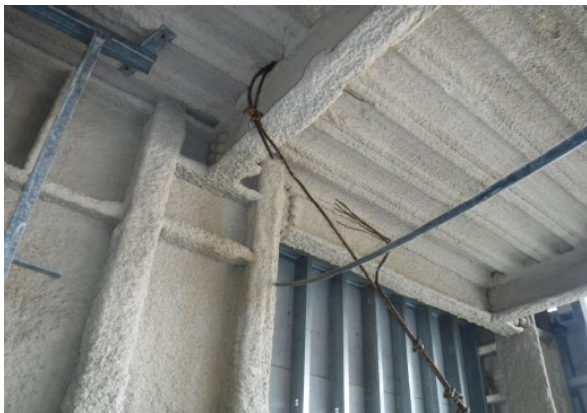
Figure 30 – Failed cable connections

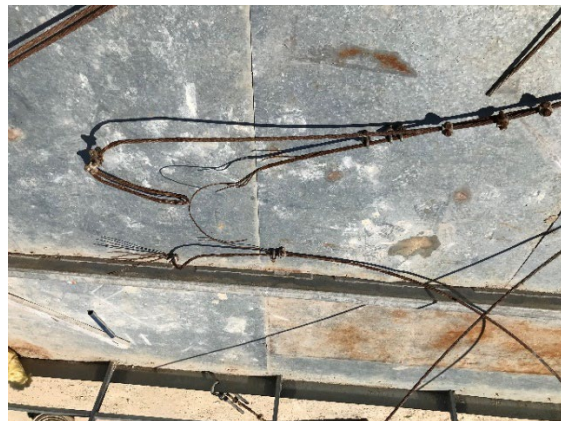
Figure 31 – Failed cable connections

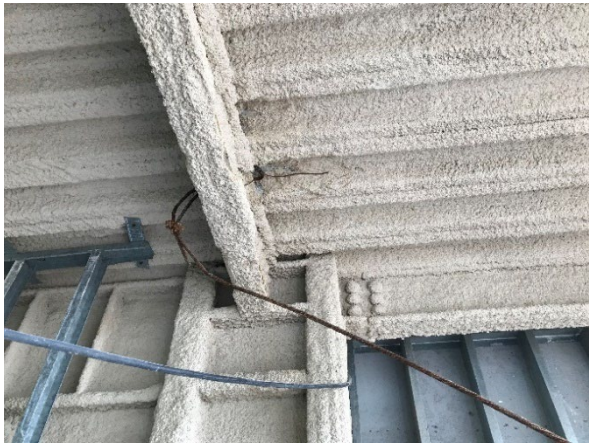
Figure 32 – Failed cable connections

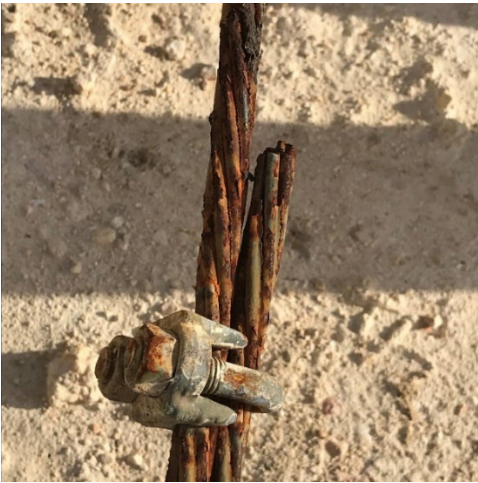
Figure 33 – Failed cable connections

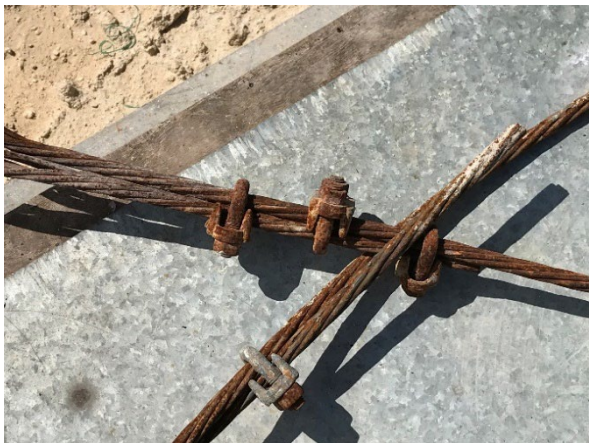
Figure 34 – Failed cable connections

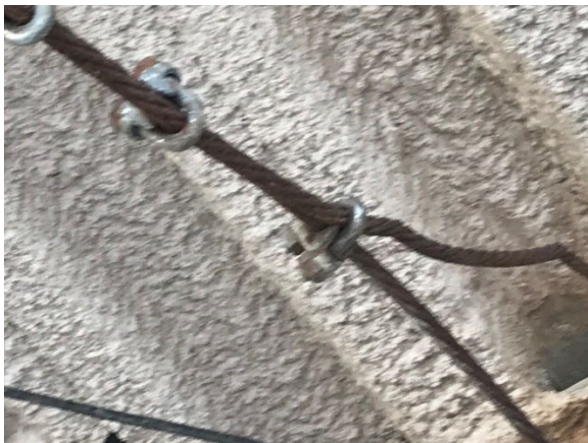
Figure 35 – Cable with kink that was used to support a scaffold on the fifth floor

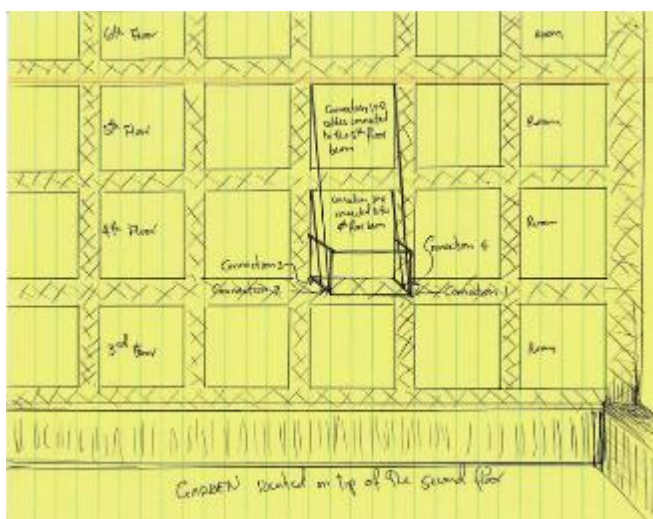
Figure 1: Diagram of the scaffold mounting on the hotel, showing the relative locations of the four cables supporting the platform.

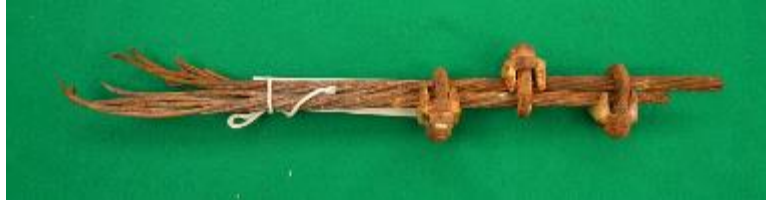
Figure 2: Sample 1 - Cable sample from the cable attached to the damaged scaffold Connection 1 (see Figure 1) Note the deformed ends at the left. Also note that the cable clips are installed improperly.

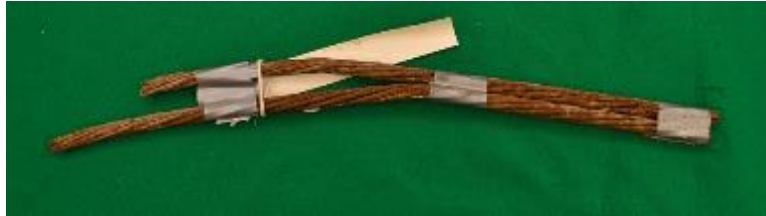
Figure 3: Sample 2- Cable sample from the cable attached to the damaged scaffold Connection 2 (see Figure 1). The sample was wrapped around the beam before it broke.

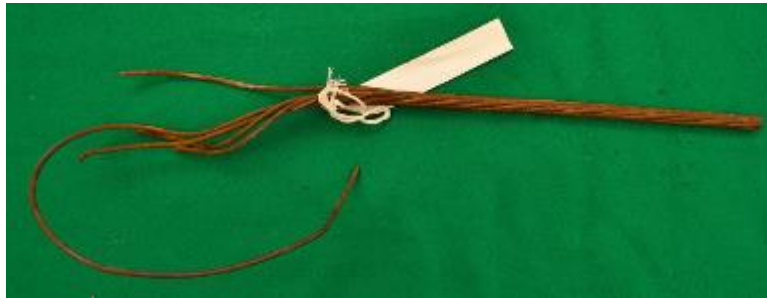
Figure 4: Sample 3A - Cable sample from the cable attached to the damaged scaffold Connection 3 (see Figure 1)

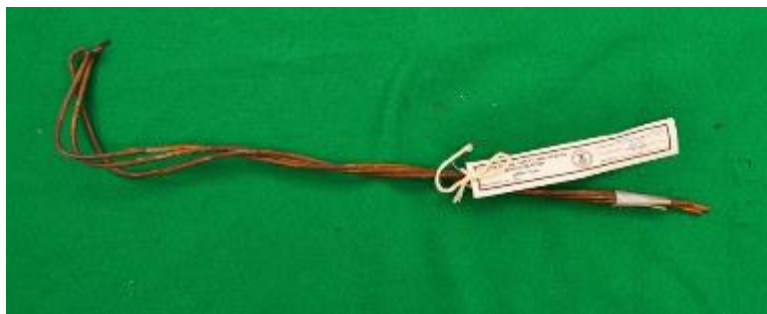
Figure 5: Sample 3B – Cable from scaffold Connection 3 (see Figure 1). The sample was the piece of cable left on the beam where Connection 3 was anchored to the building.

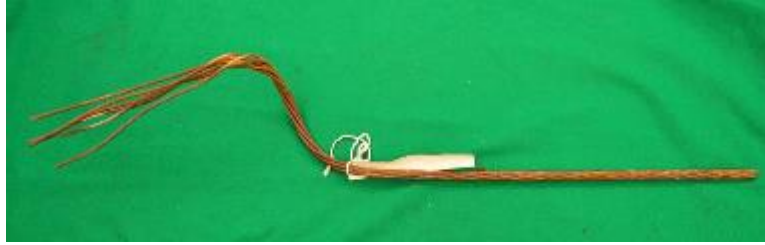
Figure 6: Cable sample from the cable attached to the damaged scaffold Connection 4 (see Figure 1). Note that all of the wire ends are cut.

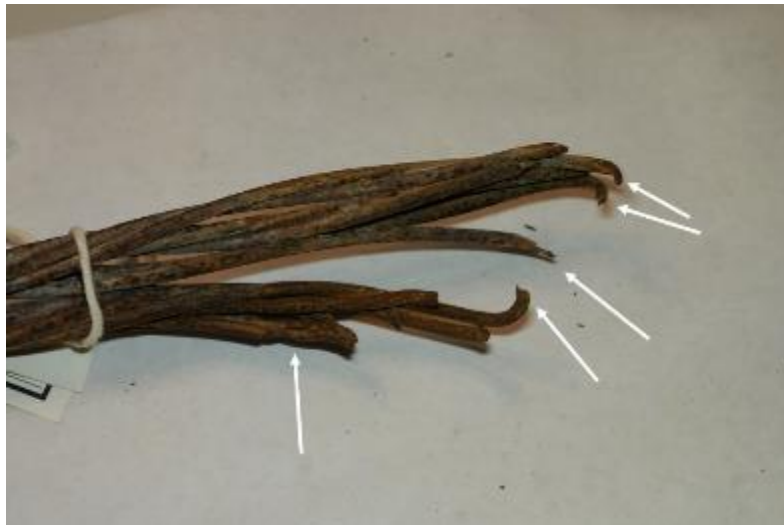
Figure 7: Failed end of Sample 1. The white arrows point to wire ends that failed in corrosion-assisted brittle failure. Also note several of the wires were bent around a small radius, which contributed to the failure.

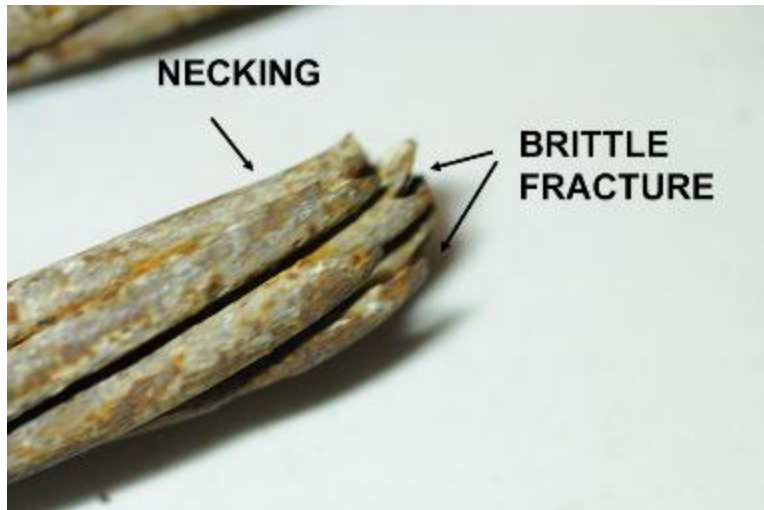
Figure 8: This is one of the ends of Sample 2. The overall cable showed some necking due to tensile failure. However, the individual wires demonstrate fracture typical of brittle failure.

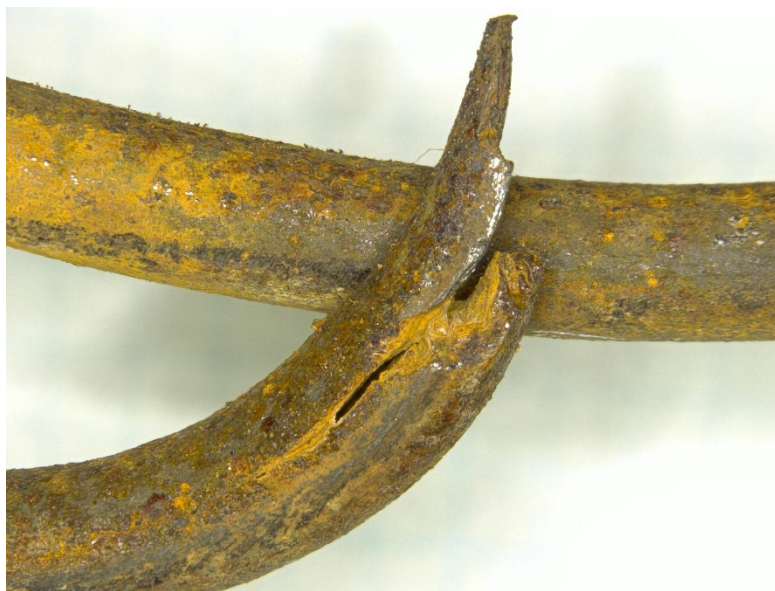
Figure 9: Failure of one of the wires in Sample 3A. The longitudinal crack is typical of corrosion-assisted brittle failure.

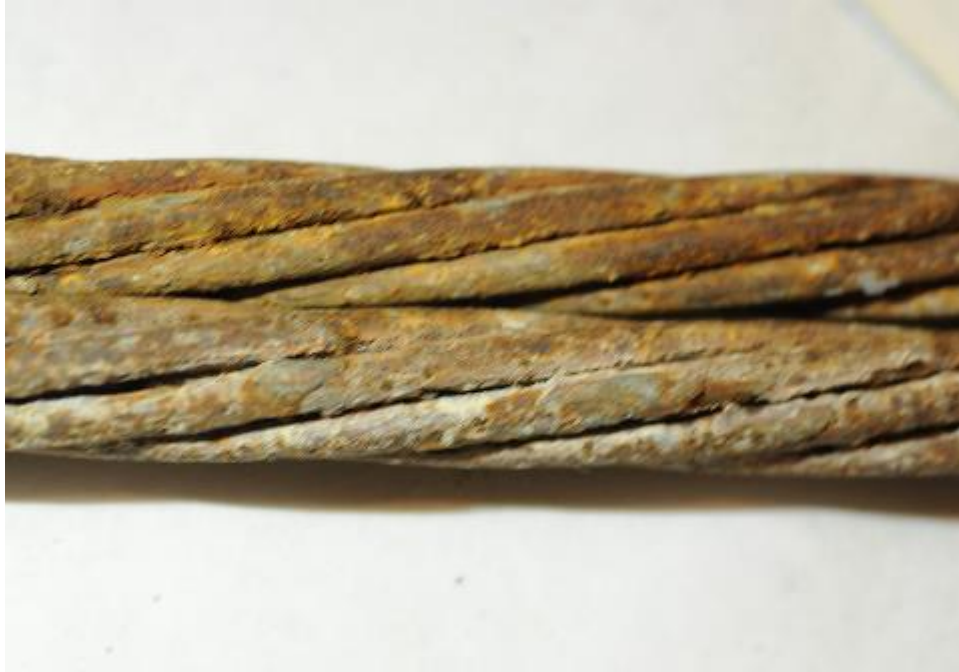
Figure 10: Example of the corrosion on the wire rope. Sample 4

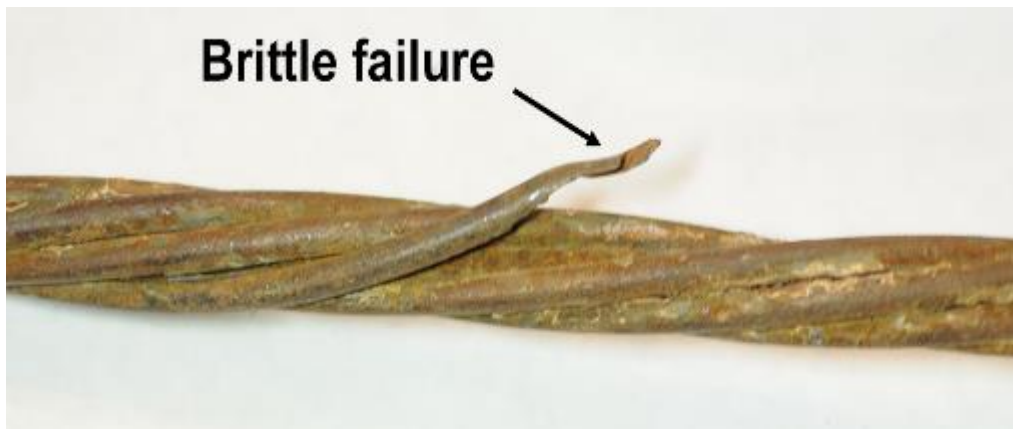
Figure 11: A broken wire on Sample 4 showing brittle failure with corrosion internally.

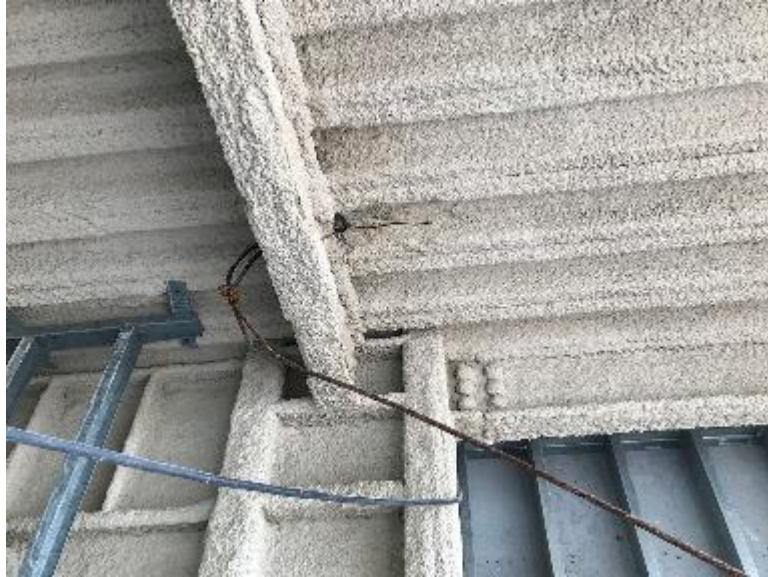
Figure 12: Broken wire rope where it went over a beam. There was no protection for the wire guy rope.

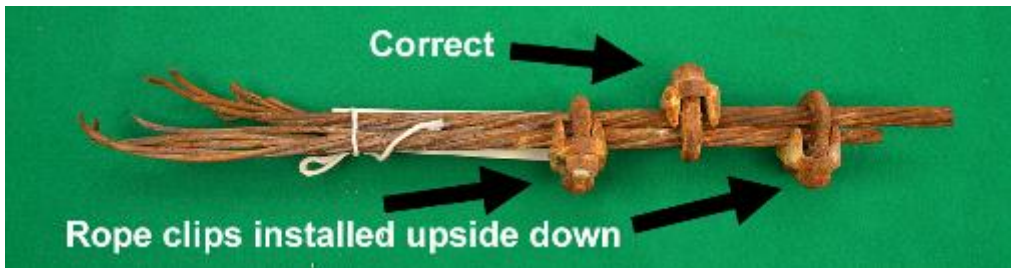
Figure 13: Sample 1. The rope clips are not installed correctly. The "U" shape of all of the clips must be installed on the short end of the wire rope.
