Aurora OSHA Construction News

Trenching Still A Concern

Volume 3, Issue 2
Fall 2002

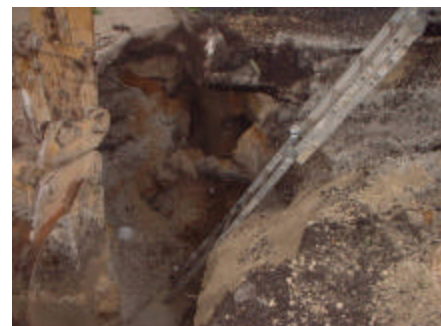
This is not a trench you would want to be in—even with a ladder.

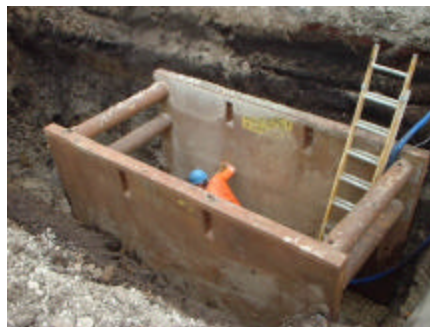
A trench box is being used—but what is wrong with this picture? Hint—what would happen if the soil on top collapsed?

- Personnel should be out of the box and above ground when the shield is being moved. You could be caught between the moving box and fixed object(s);
- The top of the shield should extend at least eighteen (18) inches above the level of any materials that could cave or roll into the trench;
- Some shields are designed to be stacked, one on top of another. **Never** stack shields that are not designed for that purpose, and do not stack shields from different manufacturers, as they may not be compatible.
- The forces of a cave-in can literally push a box sideways, causing a crushing hazard. After a

box is positioned for the work, the voids between the box and the trench wall should be filled with excavated material to prevent displacement caused by a cave-in.

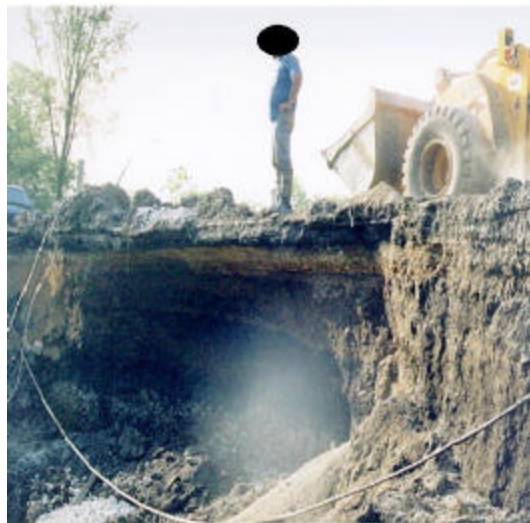
Yes—this is a violation. The excavation is undercutting the street and the front end loader only adds to the problem.
