# INVESTIGATION OF THE MARCH 22, 2012 PARTIAL BUILDING COLLAPSE DURING DEMOLITION AT 604-606 WEST 131<sup>ST</sup> STREET, NEW YORK, NY

U.S. Department of Labor  
Occupational Safety and Health Administration  
Directorate of Construction

July 2012

This report was prepared by  
Mohammad Ayub, P.E.; S.E.  
Office of Engineering Services  
Directorate of Construction

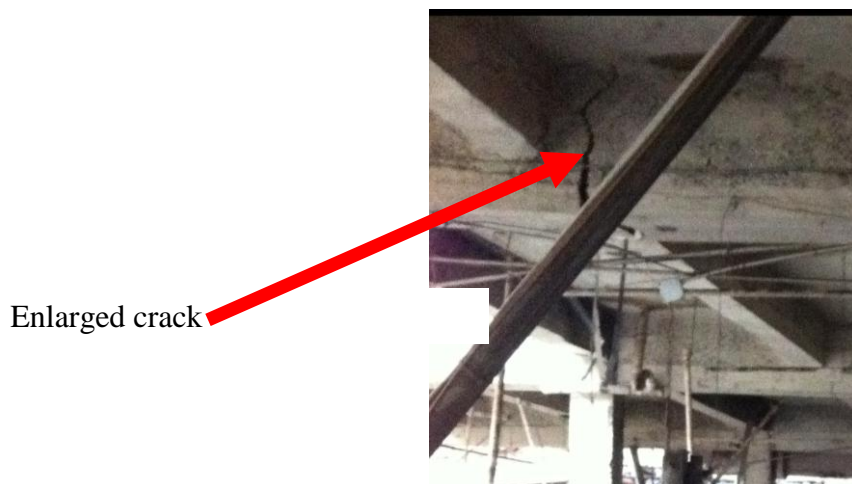
Despite the existence of the crack that developed after the girder on grid line B was cut, the next day, the contractor proceeded to torch cut the girder on grid line C some 4 feet away from column C2, similar to the cut made on grid line B. Soon after the cut was made, the collapse occurred, see Figure 10. Columns B2 and C2 remained standing upright but the segment of the girders on grid line B and C up to the location of the splice, along with two filler beams, fell in one piece towards the west. The longer girder segments on grid lines B and C, west of grid line 2, fell to the ground.

After the incident (Figure 10), the following were observed:

Post-incident observations from photographs revealed that the 30” girders located on grid lines C and B between column lines 1 to 2 failed at shear splice locations (Figures 11 to 14). The splice connection consisted of pairs of angles (5x4x5/16”x 1’-11½” long) riveted to the girder web and fastened back-to-back with 26-3/4” diameter square-head bolts (two rows of bolts at each angle, one row of 7 bolts and another row of six bolts), see figure below. Top and bottom flanges of the 30” girder were noncontiguous at the splice location.
