INVESTIGATION OF THE OCTOBER 10, 2012 PARKING GARAGE COLLAPSE DURING CONSTRUCTION AT MIAMI DADE COLLEGE, DORAL, FL

U.S. Department of Labor
Occupational Safety and Health Administration
Directorate of Construction

March 2013

This report was prepared by
Mohammad Ayub, P.E., S.E.
Directorate of Construction

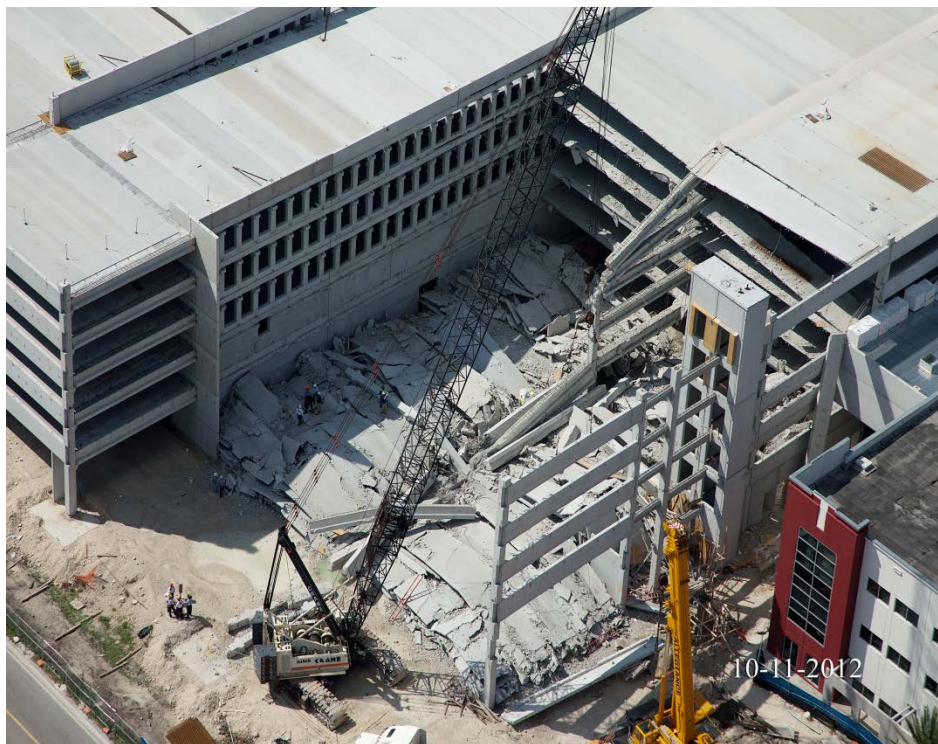
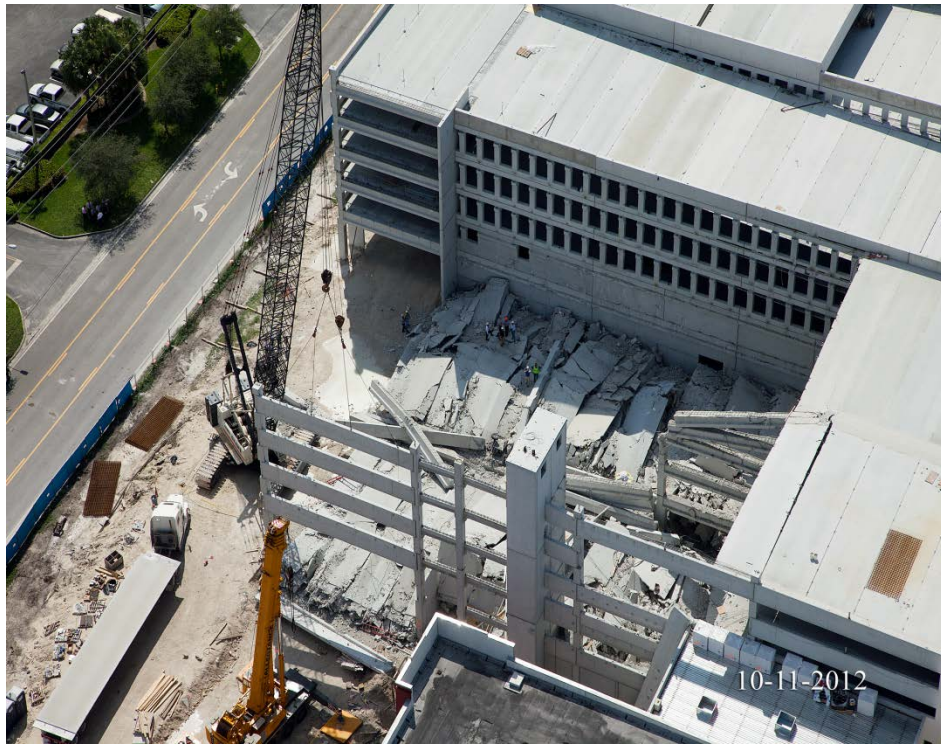
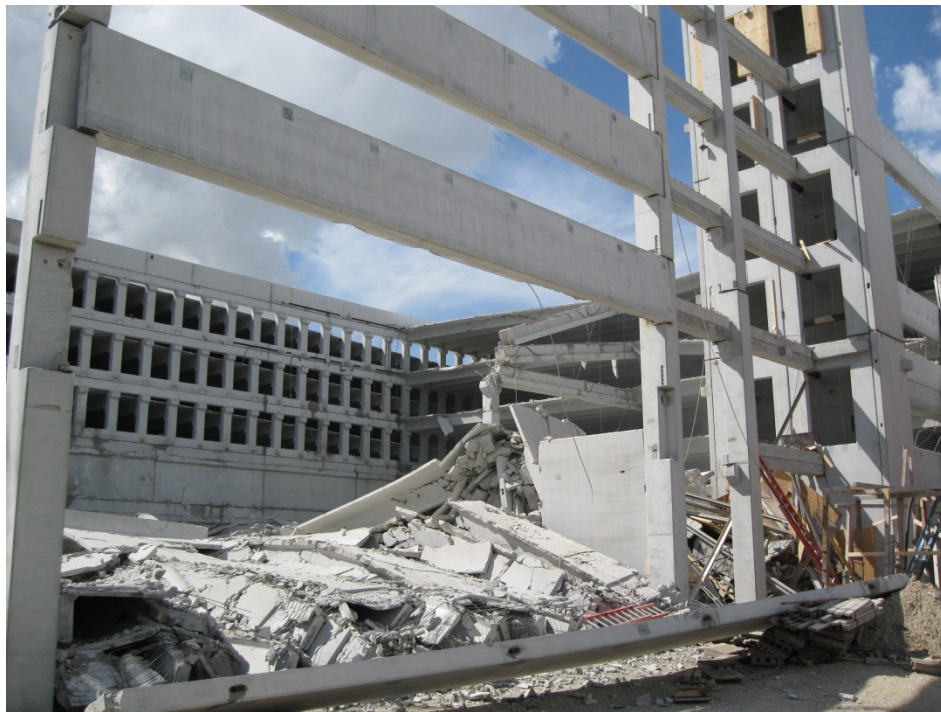
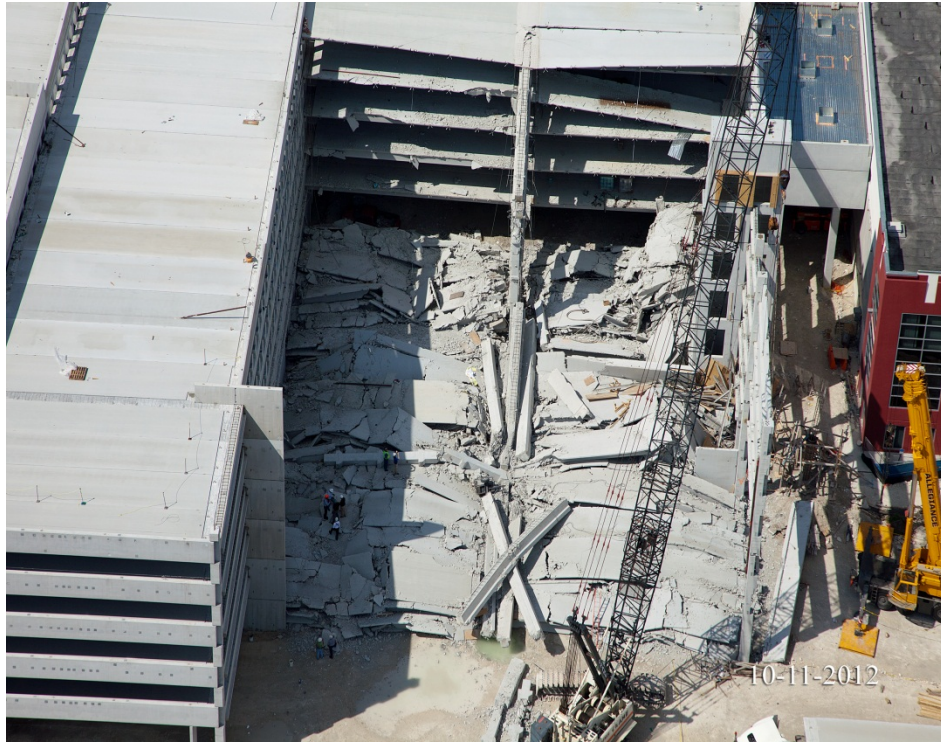
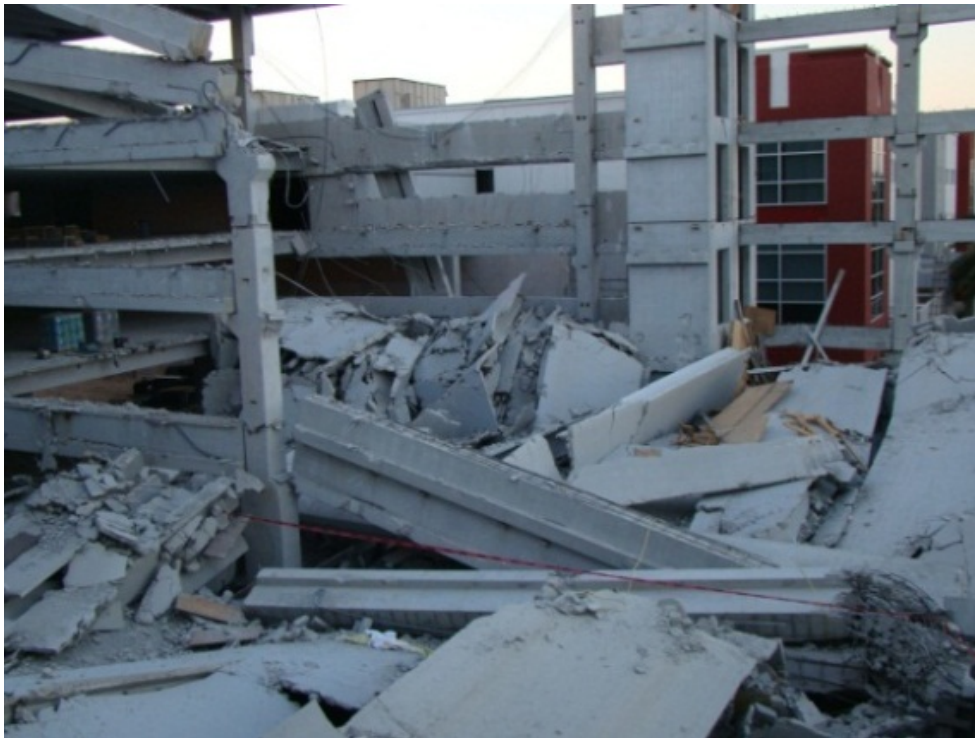
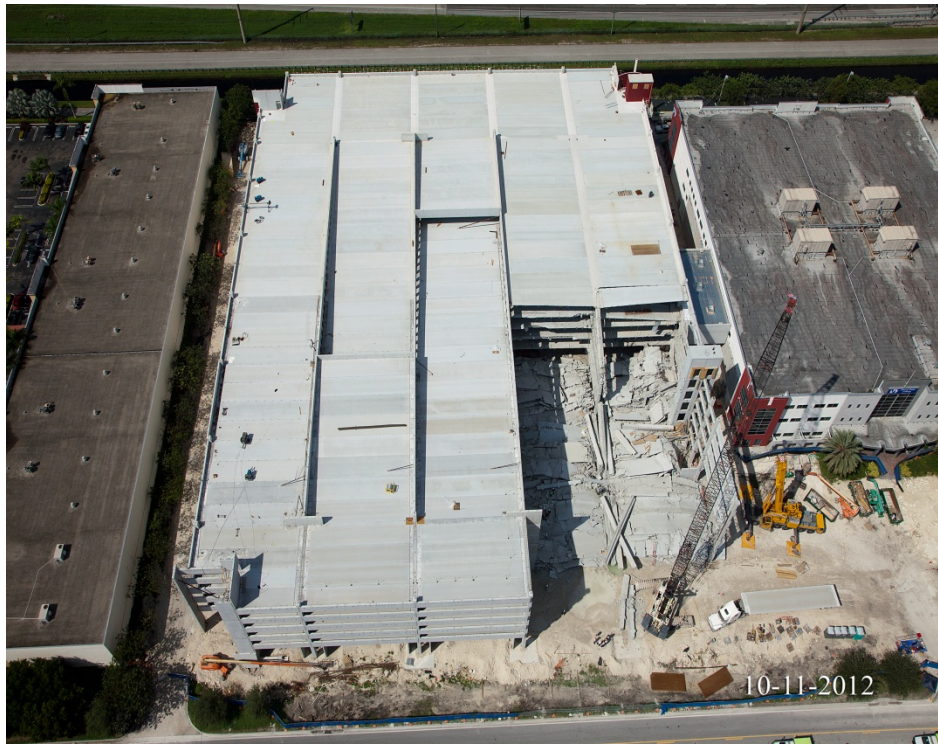
Fig. 11 – Aerial view of the collapse looking west

Fig. 12 – Aerial view of the collapse looking south

Fig.13 – Another aerial view of the collapse looking south

Fig. 14 – Another view of the collapse looking south

Fig. 15 – Aerial view of the collapse looking west

Fig. 16 – Another view of the collapse looking northwest

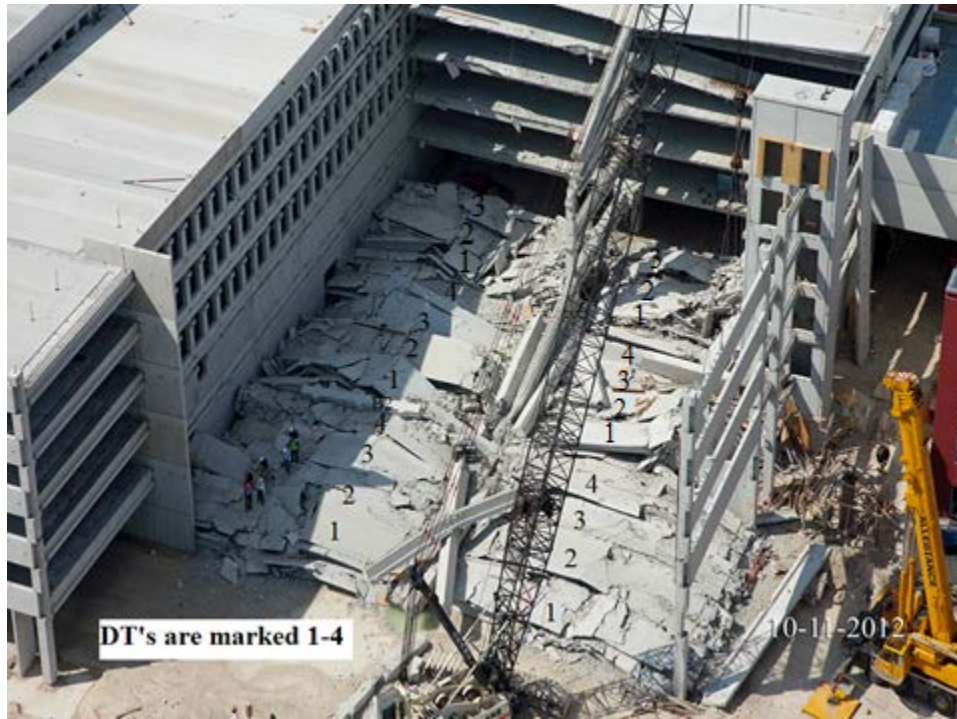
Fig. 19 – Some of the fallen DT's

The upper and lower segments of columns B2 and B3 fell to the ground near their bases but skewed in different directions, see Fig. 18. The upper segment of column B4 above the fourth level fell to the ground, but the lower segment of column B4 and the remaining upper segment remained standing almost plumb, still attached to its footing. The splice between the upper and lower segments of column B4 remained intact. The weight of the B2 and B3 columns were approximately 45 tons. Thus, the total weight of concrete members collapsed into grids A to C and 2 to 4 was approximately 3,300 tons. The columns on the A grid lines remained standing but out of plumb, see Fig. 19.

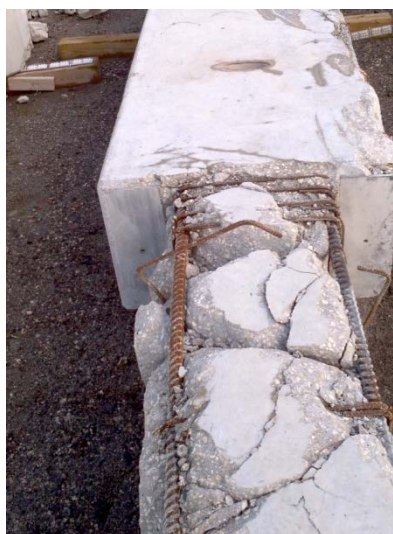
Fig. 39 – B2 lower segment C113

The southeast anchor bolt was bent toward the west. The bottom of the base plate was 6½" from the top of the concrete. The southwest and the northeast anchor bolts were also bent towards the west. The northwest bolt remained nearly vertical. The space below the base plate was grouted although it could not be ascertained whether it was 100% grouted over the entire area.

The column was 24"x24" except 42" (east-west direction) x 24" below the second floor bearings for the IT beams.

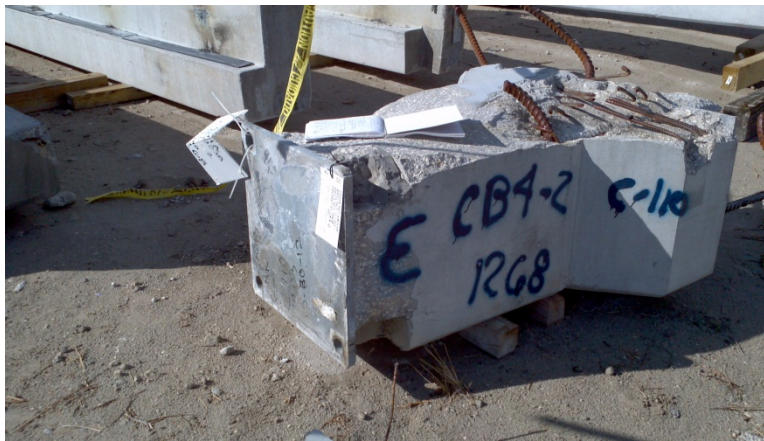
The upper segment of column B4 disintegrated between the fifth level and fourth level corbels. The fourth floor splice remained intact. The remaining portion of the column fell to the ground towards the east-west direction, see Fig. 40. When the column partially disintegrated above the fourth floor and below the fifth floor corbels, see Fig. 53 thru 55, the IT beams between columns B-4 and B-5 supported over the sixth and fifth floor corbels fell over the fourth floor IT beam, and remained there after the collapse, see Fig. 52. The remaining portion of the upper segment remained connected to the lower segment through the splice. The column was 24"x24" reinforced with four #11 bars.

Fig. 53 – Column B4 upper segment above splice after demolition

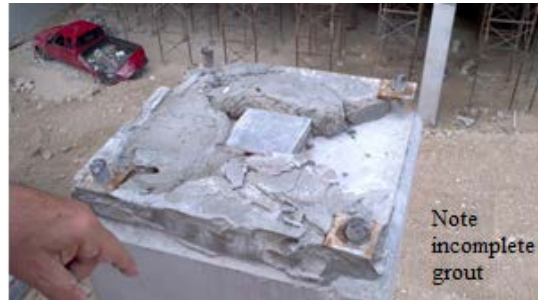
The column was nearly plumb within an inch. The splice between the segments was grouted for $\frac{3}{4}$ of the area but $\frac{1}{4}$ of the area did not appear to have been grouted, see Fig. 56 and 57. Also, smaller shim plates were used at the splice. The four anchor bolts at the splice remained intact, and had to be burnt during the removal phase. The third floor corbel was unremarkable. The column became wider below the second floor to 42" (E-W) x 24" (N-S). The lower segment was undamaged.

Fig. 57 – Close-up of the grout at splice of B4 column

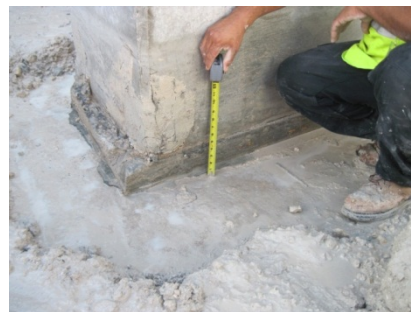
Fig. 59 – Grout at base of Column B4

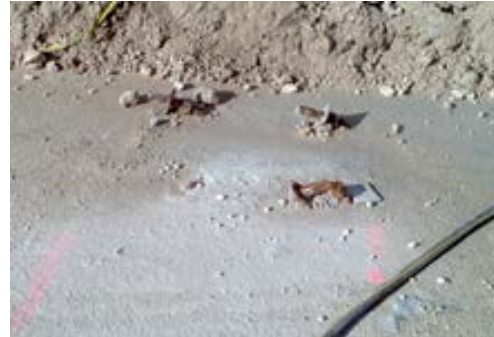
Fig. 62 – Base of column A3.3. No grout
