# **INVESTIGATION OF THE MARCH 25, 2014 FAILURE OF GIN POLE RIGGING, AND COLLAPSE OF CELLULAR TOWERS AT BLAINE, KS.**

U.S. Department of Labor  
Occupational Safety and Health Administration  
Directorate of Construction

August 2014

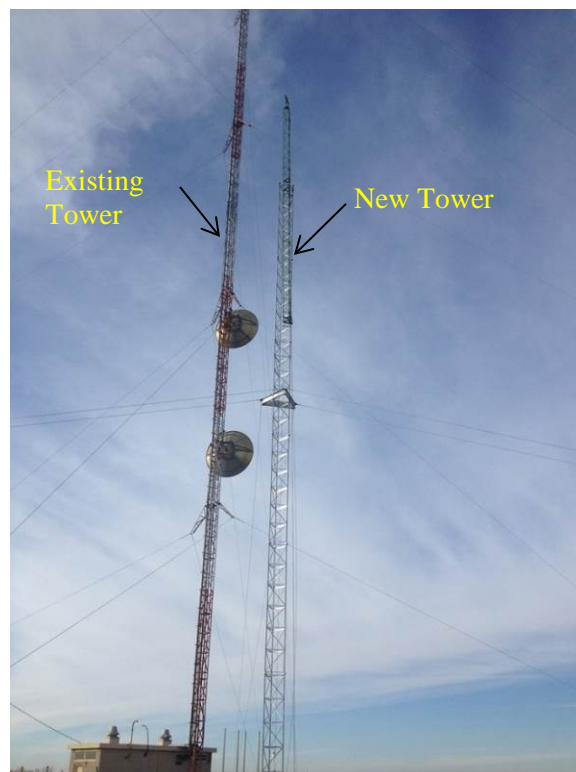
Sabre in turn retained Wireless Horizon, Inc. , of 7870 Mexico Road, St. Peters, MO 63376 (Horizon) to construct new towers at the two locations including foundations and fences, and to transfer necessary equipment to the new towers. Sabre was also to remove the existing towers at both the locations. Horizon installed the new towers at both the locations and then proceeded to remove the older towers, see figure 1.

Figure 1 – Existing and New Tower at Blaine, KS

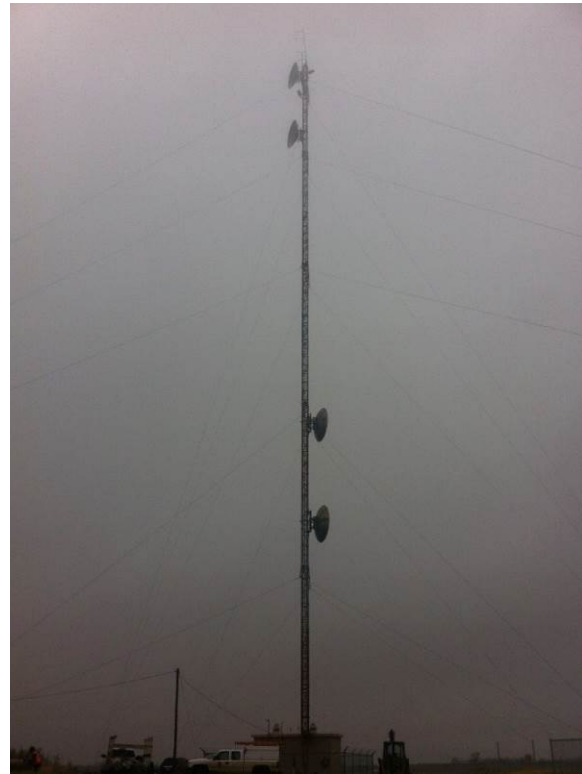
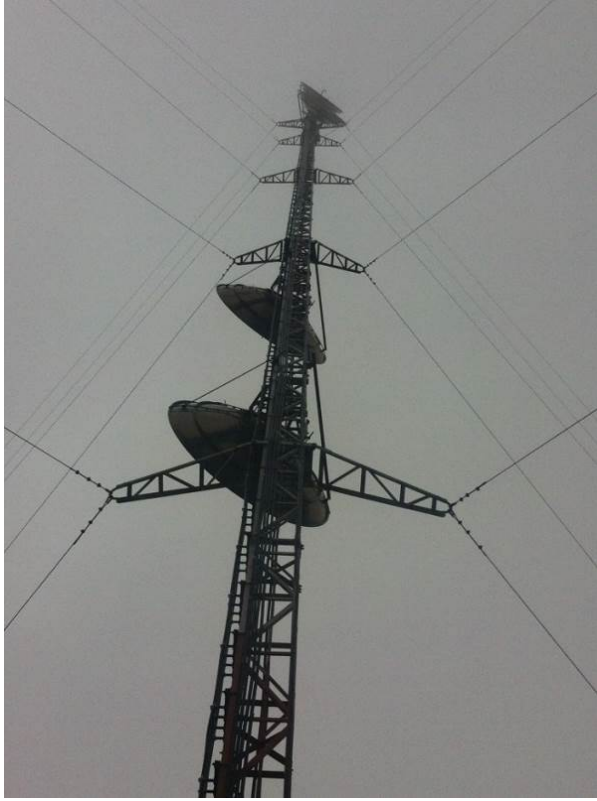
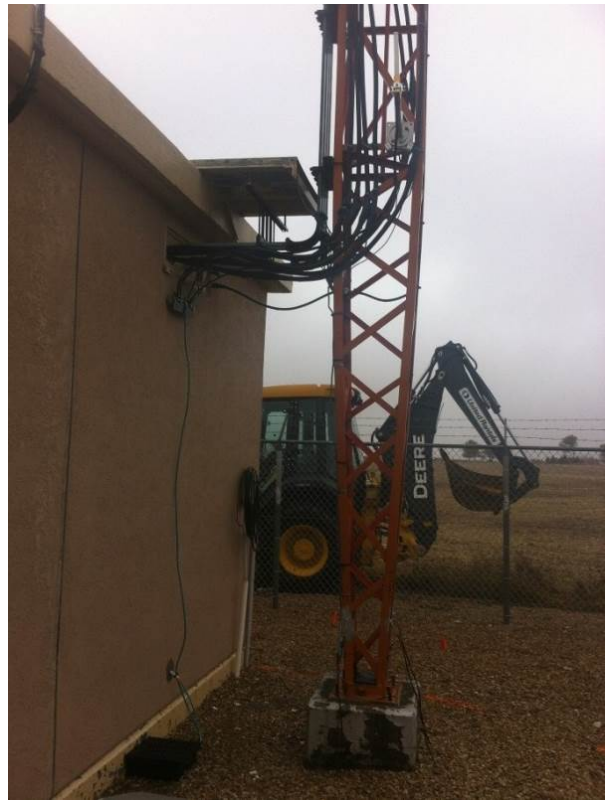
Figures 3 to 5 show the tower before the collapse, and figures 6 and 7 show the tower lying on the ground after the collapse. Existing tower elevation drawing and existing loads are shown in figures 8 and 9.

Figure 3 – Existing Tower – photo before collapse

Figure 4 – Existing Tower – photo before collapse

Figure 5 – Existing Tower – photo before collapse

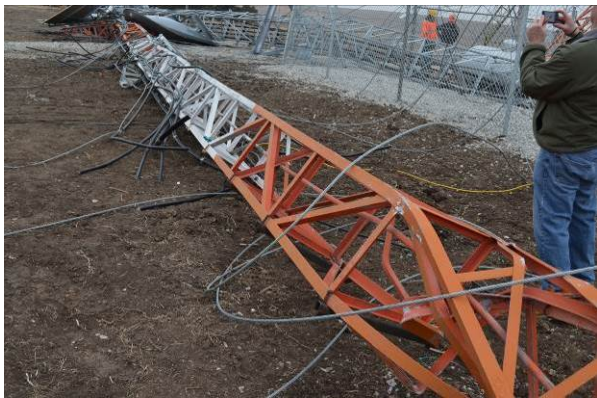
Figure 6 – Existing Tower on the field after collapse

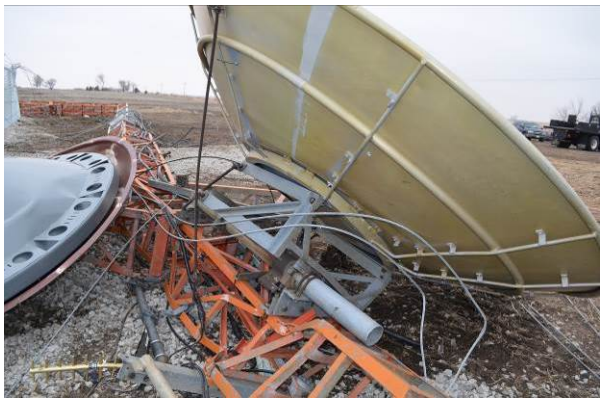
Figure 7 – The dish that was being removed

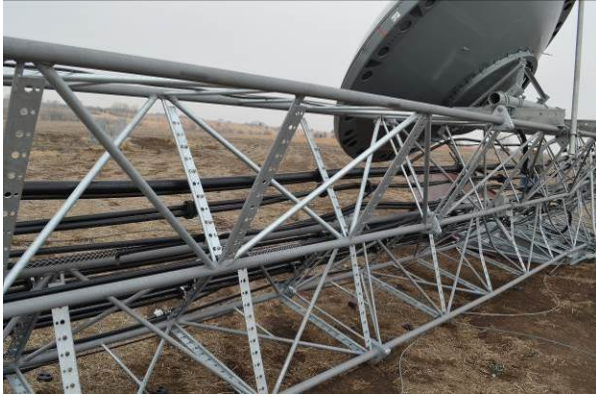
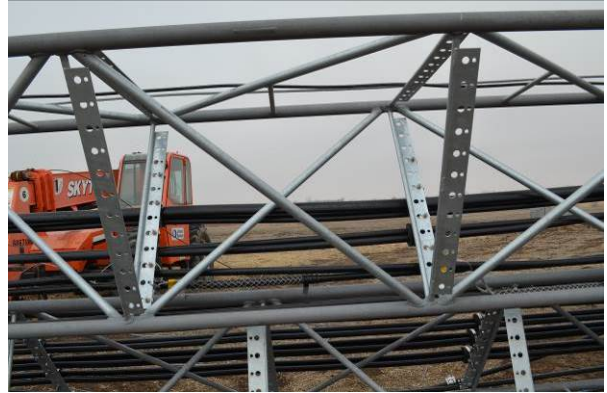
Figure 14 –New Tower after collapse

Figure 15 –New Tower after collapse

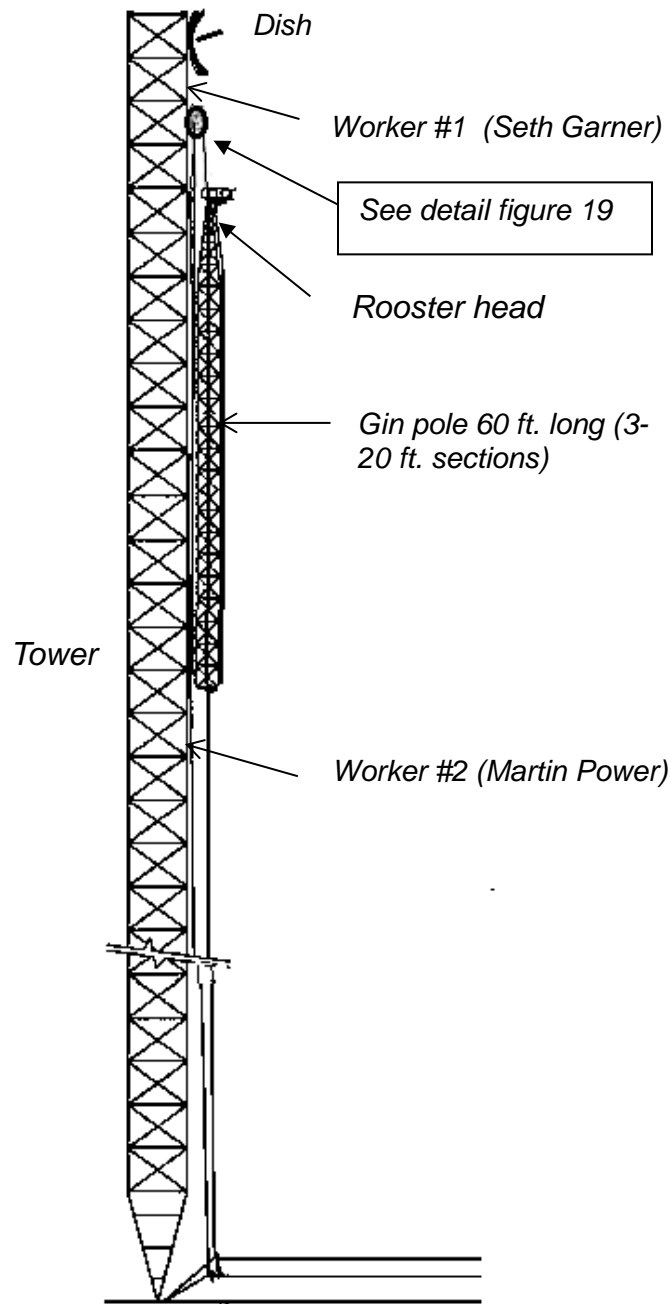
crew was trying to disconnect the 10 ft. diameter dish located at an elevation of 240 ft. to be removed later by the gin pole, see figure 18. The crew consisted of four employees; a foreman, a winch operator and two workers on the tower. The task for the day was to jump and install the gin pole on the tower, lower the remaining dish and then begin dismantling the old tower section by section with the assistance of the gin pole.

Figure 18 – Rigging elevation at the time of the incident

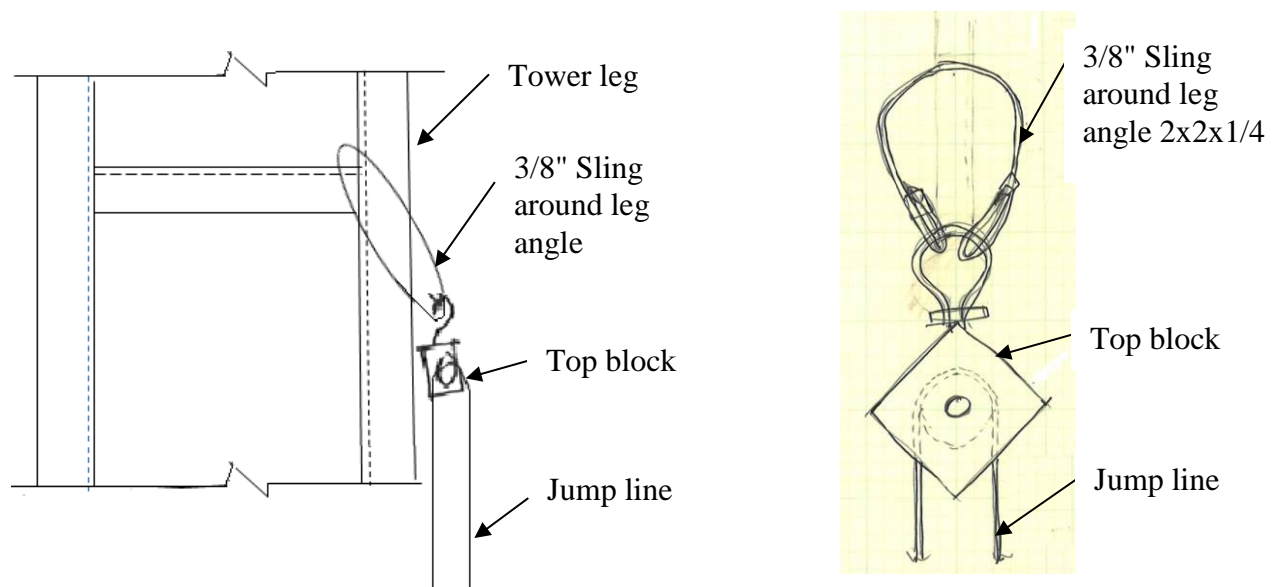
Horizon was using a 12” triangular gin pole 60 ft. long comprised of three sections, 20 ft. each. The top block of the jump line was rigged to a single tower leg as shown in figure 19. The legs of the tower consisted of steel angles 2x2x1/4. The sling which was wrapped around the tower leg and connected to the top block for jumping the gin pole was a 6x19 IWRC 3/8” diameter wire rope, 3 ft. in length. The ratings marked on the sling tag were 1.2, 0.92 and 2.5 tons for vertical, choker, and basket configurations, respectively, see figure 19. The top block had a stamp of McKissick, Tulsa, OK with a rating of 4 tons, see figure 20. The jump and load lines were 3/8” and 7/16” diameter wire ropes, respectively. The gin pole from the site is shown in figures 22 and 23. The load chart provided by Horizon indicated LeBlanc as the manufacturer. The winch was Braden Model PD10D, see figures 24 and 25.

Figure 19 – Hand drawn rigging details

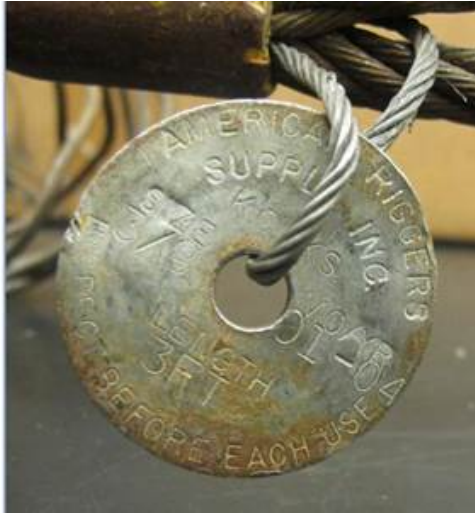
Figure 20 – Slings

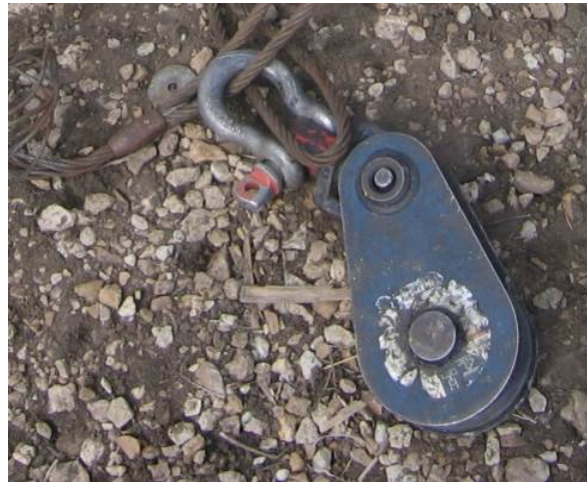
Figure 21 – Top block

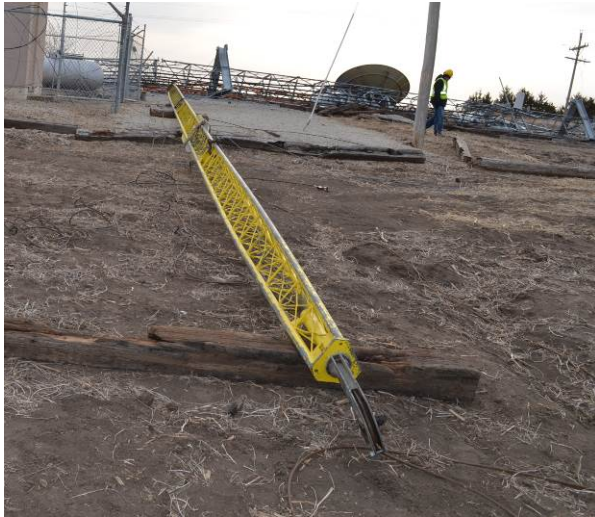
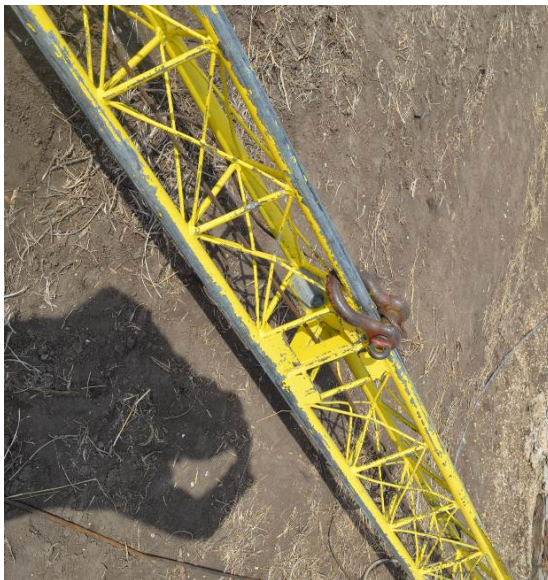
Figure 22 – Gin pole

Figure 23 – Gin pole

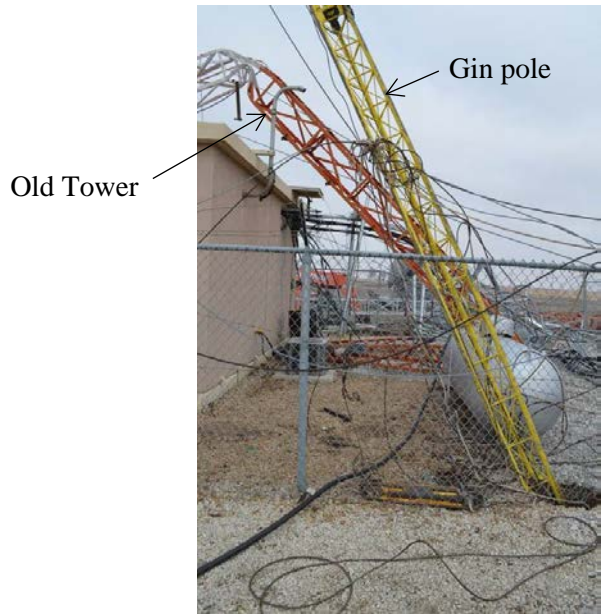
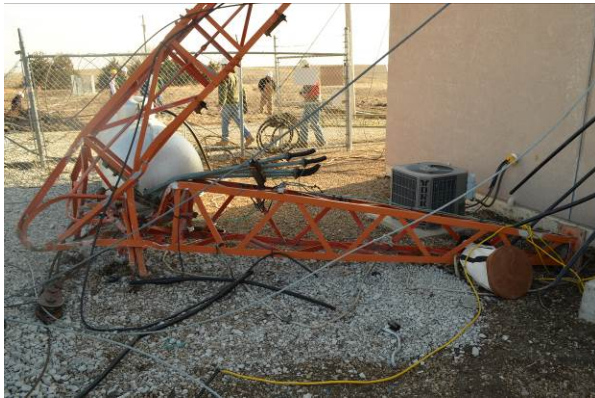
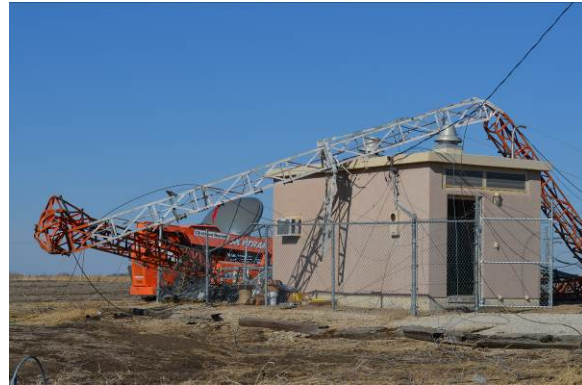
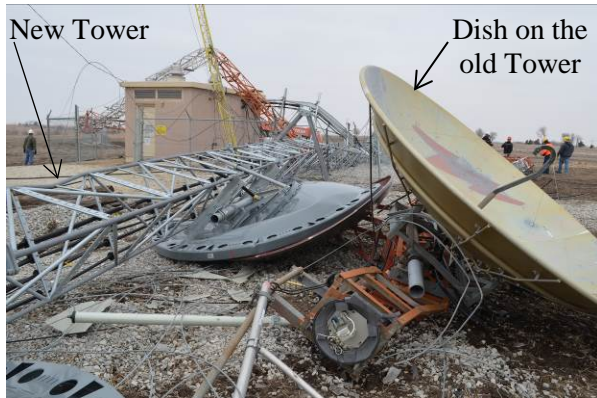
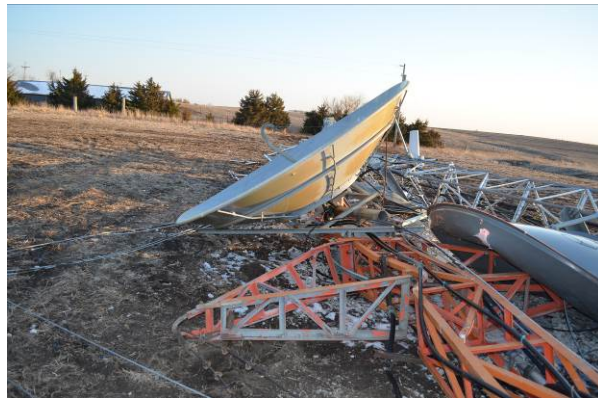
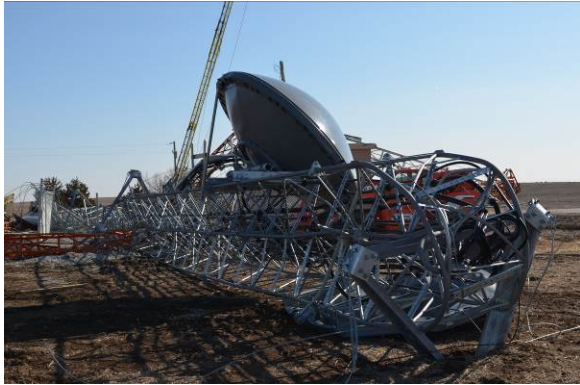
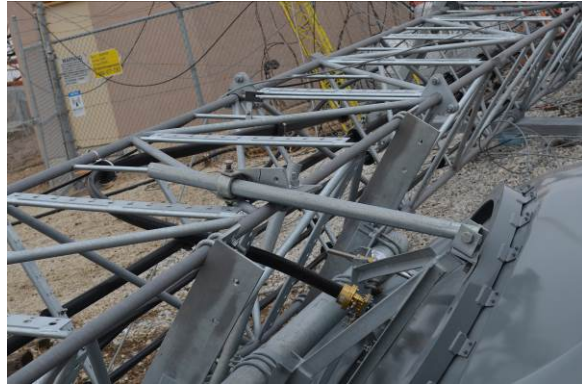
The crew had already unbolted the stiffener arm of the top-most dish and rotated to clear the gin pole. At the time of the incident, the gin pole was being jumped. There was no load on the jump line other than the weight of the gin pole, wire rope and the top block. . The two workers on the tower were monitoring the movement of the gin pole to raise it to a level to facilitate the removal of the dish. Around 9:30 a.m., suddenly there was a popping sound and the gin pole came crashing down along with the tower. When the tower collapsed, it took down the new tower that was just next to it, resulting in a pile of twisted metal laying on the ground, see figures 26 to figures 32. The workers on the tower were equipped with personal fall arrest protection.

Figure 26 – Collapse photo

Figure 27 – Collapse photo

Figure 28 – Collapse photo

Figure 29 – Collapse photo

Figure 30 – Collapse photo

Figure 31 – Collapse photo

Figure 32 – Collapse photo

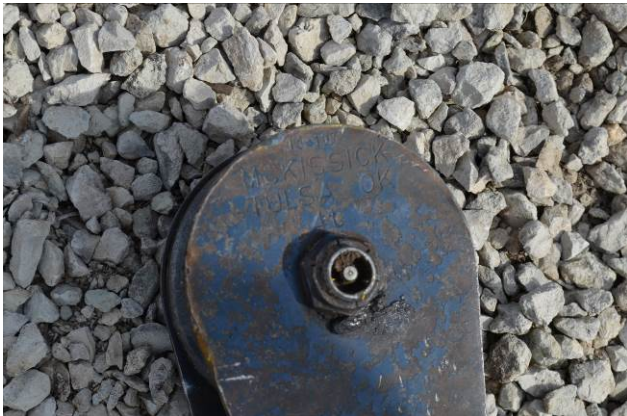
Two days after the incident, on March 28, the gin pole (see figures 33 and 34), the sling and top block assembly, the winch spool, the bottom portion of the existing tower and the top portion (40 ft.) of the existing tower were identified as evidence for the forensic investigation. The 3 ft.-long 3/8" sling, wrapped around the leg of the tower was found damaged and broken, see figures 35 and 36, and OSHA took custody of the sling and block assembly. The sling and block assembly

Figure 36 – Top block
