# Investigation of the November 13 and 14, 2014 collapses of two pedestrian bridges under construction at Wake Technical Community College Campus, Raleigh, NC

U.S. Department of Labor  
Occupational Safety and Health Administration  
Directorate of Construction

April 2015

Report Prepared by  
Mohammad Ayub, P.E., S.E.  
Office of Engineering Services  
Directorate of Construction

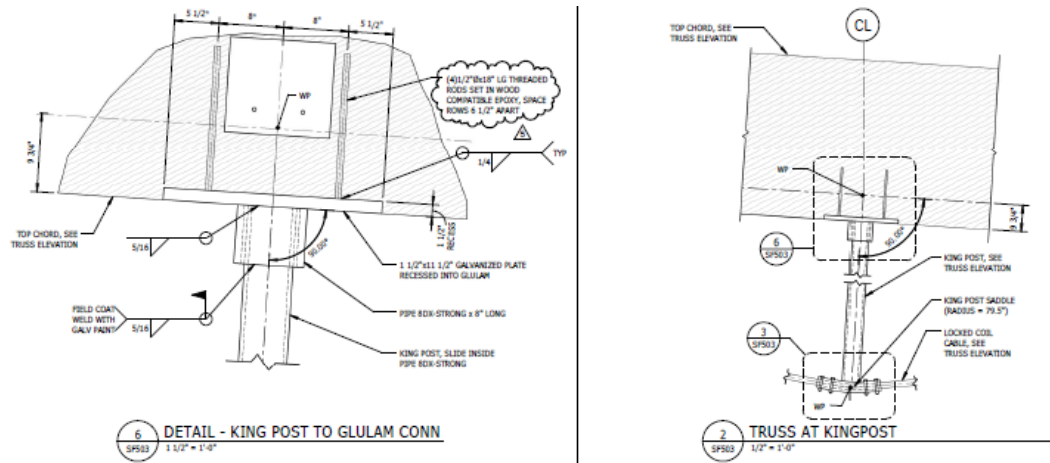
Fig. 14 – King post to glulam connection detail

The center posts were connected and welded to a larger tube attached to the underside of the glulam, see detail below.

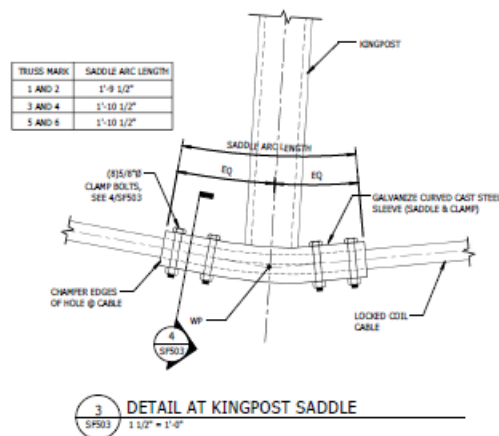
Fig. 15 – Detail at kingpost saddle

A saddle was attached to the bottom of the king post to receive the cable as detailed below.

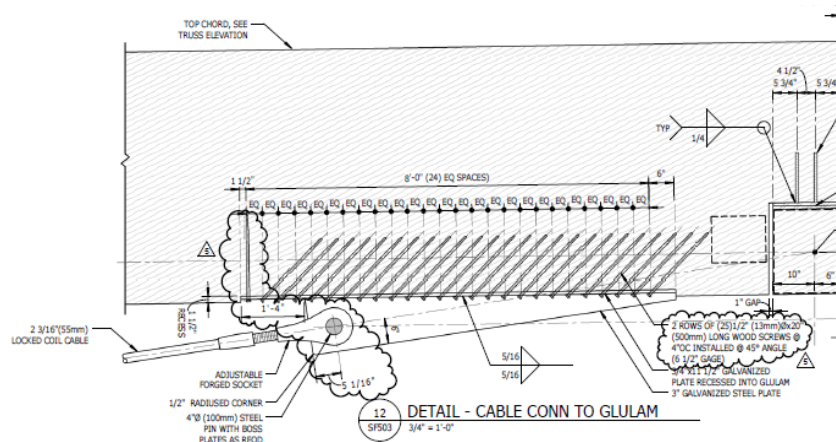
Fig. 16 – Cable connection to glulam at pinned end

The cable at each end was fastened to a plate with a 4" diameter steel pin. The plate was attached to the bottom side of the glulam beam with a series of (50) 1/2" dia. screws, 20" long at 45 degrees. The locked cable was provided with an adjustable forged socket, as shown in the following typical detail.

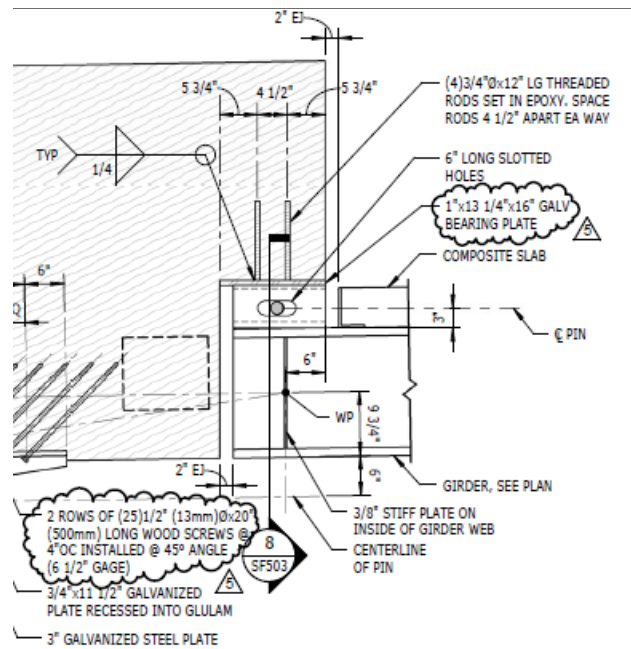
Fig. 18 – Sliding connection of the glulam girders

The sliding joint was provided with a pin which could slide in a slotted hole as shown here:

cracking due to notching. There were no cracks observed on those glulam girders projecting from the V-column after the incident. Unfortunately, similar embedded plates were not provided in the glulam girders of the trusses where long horizontal cracks were observed after the incident, and this was a primary cause of the failure.

Notches in wood members have been a perennial concern among structural engineers, and all textbooks and codes recommend against using them unless remedied by providing long lag wood screws crossing the potential line of cracks, or by steel plates bolted to the glulam beams on either side. The well-recognized concern is based upon the reduced section for shear, stress concentration at the notch in re-entrant corners, and the tendency of the notch to induce stress perpendicular to the grain, resulting in tearing of the section where horizontal shear occurs. The potential formation of the cracks is more likely in the tension zone rather than in the compression zone. The end section of the glulam girder underwent a transformation of stresses when the camber initially induced gradually diminished under the application of the dead loads of concrete. In this particular case, the situation was exacerbated by the vertical component of the tension in the cable which could accelerate the tear at the ends. Additionally, the wood near the mid-depth of the section is generally of lower quality laminations, not as high quality as wood near the top and bottom of the glulam contributing to the propagation of the cracks. Both ends were designed as pins with one end having sliding capability. The National Design Specifications (ANSI/AF&PA NDS-2005) permits notches at bearing over a support on the tension side not to exceed lesser of  $1/10$  the depth of the member or 3", and on the compression side not to exceed  $2/5$  of the depth of the member. In this instance, the limits were exceeded.

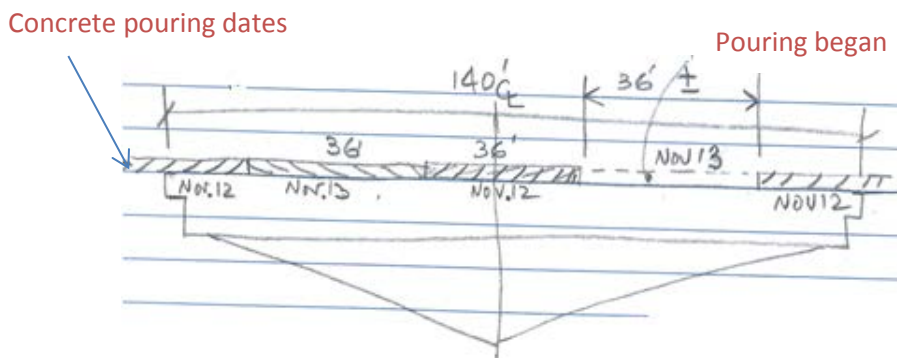
Fig. 20 – Dates of concrete deck pouring for Bridge No. 1

Buckner erected the V-columns on either side of the central span of bridge No.1 on or about September 8, 2014, and erected the central span with king post and cables on or about October 15, 2014. The steel beams and the metal deck were then erected. Central Concrete placed re-bars over the deck on or about November 10, 2014. Two days later JO Concrete began to pour concrete over the deck in a staggered manner in accord with the structural drawings. The following sketch shows the dates of pouring for the deck up to the day of the incident.

At the time of the incident the segment of the deck near the center of the span was being poured when suddenly the trusses collapsed some 25 feet to the ground with five employees of JO Concrete falling to the ground. One was fatally injured, and four others sustained serious injuries of varying degrees. The glulam girders horizontally split in two sections, as roughly depicted in the sketch below.

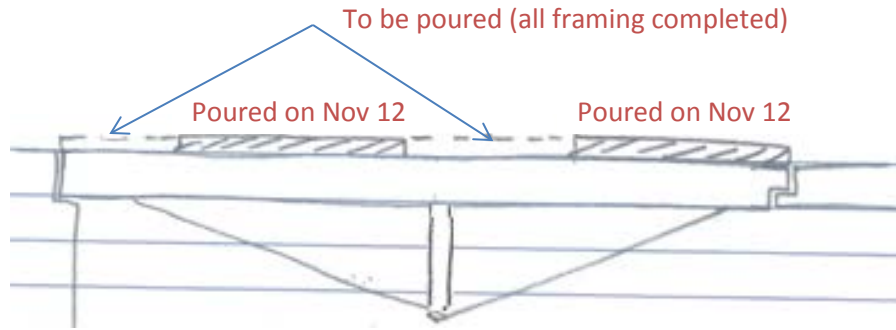
Fig. 33 – Bridge No. 2 Concrete pouring

Concrete was poured on the deck of the 131 ft. span in a staggered manner as indicated in the following sketch.

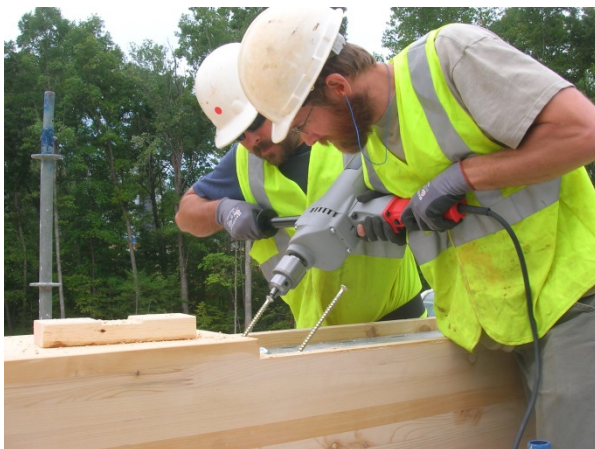
Fig. 52 – Screws being driven for splice flange plates

As discussed earlier in this report, each glulam truss girder was spliced at two locations symmetrical to the mid-span. Three-quarter inch steel plates were provided at the top and bottom flanges with  $2\frac{1}{2}$ " dia. wood screws at 45 degrees on either side of the splice to resist the flexural moment of the girder. To resist the shear, a cut-out was made inside the glulam to place a 12"-long steel tube, HSS 16x8x3/8. Similar to the predicament created by the notches at the ends of the glulam girders, the cut-outs presented a potential for developing cracks if no remedial measures were taken. One of the measures could have been to extend the screws beyond the line

of the cut-outs to arrest potential cracks. Horizontal cracks were observed extending to the bottom of the cut-outs.
