Investigation of the September 1, 2016, Formwork Table Collapse in West Palm Beach, Florida

U.S. Department of Labor
Occupational Safety and Health Administration
Directorate of Construction

February 2017

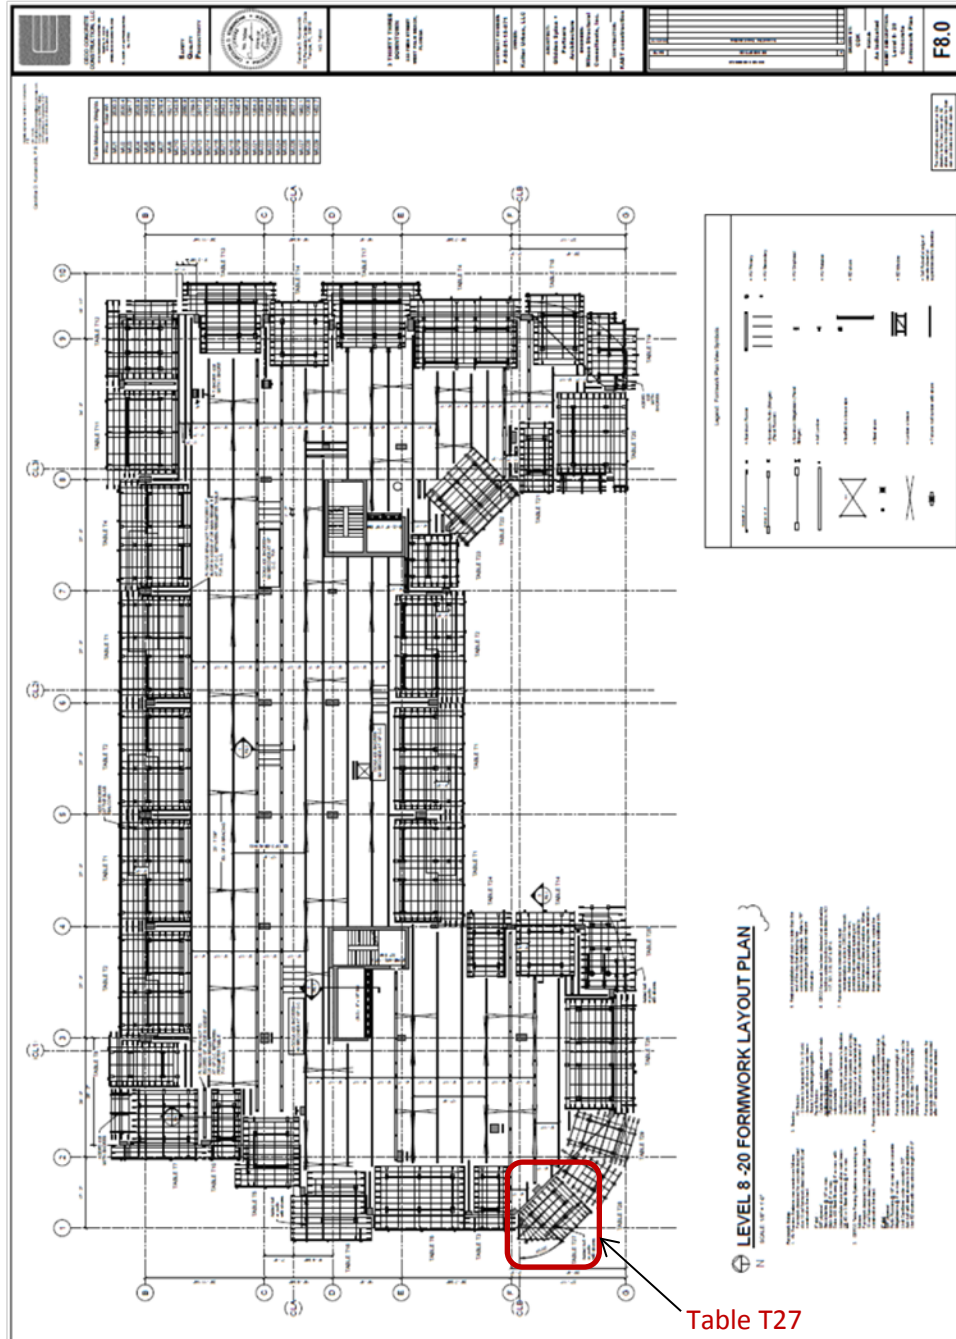
Fig. 3 – Formwork Plan Level 8-20 (CECO drawing F8.0).

Table T27 was different from other tables used at the site. It was distinctive because it had a six-foot of cantilever on two sides. Three additional shores were added in the PE stamped drawing F8.0 to limit the cantilever (see figures 3 and 4). The table-setting crew

did not add the three additional shores, and the table was installed with a cantilever of 6 feet on two sides (see figures 4 and 26). The table setting-crew was working from an unsigned makeup drawing (see figure 5) where the additional shores were not shown. CECO did not design the formwork and its anchoring system for different phases of construction. The field crew did not have proper coordination with the design drawings. The crew did not have proper instructions for anchoring the tables. CECO did not check the stability of the individual tables at different stages.

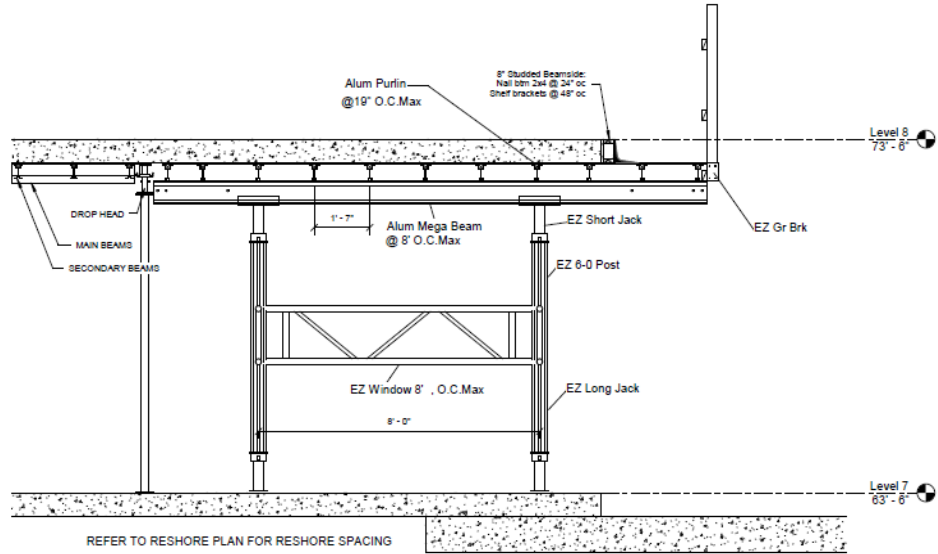
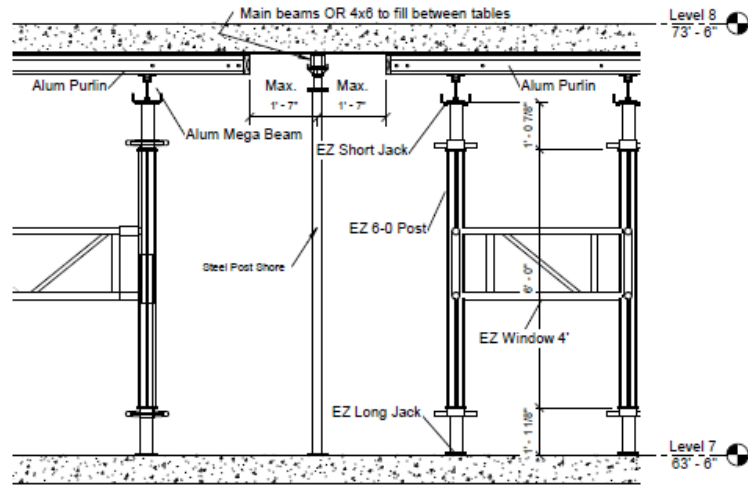
Fig. 6 – Formwork table sections. (From CECO drawing F8.1)

tower. The EFCO tower had four EZ 6-0 Posts with bracing typically consisting of EZ Window 8" and EZ Window 4". At the top, a plywood sheet 5/8" thick was nailed to the purlins. Makeup drawings for Table T27 and T28 are shown in figure 5. A typical section of the table showing EFCO Tower, Mega beams and purlins are shown in figure 6. Installed tables can be seen in figures 7 to 10.
