Investigation of the October 19, 2016, Collapse of Two Scaffold Platforms during Climbing in Miami, Florida

U.S. Department of Labor
Occupational Safety and Health Administration
Directorate of Construction

April 2017

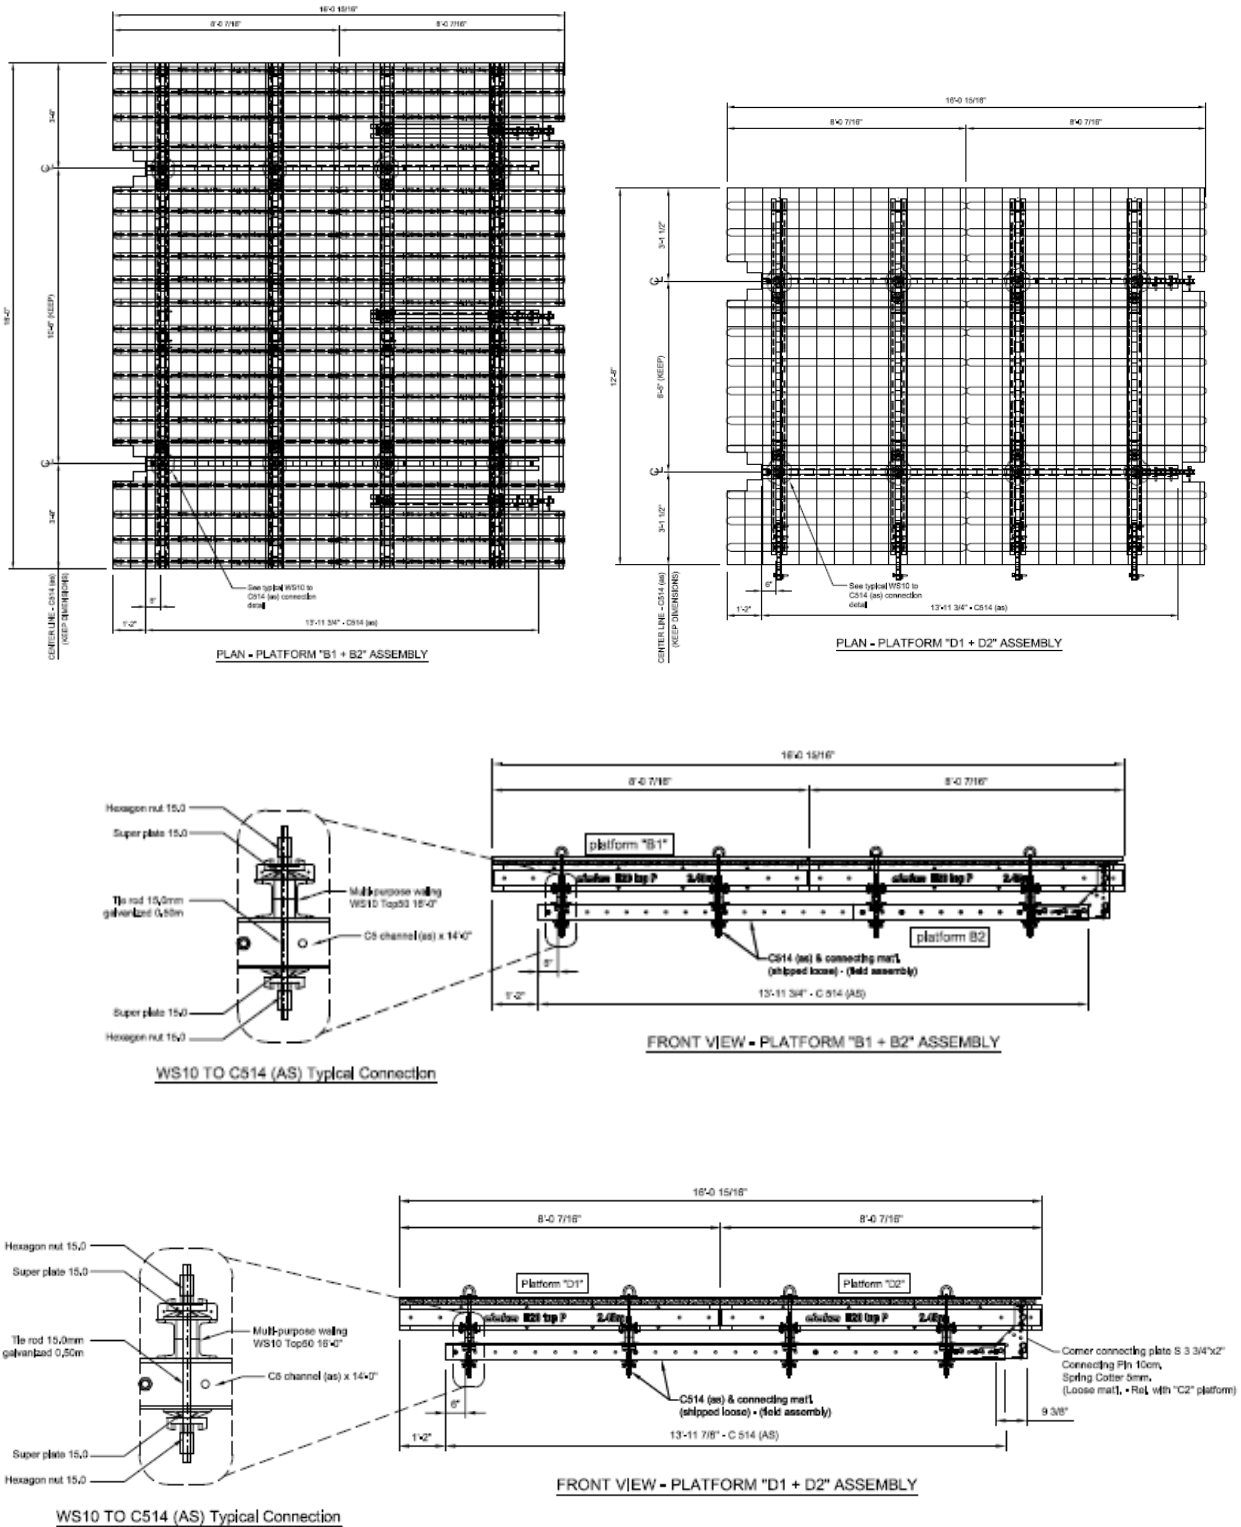
Fig. 5 – Scaffold details from manufacturer drawings (from sheet 3520 and sheet 3526)

On the day of the incident there were three platforms being raised on the north side of the building. Among these three, two of them were the larger B platform 18'x16' in size (B1+B1 combination), and the third was a smaller D platform 18'x12' in size (D1+D1 combination); see figure 5. All three of them were being raised from the 47th floor to the 48th floor. The distance between the two larger platforms was about 7 feet. CECO placed approximately 16 purlins, approximately 20'-6" long, spanning the two larger platforms (see figure 8), and also placed plywood over these purlins; therefore CECO converted this space between the larger platforms (about 7 feet x 16 feet) into a deck. By this arrangement CECO was carrying the purlins between the floors and was also using the space to carry the materials while climbing the platforms. The smaller D platform (18'x 12') was independent, separated from the larger platform by about 7 feet and was on the east of the larger platforms. The arrangement of the three north side scaffolds at the site is shown below in figure 8 and the two scaffold platforms that were involved in the incident are identified.

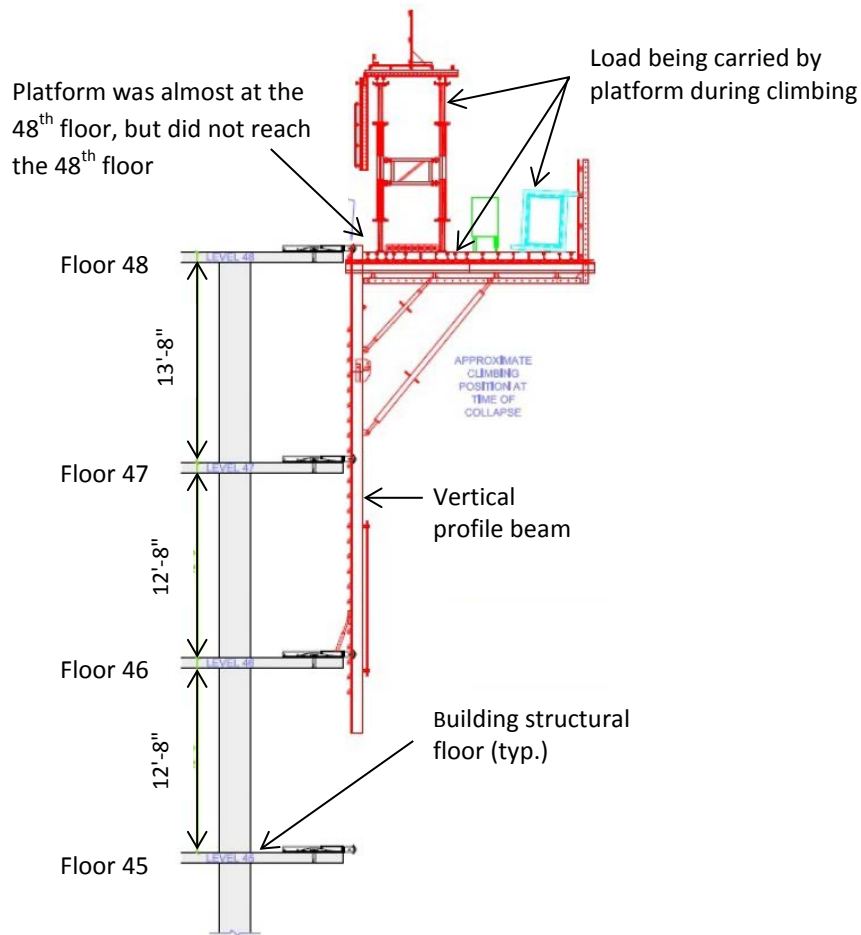
Fig. 18 – Depiction of the platform section loaded with material (provided by CECO)

After the incident, the collapsed platforms and fallen materials were moved to a yard in a nearby location. Before moving the materials, an inventory of the debris was prepared by CECO under the guidance of OSHA. From the material inventory, the two failed platforms together had a superimposed load of approximately 13,000 pounds while the platforms were being climbed by hydraulic repositioning (see figure 18 and appendix). This was a violation of the manufacturer's loading requirement and the contractor thereby violated OSHA regulations 29 CFR 1926.451(f)(1) *"Scaffolds and scaffold components shall not be loaded in excess of their maximum intended loads or rated capacities, whichever is less."* The scaffolds failed and the materials on the two platforms fell to the ground.

47 is 12'-8" and height between floors 47 and 48 is 13'-8". Platform is in climbing position with a vertical cantilever height of 13'-4". Slab shoes connected to floor slabs in floors 46 and 47. The live load was assumed to be 6,500 pounds with a combination of point loads and distributed load to simulate the actual condition at the time of the incident.

From the results for cases 1, 2 and 4, the stresses in the scaffold were within the allowable limits. For case 3, the stresses in the scaffold were within the ultimate strength stress as required. For case 5, which simulates the actual condition, the scaffold components failed with D.L.+L.L. combination. The combined stresses in the vertical profile beam were greater than the ultimate strength stress, and the vertical profile beam was stressed beyond its capacity.
