**STRUCTURAL COLLAPSE AT THE
OLYMPIC SWIMMING VENUE
ATLANTA, GEORGIA
MARCH 18, 1996**

U.S. Department of Labor
Occupational Safety and Health Administration

June, 1996

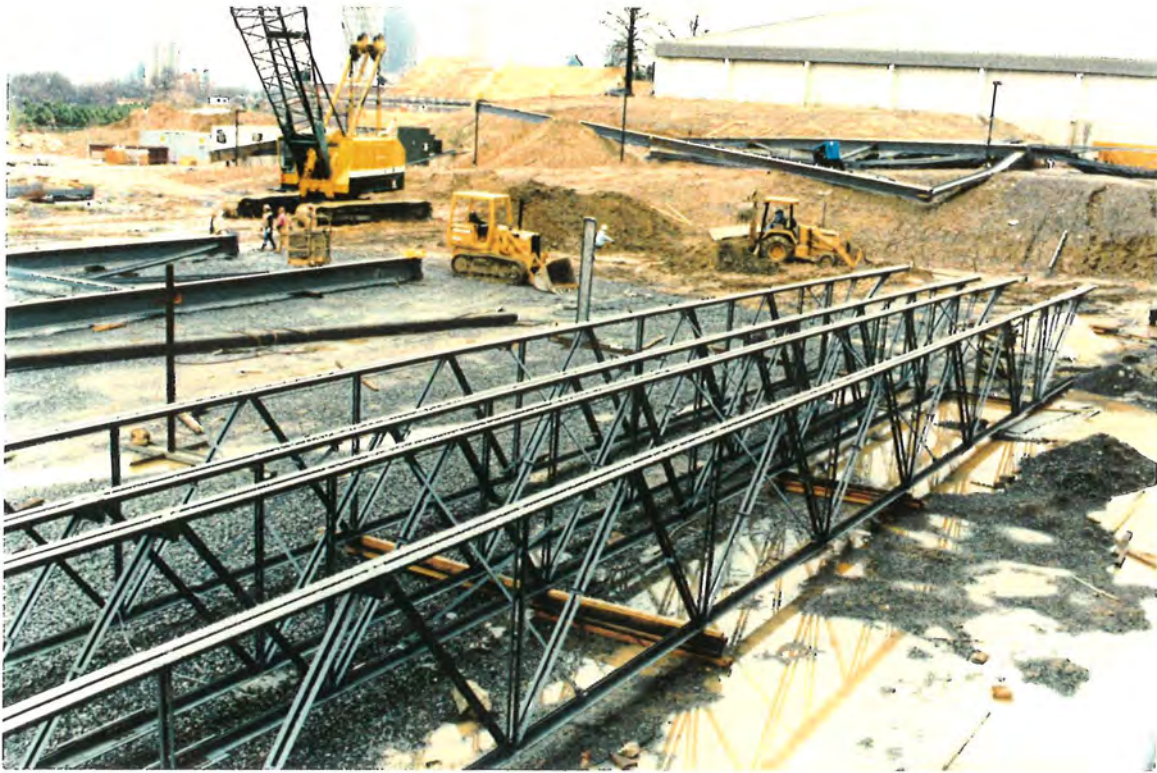
The steel erector, HELMARK, opted to assemble two joists, as a pair, on the ground with all diagonal bridging lines installed. Eight sets of diagonal bridgings were installed along the span, and they were spaced at approximately 20 feet on centers. Figure 2.5 shows two photographs of paired joists which had been assembled on the ground. After the paired joists are assembled on the ground, they are rigged and lifted via a crane to be placed on their specified locations. After installing the first pair, HELMARK intended to continue erecting subsequent pairs of joists in the same fashion. Once the subsequent pairs were set, ironworkers were to connect the pairs together with the specified bolted diagonal bridgings.

PAIRED JOISTS ASSEMBLED ON GROUND

Top Photo shows two pairs (4 - 88 SLH joists) assembled on ground, ready to be hoisted

Right photo shows diagonal bridging between two joists

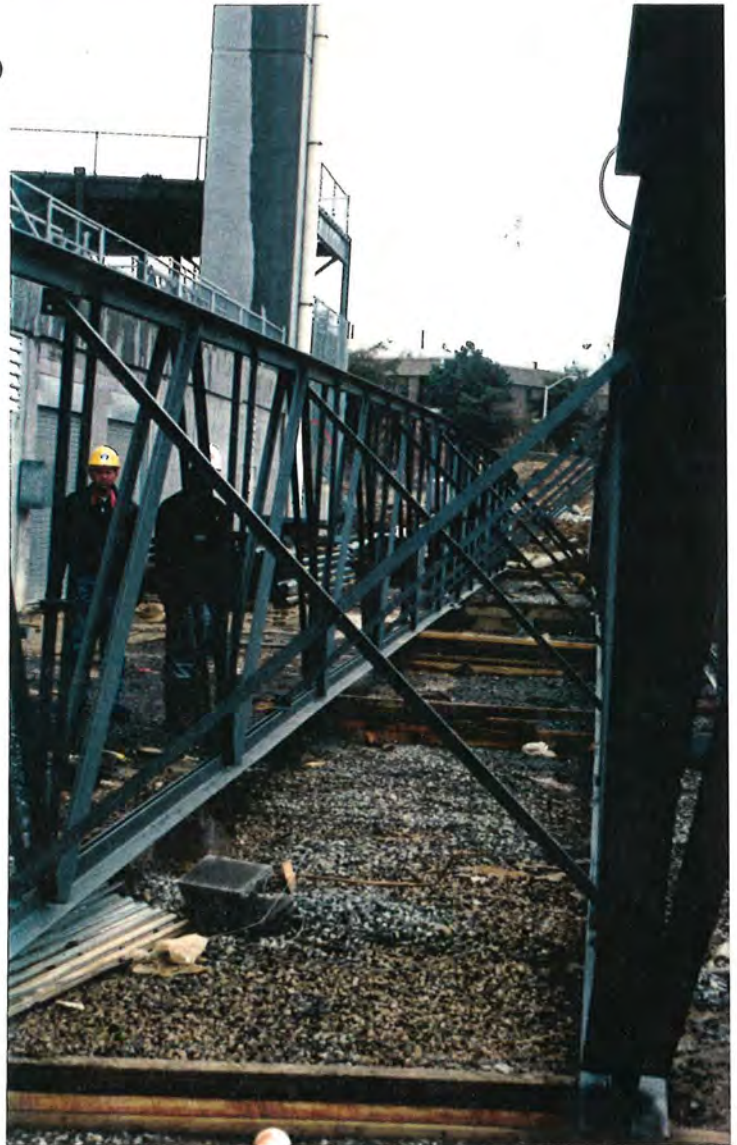
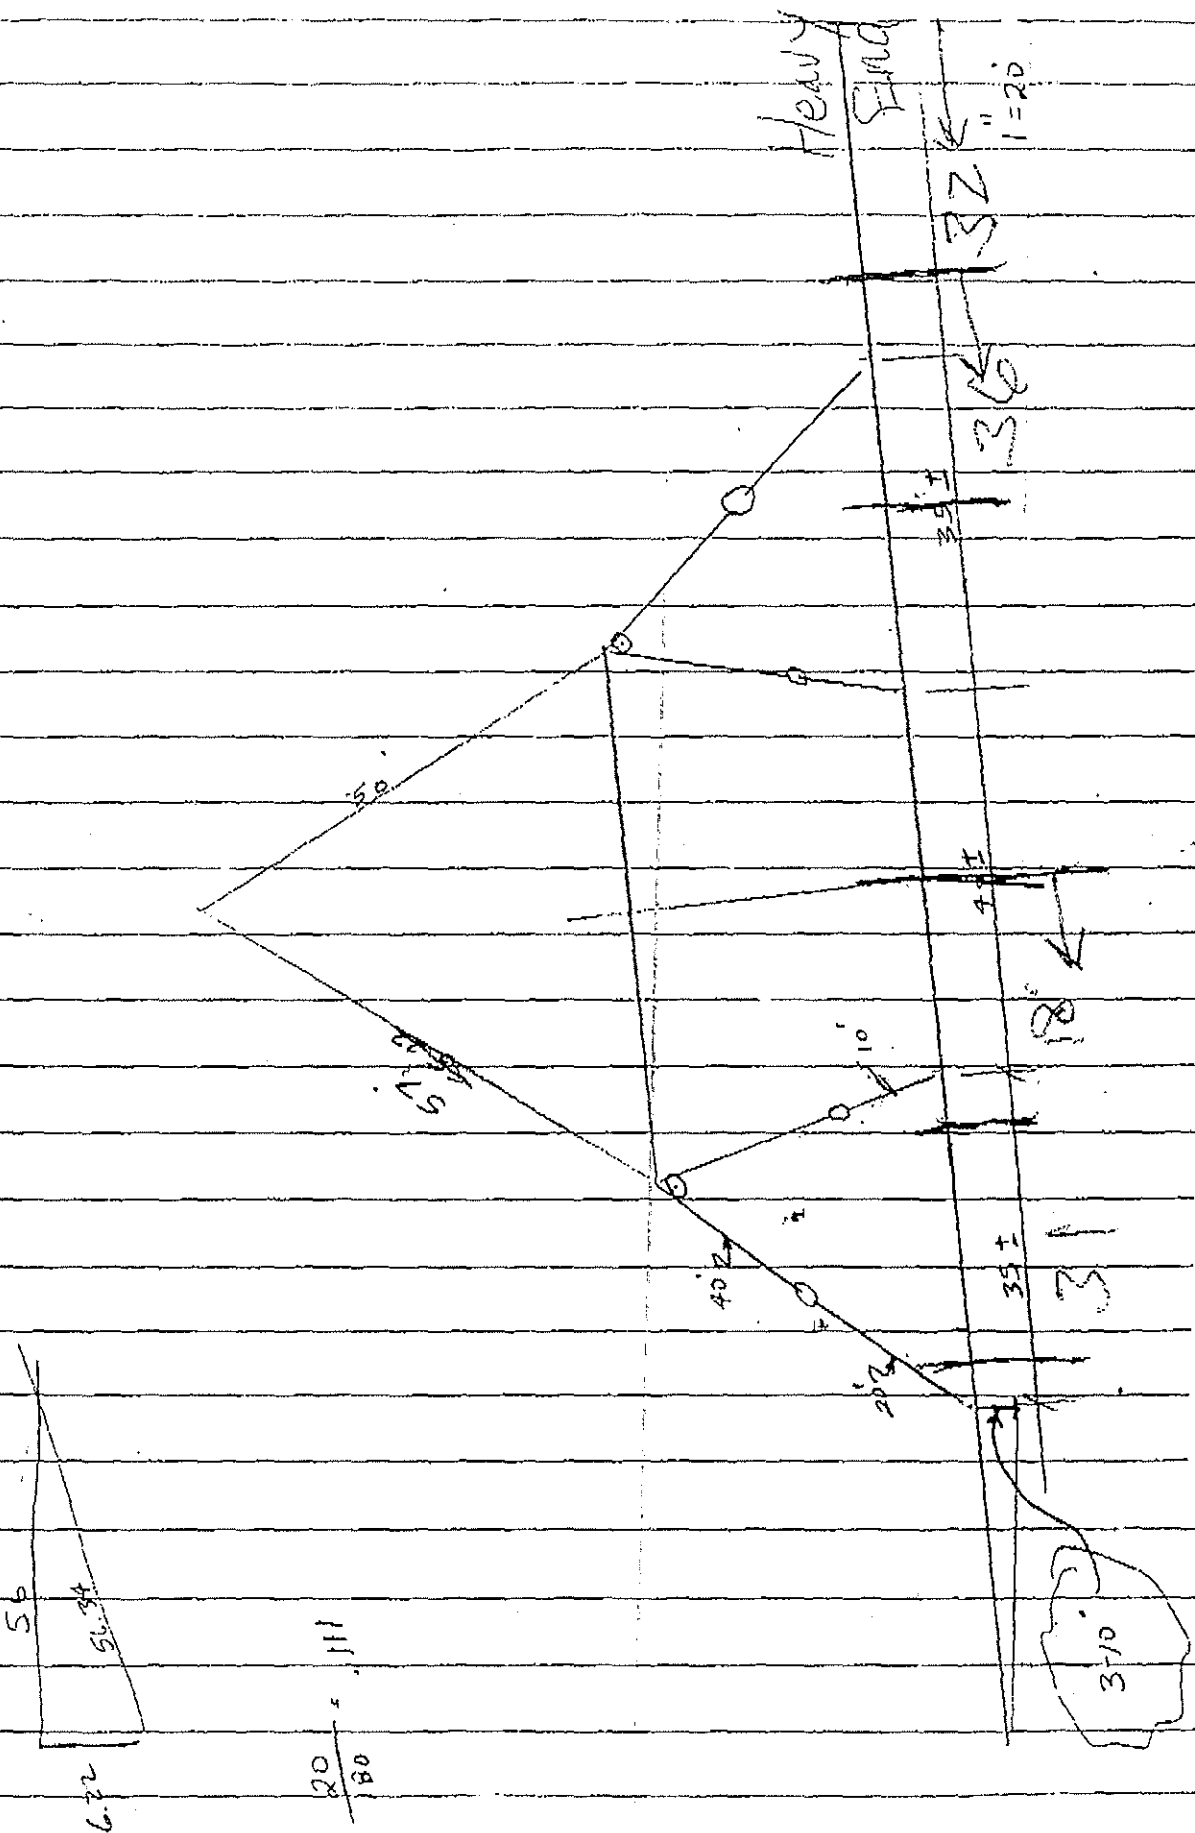
Figure 2.6 - Helmark's Rigging Sketch For Hoisting the Paired Joists

There was no written erection plan developed for this job. HELMARK developed a sketch after consulting with VULCRAFT for the rigging of the paired joists. Figure 2.6 is a copy of that sketch. This sketch was developed after an original attempt to lift a paired joists resulted in the failure of the welds in some of the joist members. The cause of the weld failures was alleged to be the stresses induced on the structure due to the inappropriate

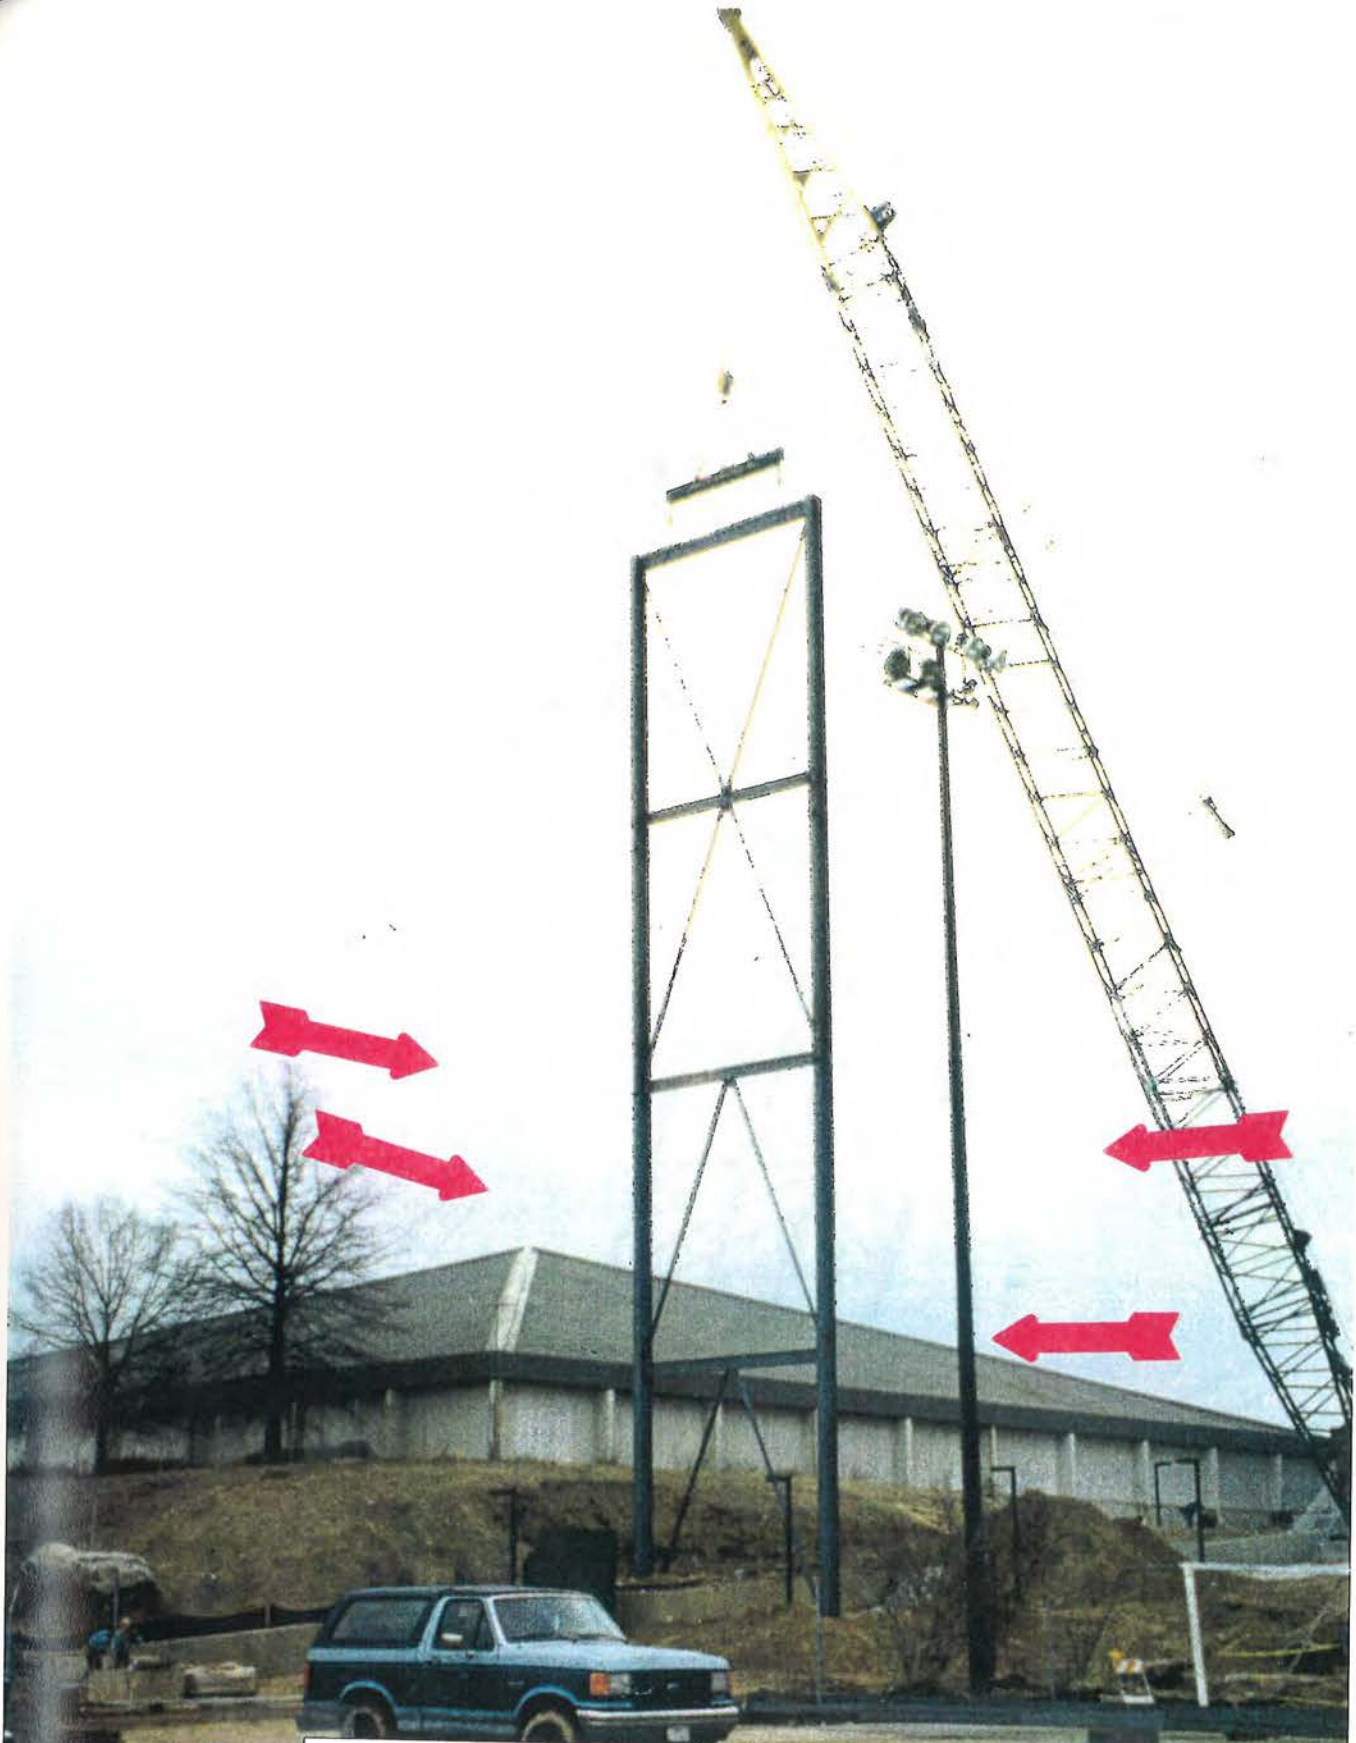
| Date/Time | Activity |
|---|---|
| 6. March 18, 1996 (Day of event) | o The steel frame was erected by the HELMARK ironworkers at columns 11B & 11C. This included: a) raising the frame with the crane; b) bolting the frames legs (columns) to the concrete footings; c) connecting the temporary guy supports to deadmen; d) plumbing the frame; and e) tensioning the guys. See Figure 4.1. |

Setting Steel Frame at Column Line 11 B & C
(Arrows depict temporary guy lines)
Figure 4.1
21

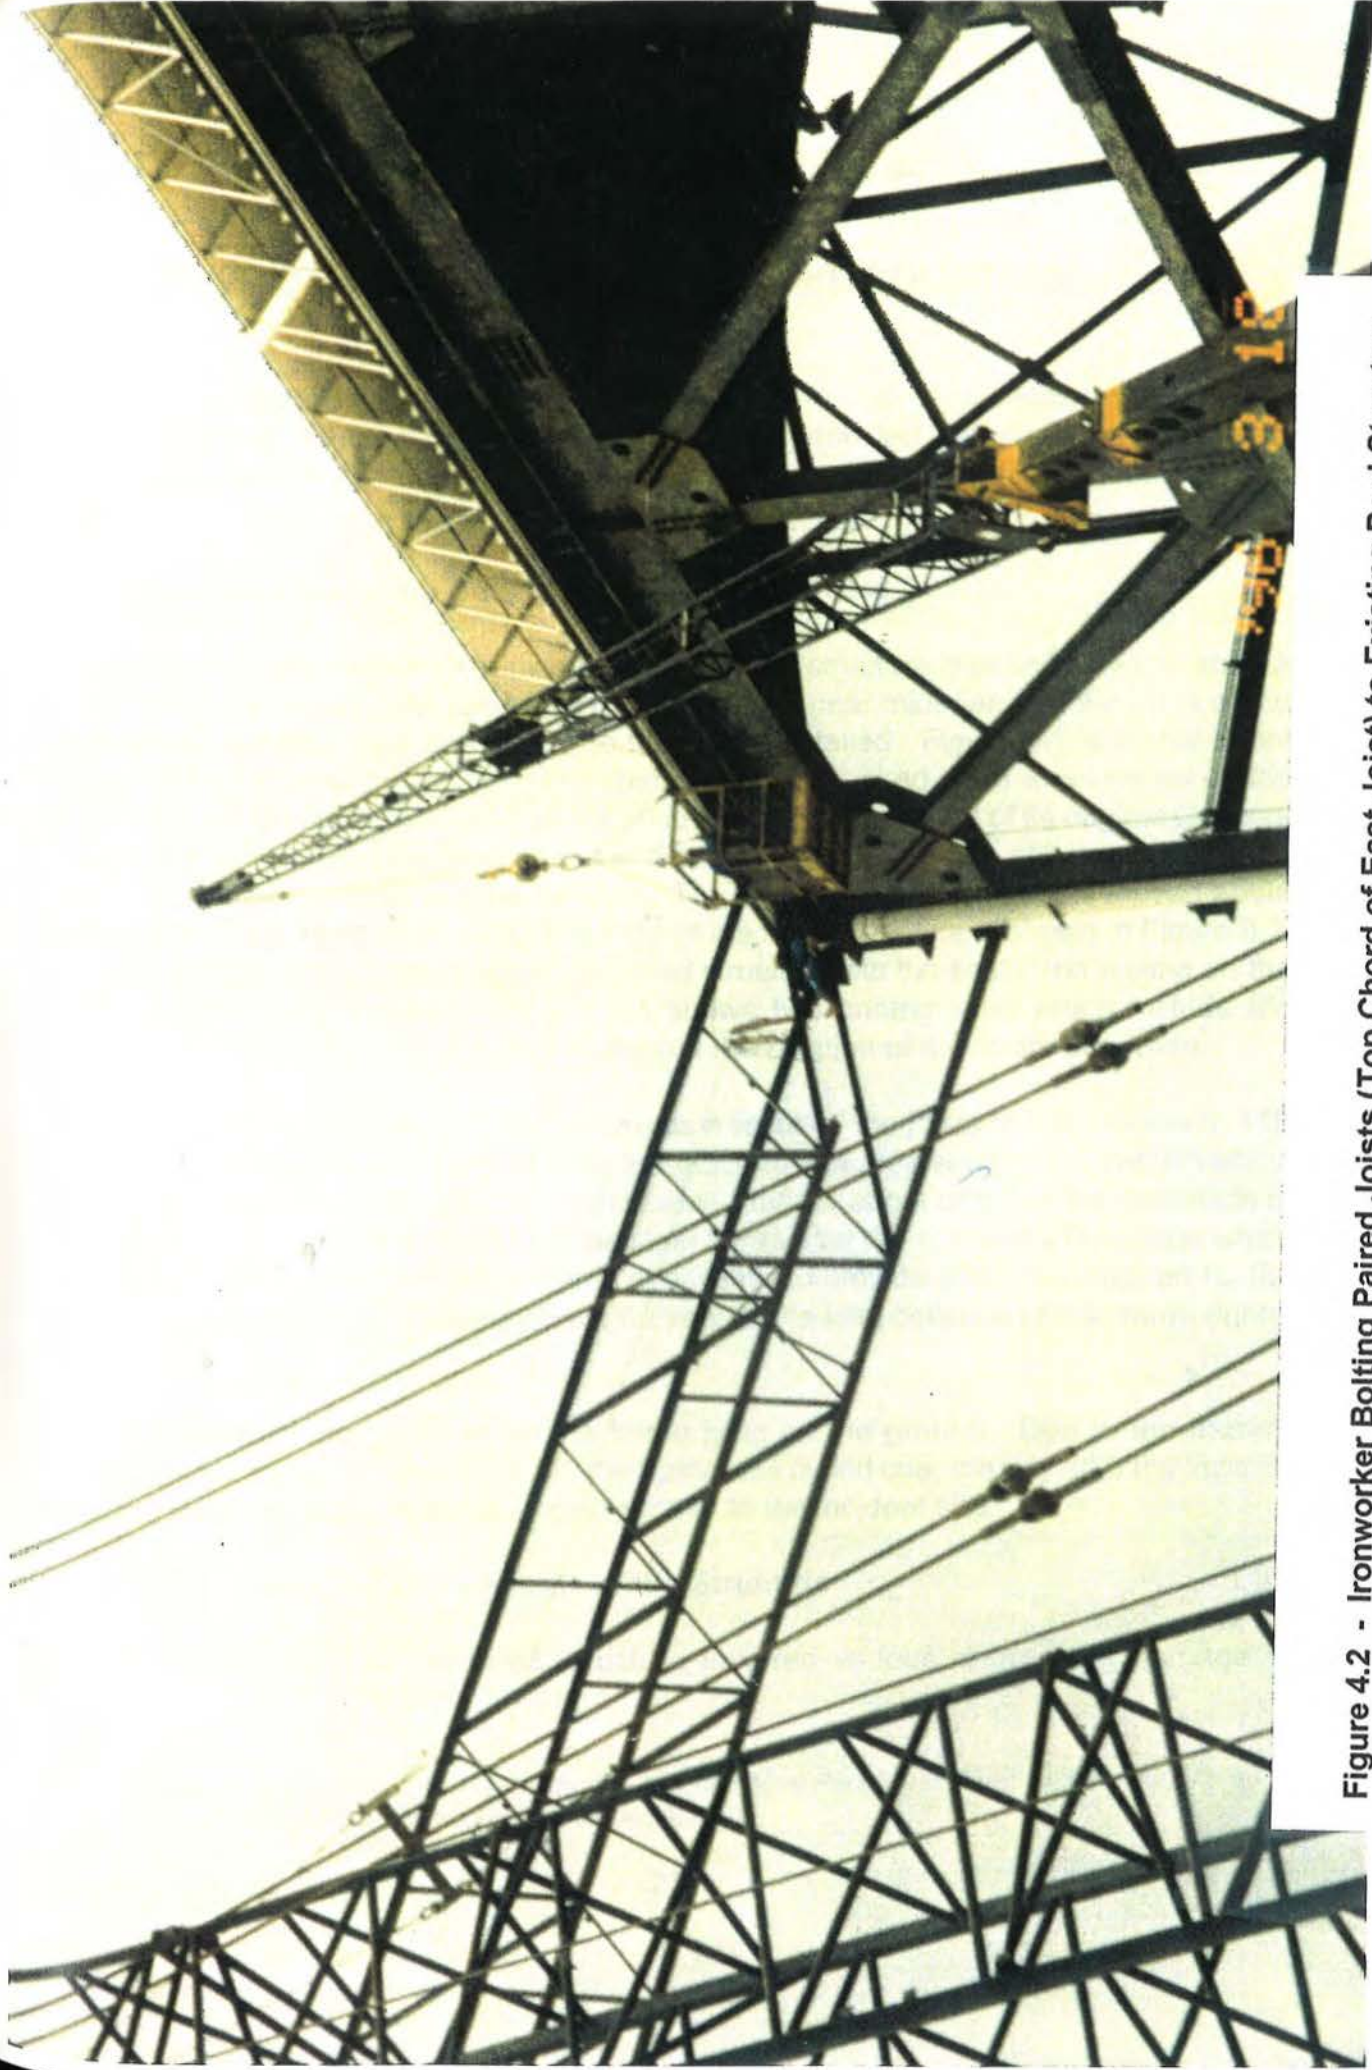
Figure 4.2 - Ironworker Bolting Paired Joists (Top Chord of East Joist) to Existing Pool Structure

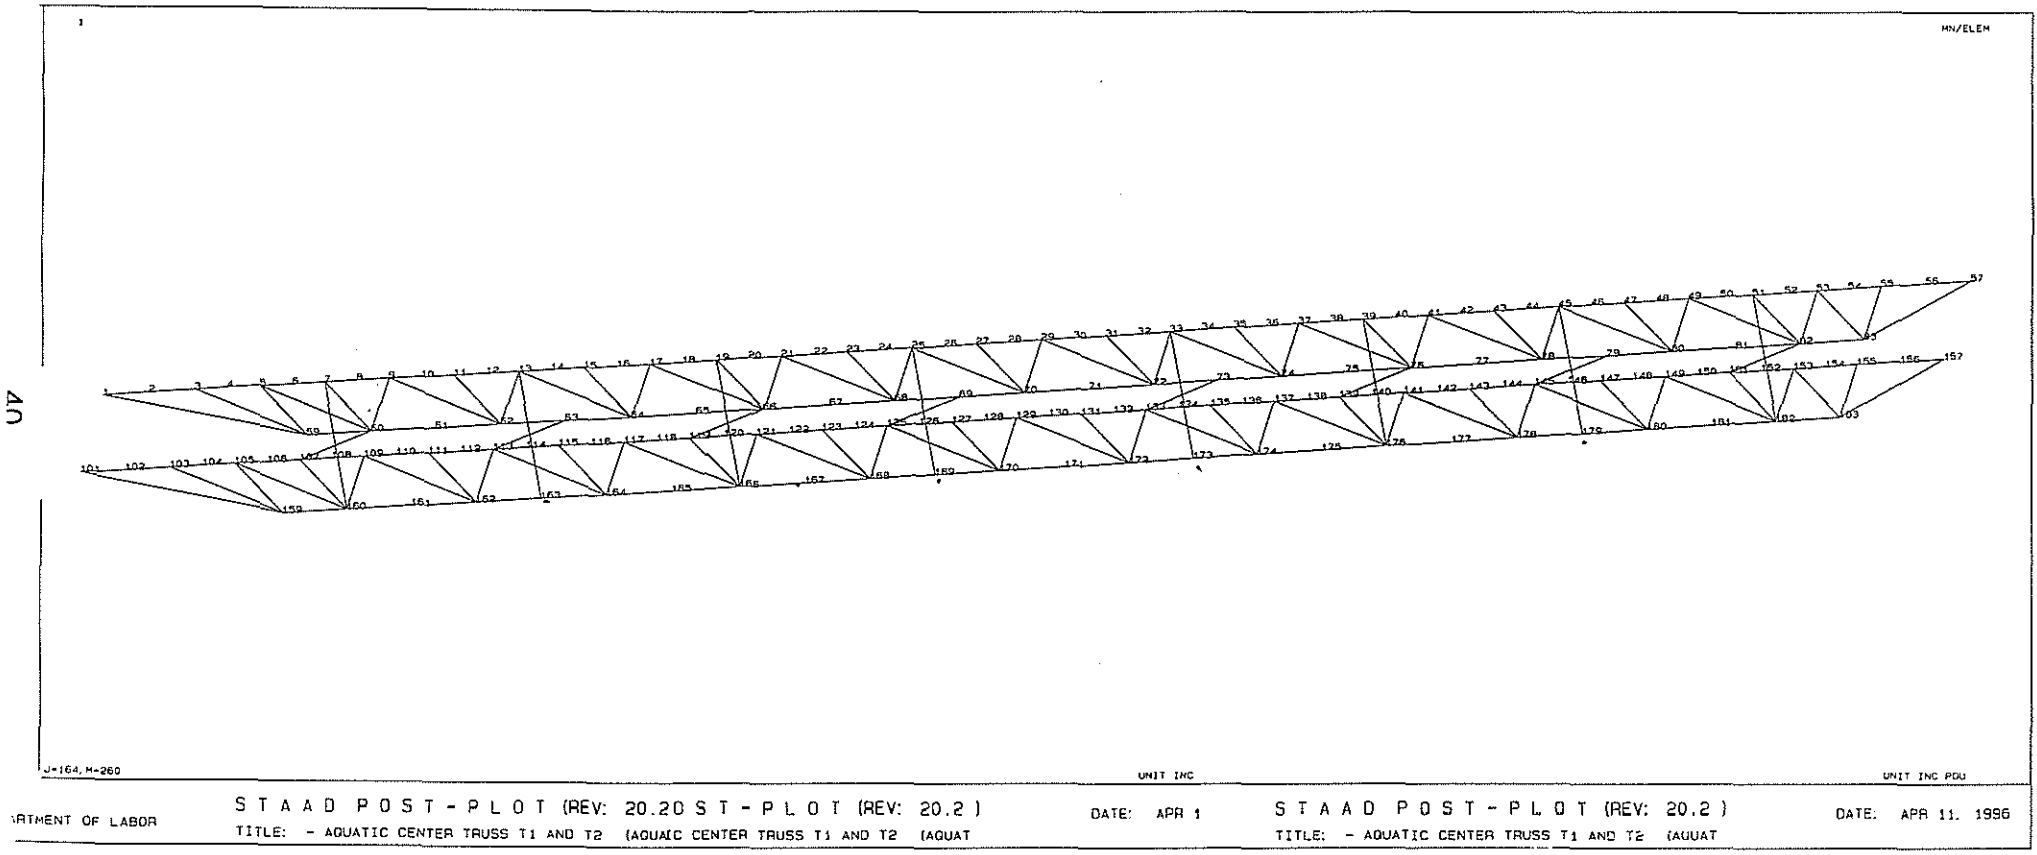
Figure 6.1 - Computer Model of the Paired Joists

A three-dimensional space frame computer model, consisting of 164 joints and 260 members, was developed for the analyses which represented the erected roof joists, marked 3T1 and 3T2, and their eight sets of diagonal bridging, see Fig. 6.1. The diagonal bridgings were assumed to have been located symmetrically with respect to the center line of the joists and have been connected to the top and bottom chords of the joists at their panel points.

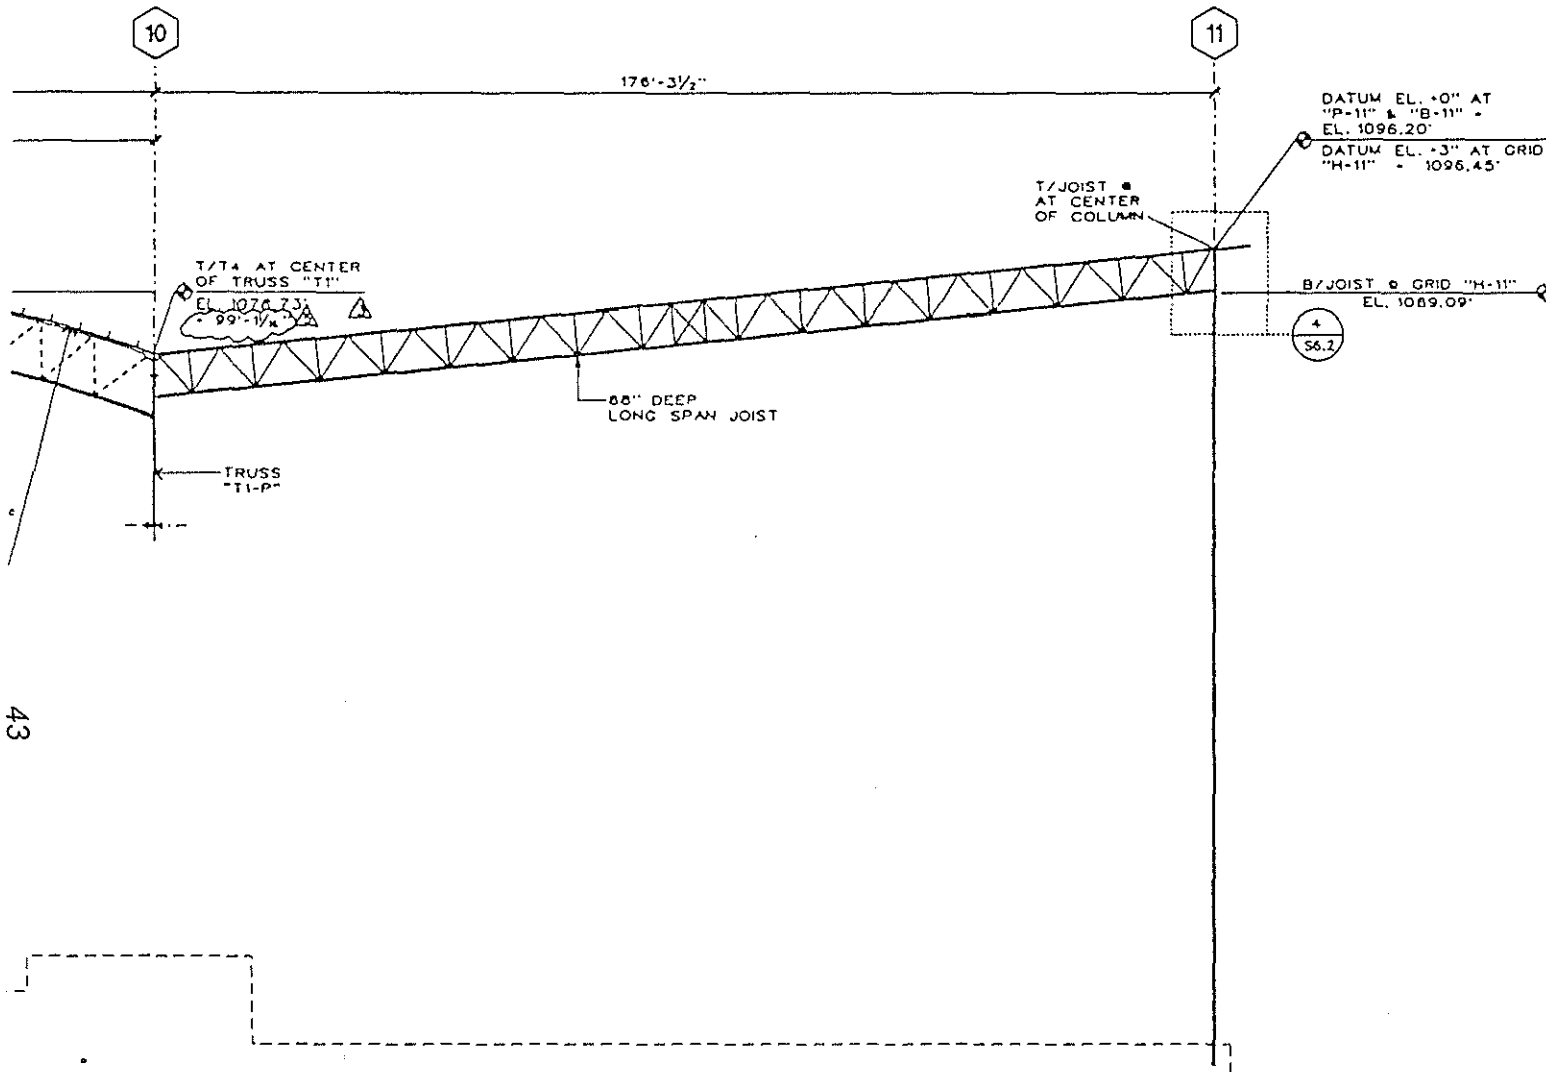
Figure 6.4 - Elevation Showing Sloping Joists on End Supports

- o. The joists were sloping from the south toward the north end. Their bearing ends were placed on the steel members at the specified locations. The slopes of the joists were established as per the bearing elevations shown on the structural drawing prepared by the project structural engineer of record, see Fig. 6.4.

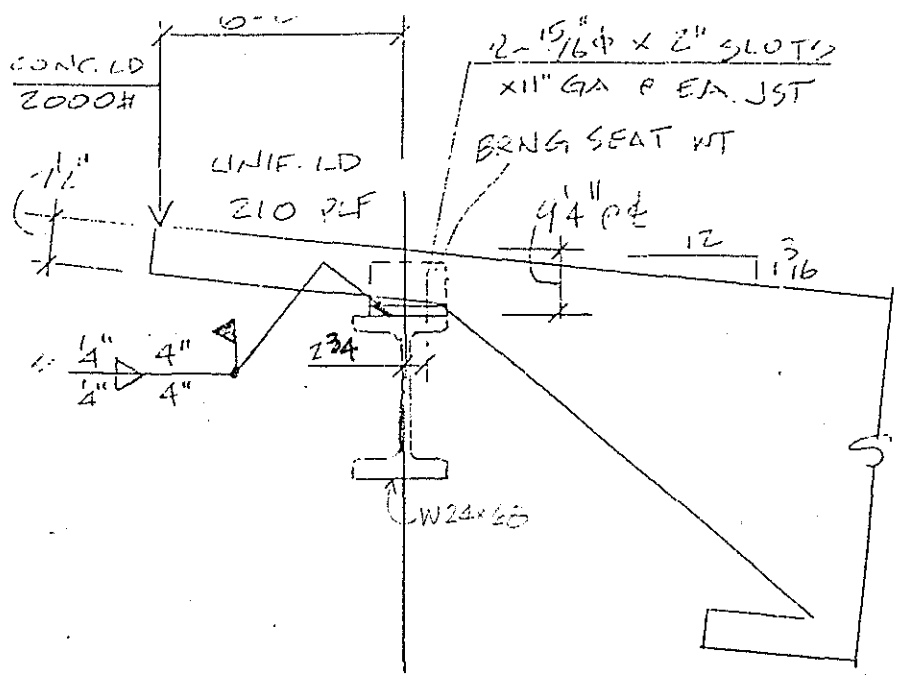
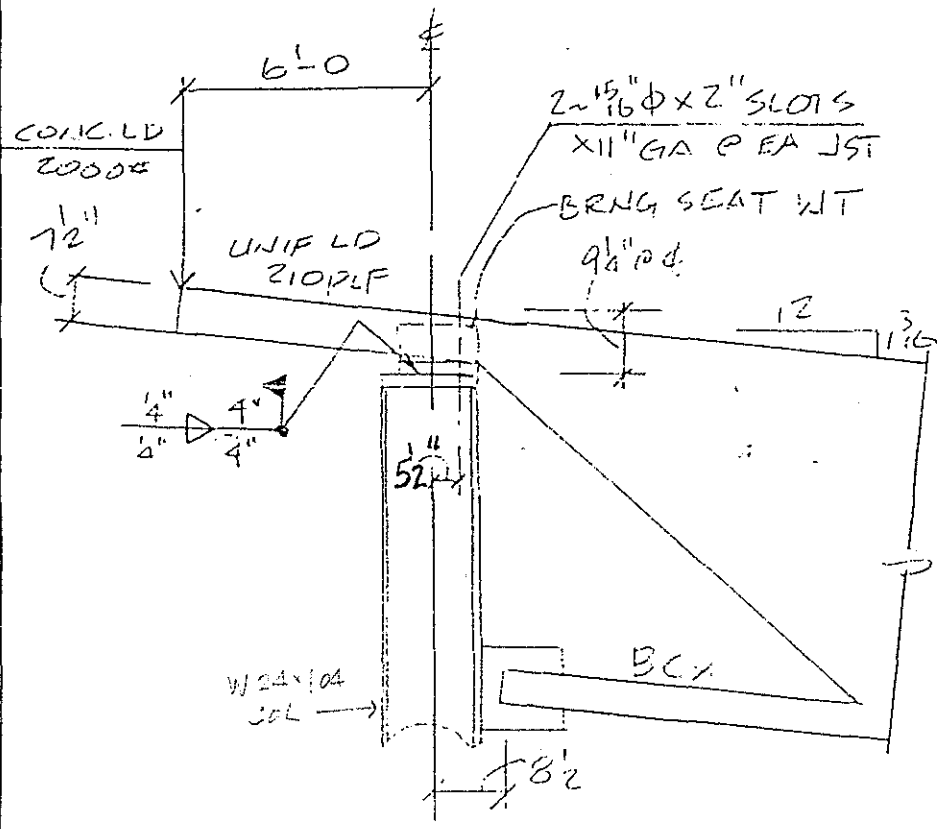
Bearing Detail of Joist on End Supports
Figure 6.5

They were, therefore, assumed as "roller" supports in the computer modeling. See Fig. 6.5.

The erection drawing prepared by the joist manufacturer indicated different bearing details for joists T1 and T2 at their north ends. The T1 joist was to be positioned at the top of a steel wide flange beam whereas the T2 joist was to be supported on top of the steel column member, see Fig. 6.5. Due to these different support conditions, the span lengths of the two joists between the bearing ends were not identical, i.e., 177'-3/8" for T1 joist and 176'-4 3/4" for T2 joist, see Figs. 6.2 and 6.3. The length variations have been taken into consideration in modeling.

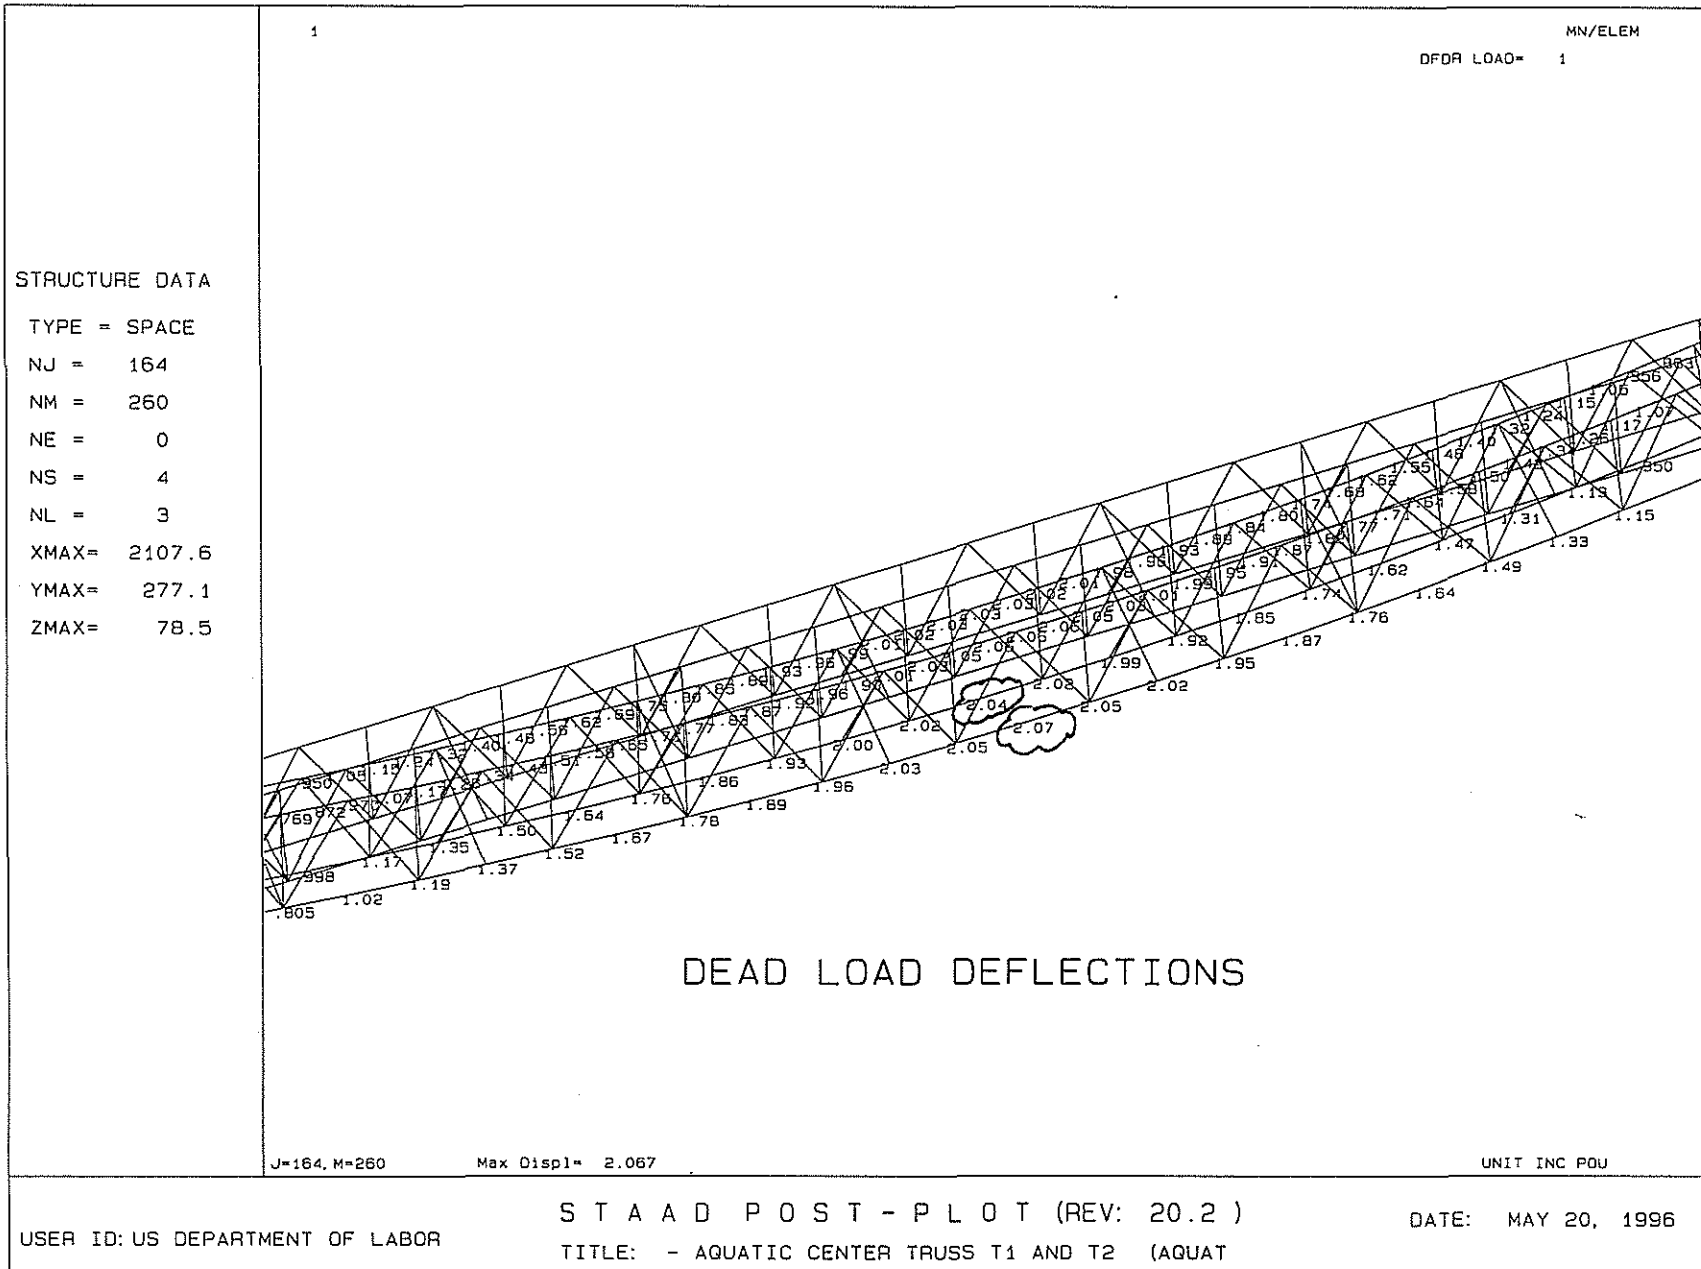
Figure 6.7 - Computer Model Showing Maximum Dead Load Deflections in the Paired Joists

- (4). The maximum deadweight deflections at the mid-span of the joists were approximately 2.066" and 2.039" for joist T1 and T2 respectively. The maximum mid-span deflection would be approximately 8.23" and 8.12" for the joists under the full design loads. See Figs. 6.7 and 6.8. The difference in the midspan deflections due to the varying overall joist lengths was insignificant and would not be a cause of failure.

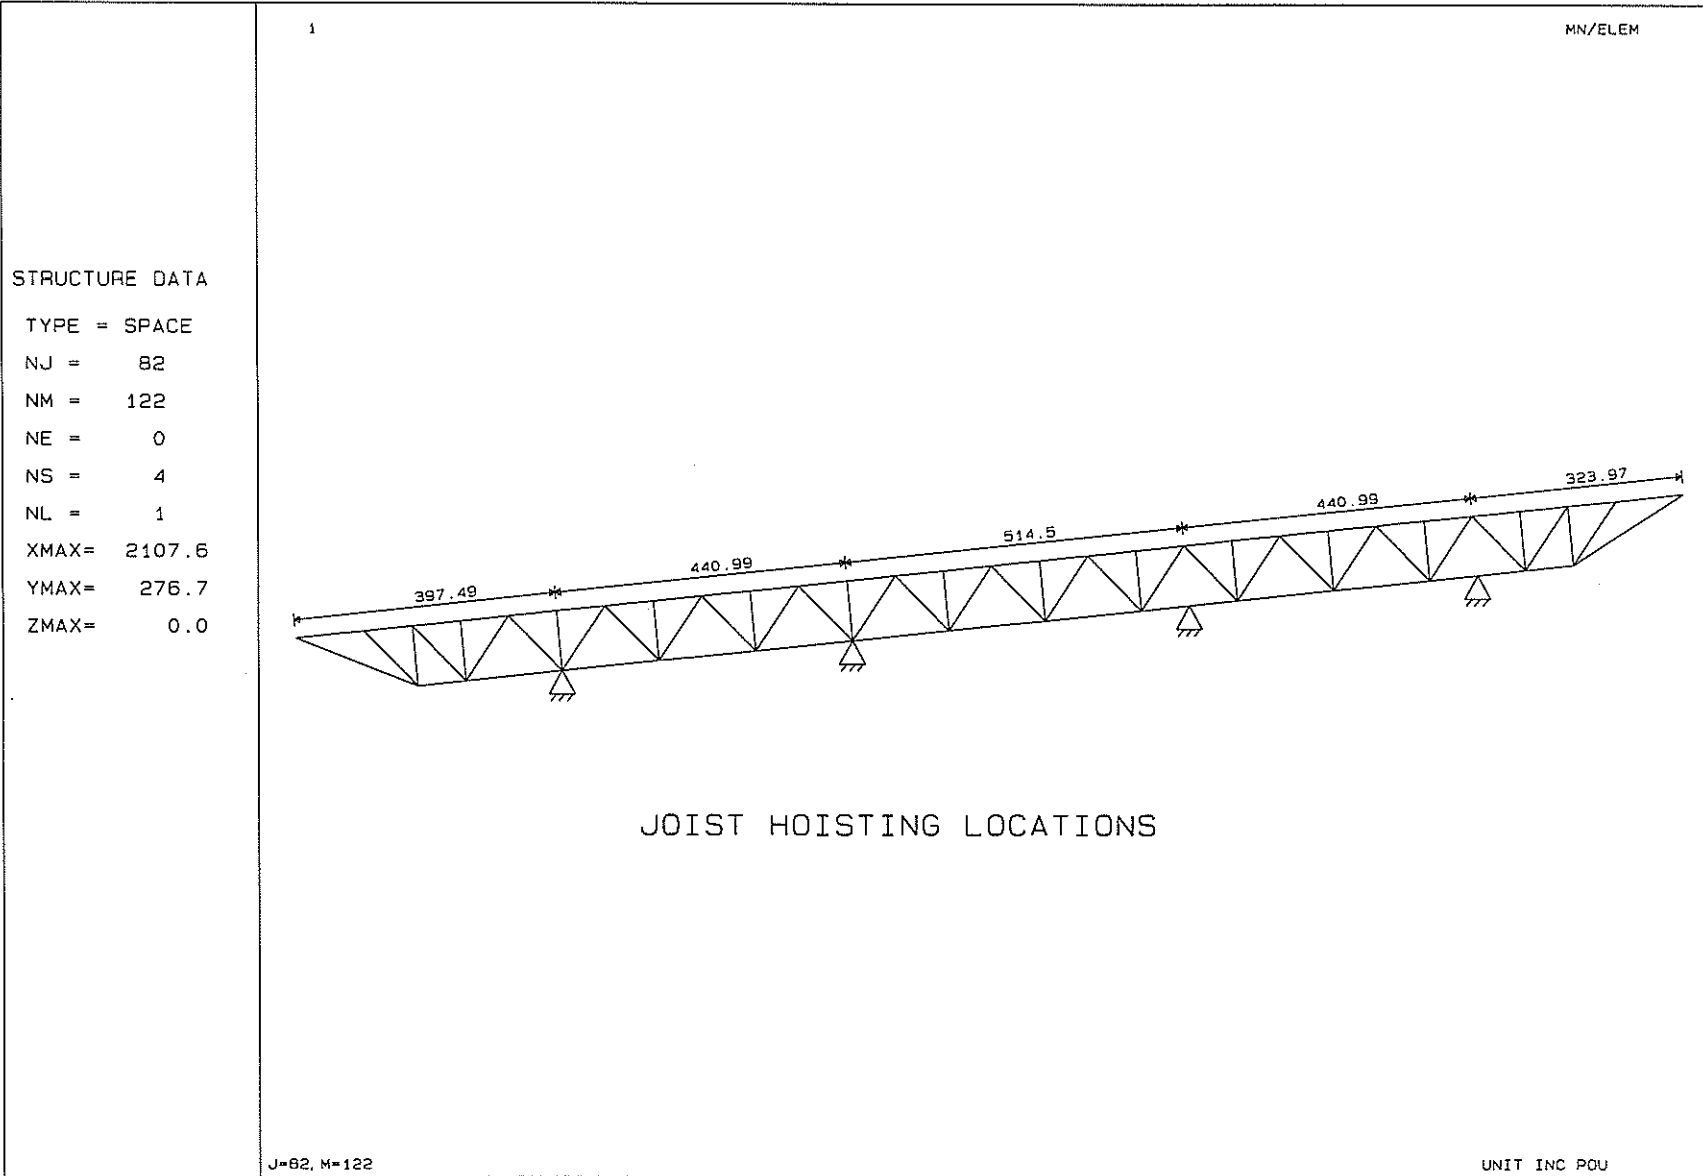
Figure 6.9 - Computer Model of the Rigging Support Points

- (5). The joists were hoisted at four places before being placed to their final elevation. Therefore, the joists were analyzed to determine whether the manner in which the joists were lifted contributed to the failure or not. Based on lifting locations shown in Fig. 6.9, it was concluded that the forces induced into the joists members during lifting/erecting operation were minimal and were all within the acceptable range.
